Tanami Gas Pipeline: Annual Compliance Assessment Report EBPC

E-REP-069

Date: 7 August 2023

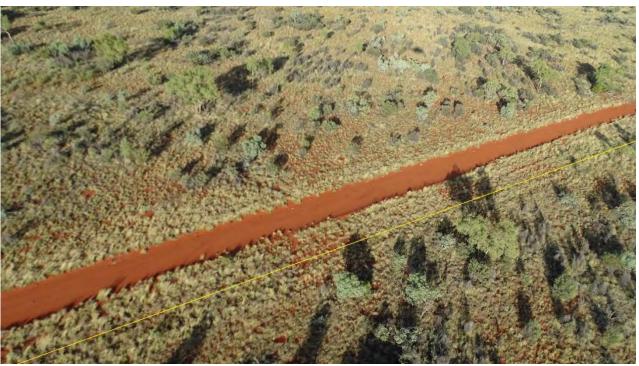
KP 0.605 – 1.897

- Below images show the current condition of the corridor and access track between KP 0.605 KP 1.897
- Corridor is thickly covered in Buffel Grass

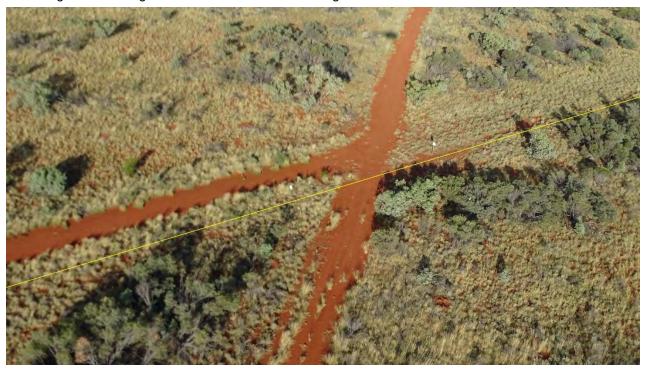
Gravel Rd to No.26 Bore

No significant changes observed to the road crossing.

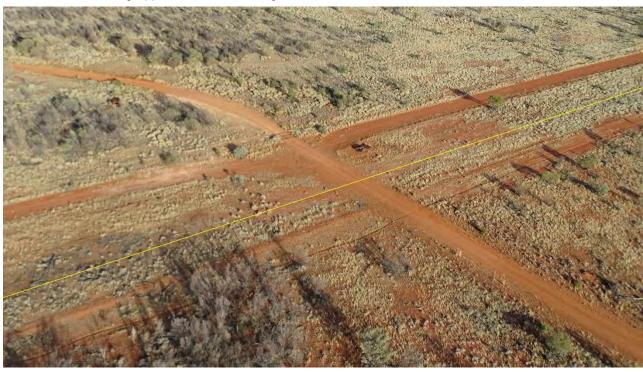
New Well Rd KP 13.44 The road crossing appeared to remain in good condition.

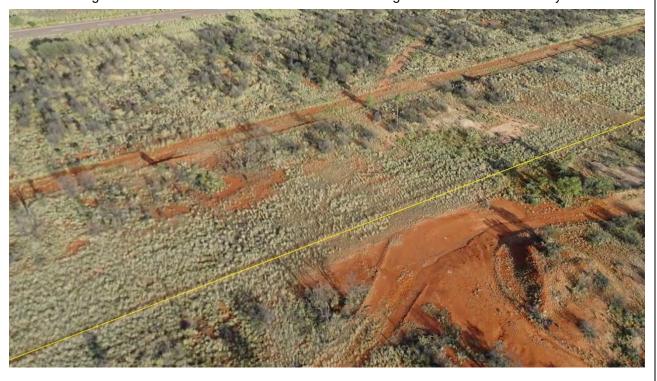
Gravel Track to Water Bore RN16883 KP 21.83 Below images shows the current condition of the road crossing and access track to the laydown area.

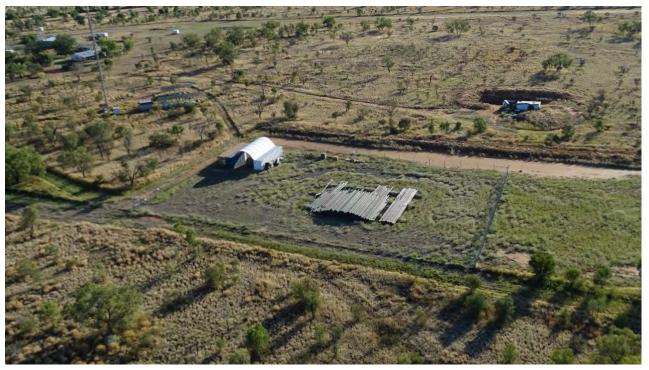
Tilmouth Road House Compound

- All appeared correct and secure at Tilmouth compound.
- Significant build up of grass observed since last flight.

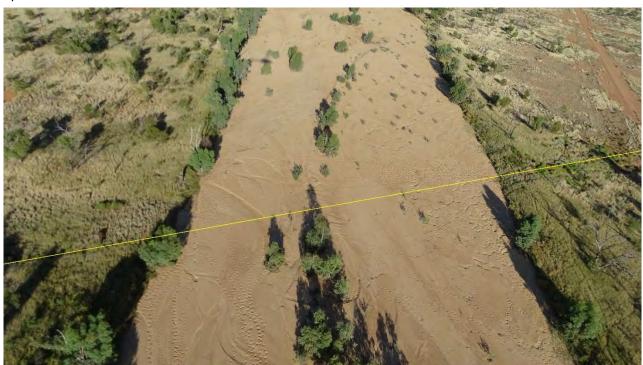
April 2023:

- Below image shows the current condition of the creek.
- Upstream bank had significant damage but no major changes since Feb 2021.

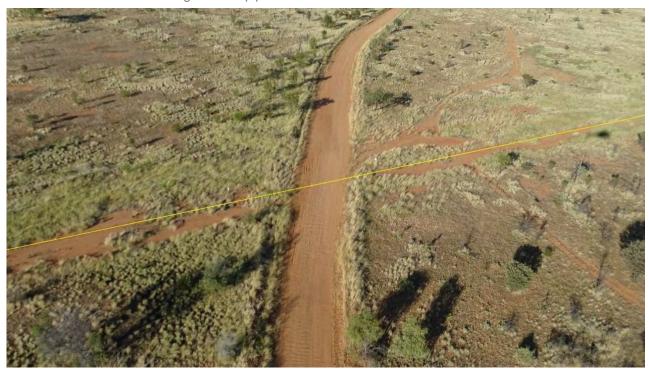
Napperby Station Access Road

- Below image shows the current condition of the access road.
- Minor water erosion damage across pipeline area.

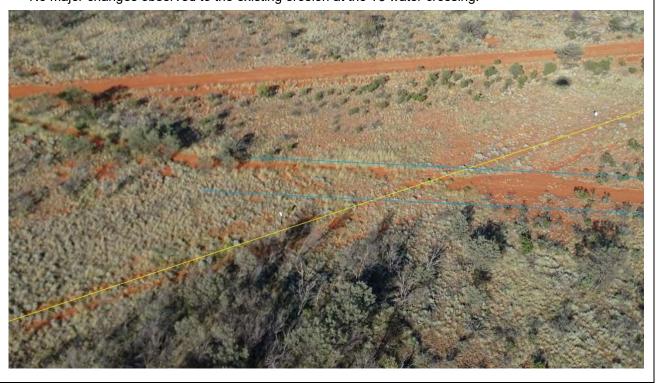
KP 40.01

No major changes observed to the existing erosion at the T3 water crossing.

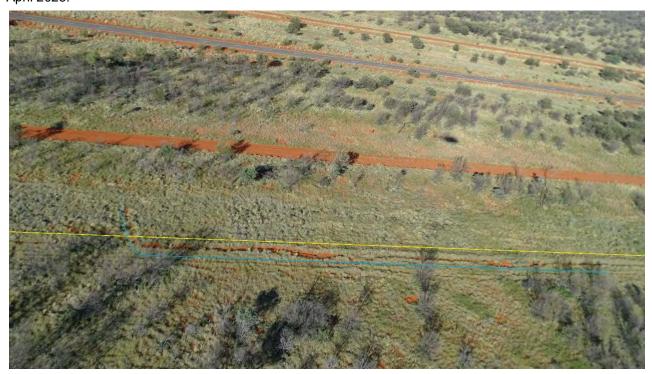
KP 42.00 – 46.00

- Below images provides an example of minor water erosion between KP 40 KP 46.
- Most erosion through this section is now unable to be observed due to vegetation cover. April 2023:

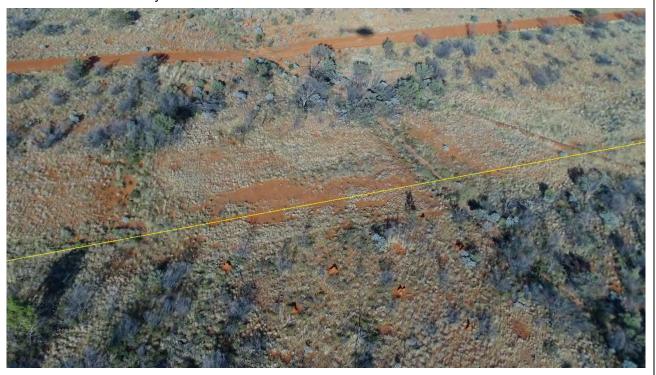
KP 47.06

• Below image shows the current condition of the T2 water course crossing, minor water erosion damage to the bottom of the system.

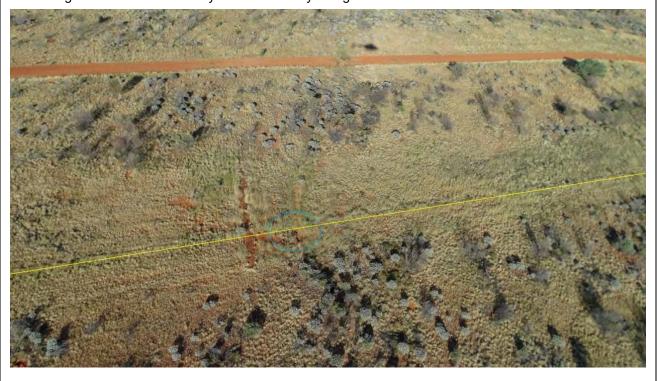
KP 47.50

• Below image shows the current condition of the T3 water course crossing, moderate water erosion damage to the bottom of the system covered by overgrowth.

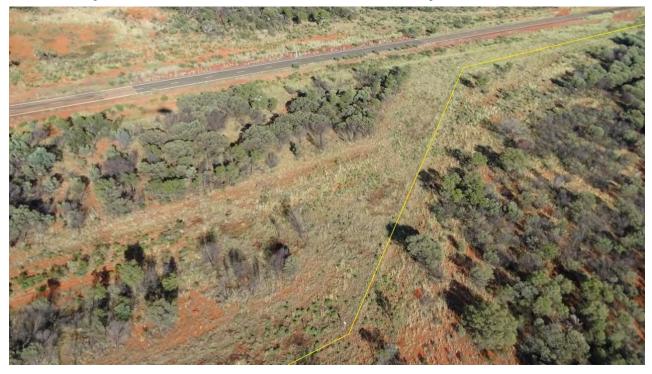
ROW KP 111.33 Below image shows the ROW condition; easement has thick Buffel grass cover at this location.

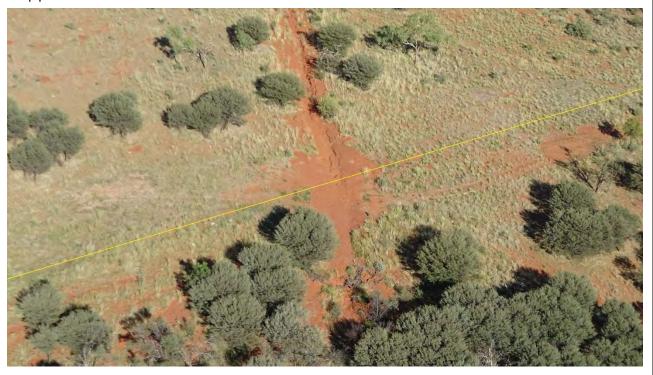
KP 133.60

• Image below shows no significany changes observed to the moderate erosion developing across the pipeline at this location.

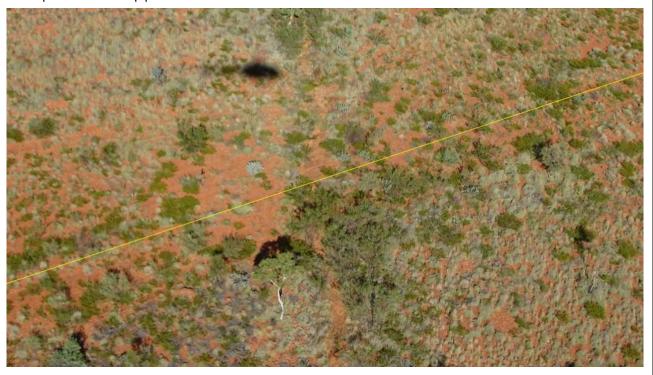
KP 136.86

• T3 water course crossing the pipeline has minimal damage to its banks; the hard clay appears to be exposed over the pipeline area.

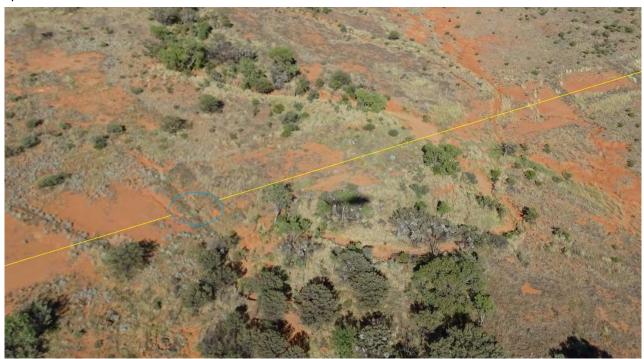
April 2023:

- Creek appears to be in reasonable condition and no significant change to erosion observed since the time of last flight.
- The erosion appears to be at least 1m in depth on the D/S bank.

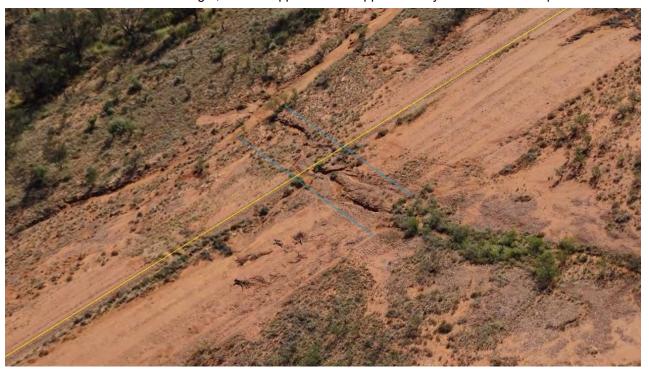
KP 156.13

• Below image shows moderate water erosion developing across the pipeline, no significant changes observed since time of last flight; erosion appears to be approximately 200-300mm in depth.

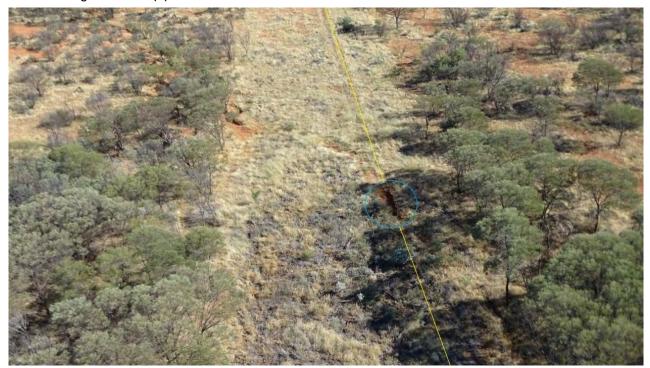
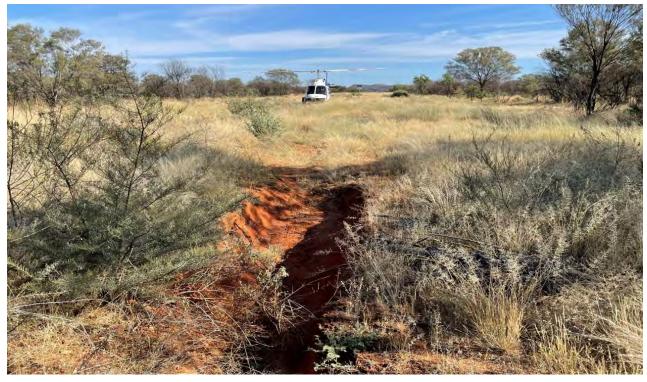
- Below image shows the current condition a of previously reported significant water erosion area.
- Helicopter landed and fould the erosion is 900mm in depth, with approximately 600mm of cover remaining above the pipeline.

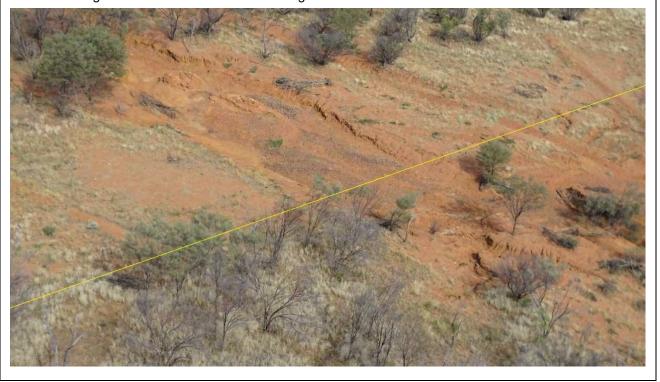
KP 229.61 Water Course T3

Below image shows minor to moderate damage to the banks of this creek.

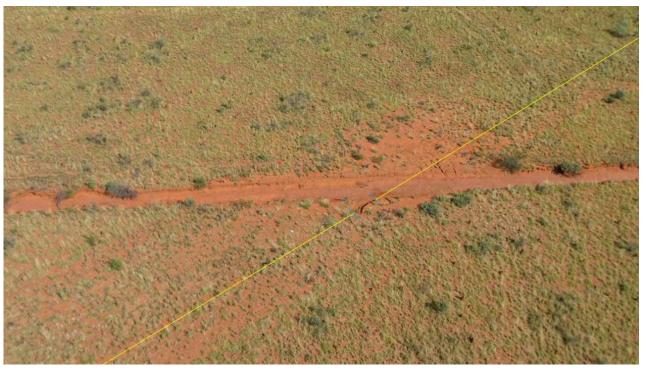
KP 241.18

- No major changes observed to the significant erosion on the upstream bank of the swale drain.
- This had increased in size over the past 6 months following heavy rains prior to February 2023.

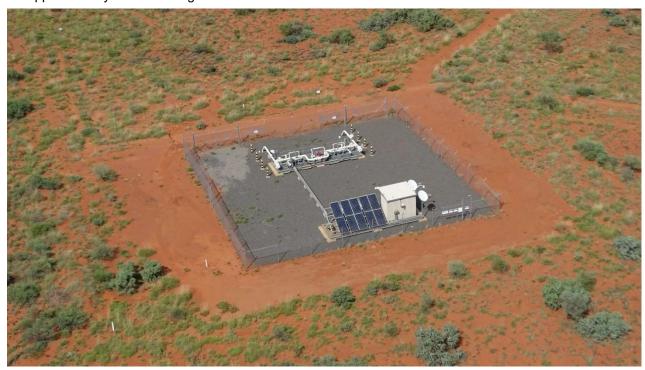
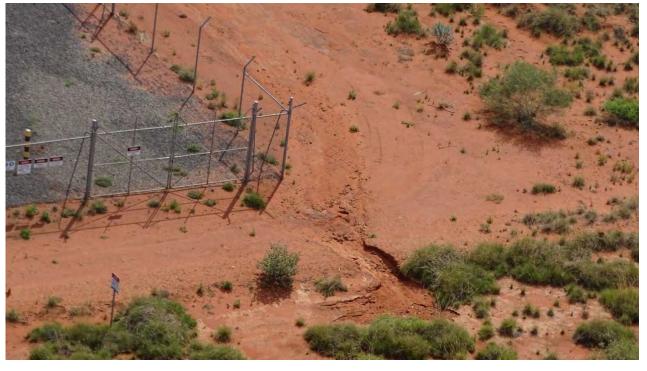
- Appeared correct and secure at the facility.
- No significant changes observed to the previously noted erosion; 400mm deep, 600mm wide and approximately 4 metres long.

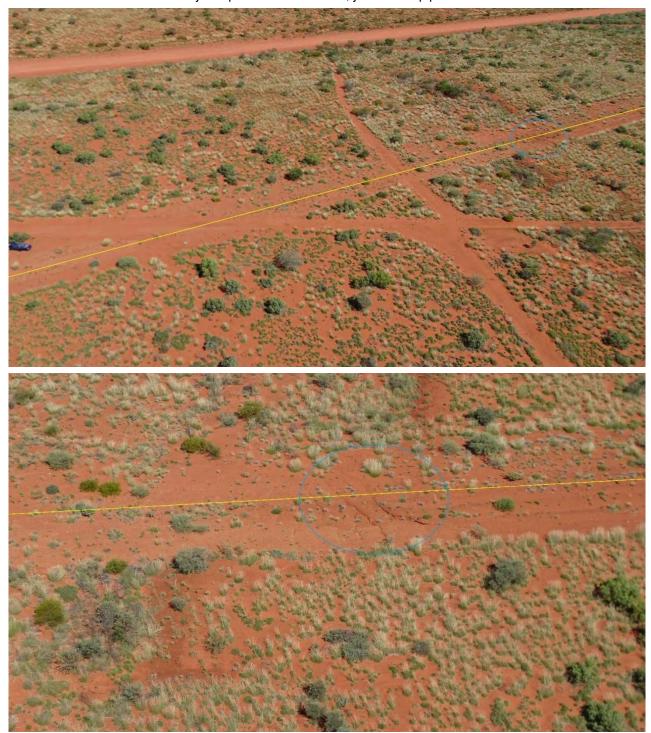
- Access track to the gravel extraction site in proximity to the easement appears in good condition.
- Moderate erosion observed just upstream of the track, just off the pipe centreline.

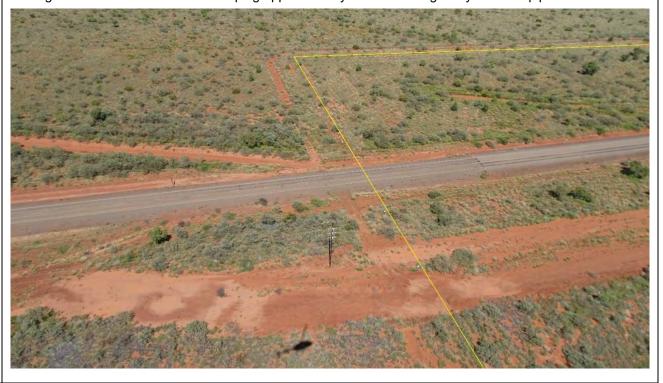
- Below image shows the Mine Road crossing the pipeline remains in good condition.
- Significant water erosion is developing approximately at the crossing away from the pipe centreline.

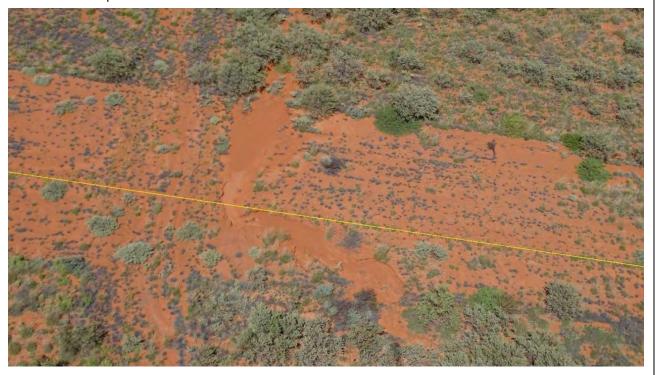
• No changes observed to the significant water erosion at the T3 Water Course; erosion is approximately 600mm in depth.
