Tanami Gas Pipeline

EPBC 2017/7997

COMPLIANCE ASSESSMENT REPORT 2018-2019

E-REP-035

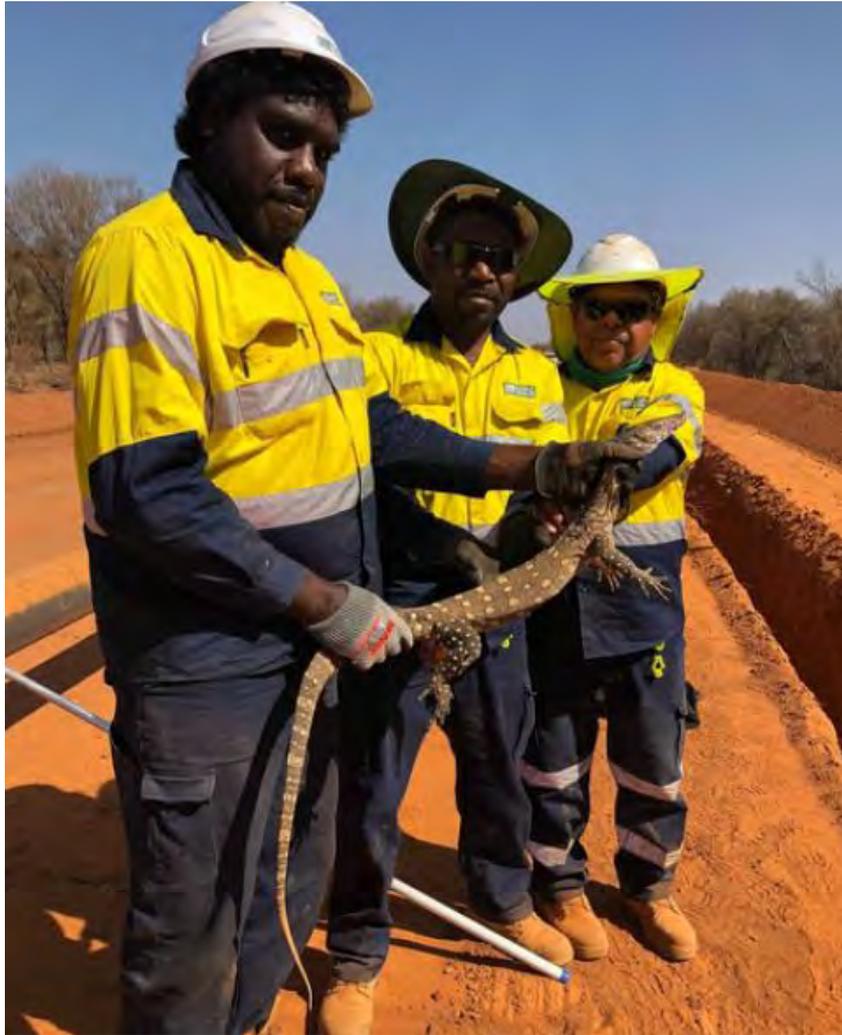
Figure 2: Fauna team conducting removal from trench

The project implemented a rigorous fauna management process to ensure animals impacted from the construction of the trench (under the Trench Clearing Procedure) had a high chance of being found and relocated. Over 16,000 animals were interacted with during the project construction and stringent controls were in place to mitigate impacts.

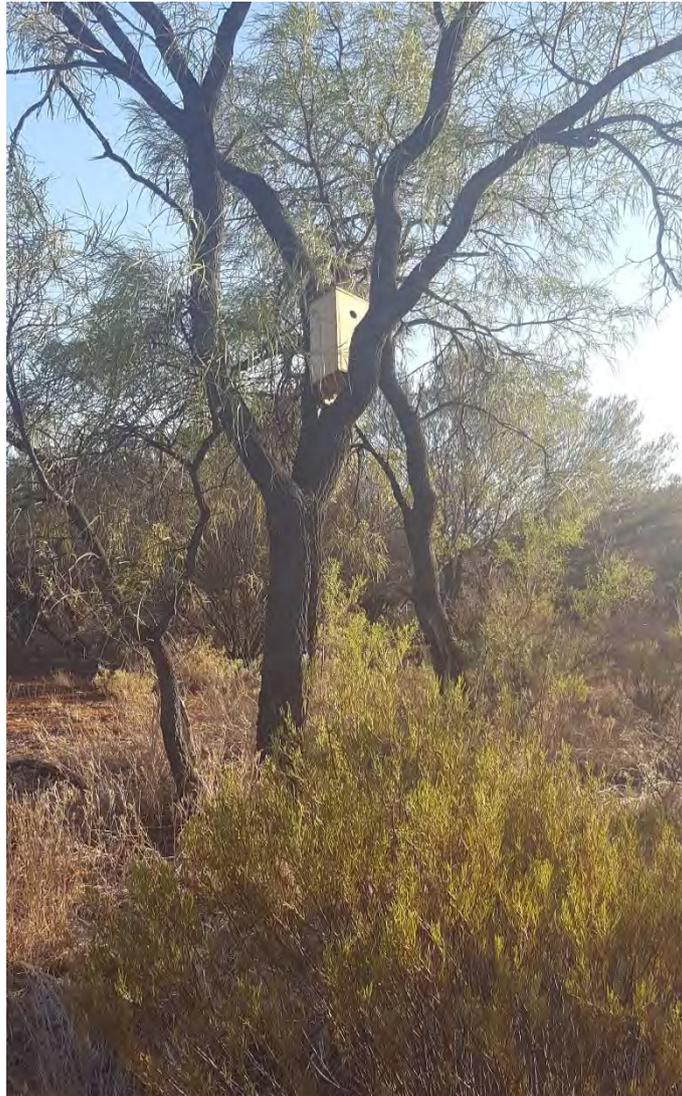
Figure 5: Nesting box installed adjacent to the right of way

In accordance with the CEMP, where the project impacted any area of confirmed princess parrot habitat or any densely vegetated areas of potential princess parrot habitat, the requirement for alternative safe habitat was assessed. Accordingly, approximately 28 nesting boxes were constructed by Local Traditional Owners (Yapa-Kurlangu Ngurrara Aboriginal Corporation) and fitted to trees adjacent to the pipeline route.

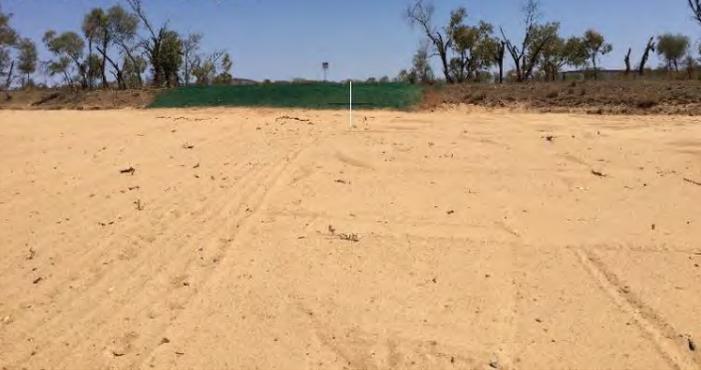
RMP: 1A POSITIVE AND NEGATIVE	RMP: 1B POSITIVE AND NEGATIVE
<p data-bbox="338 293 607 451"> Date & Time: Thu, 18 Oct 2018, 10:58:04 ACST Position: 022.804587° S / 132.607067° E Altitude: 570m Datum: WGS-84 Azimuth/Bearing: 319° N41W 5671mils (True) Elevation Angle: -02.4° Horizon Angle: +00.4° Zoom: 1X RMP 1A construction reinstatement positive </p>

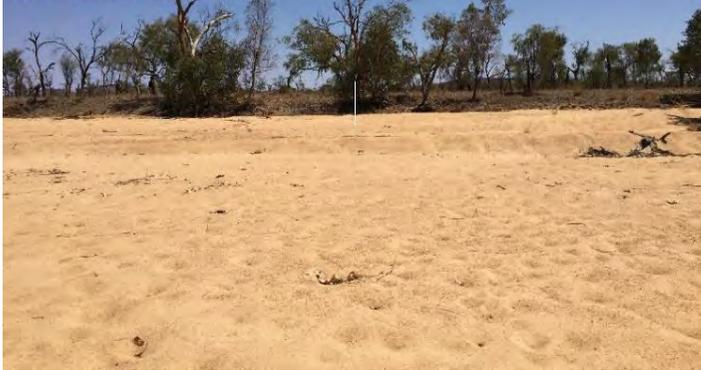
<p data-bbox="1267 293 1536 451"> Date & Time: Thu, 18 Oct 2018, 11:08:19 ACST Position: 022.805522° S / 132.603874° E Altitude: 570m Datum: WGS-84 Azimuth/Bearing: 338° N22W 6009mils (True) Elevation Angle: -02.1° Horizon Angle: +00.7° Zoom: 1X RMP 1B construction reinstatement positive </p>

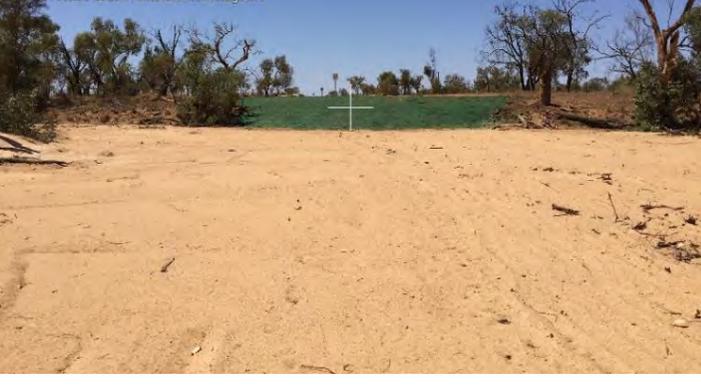
<p data-bbox="338 837 607 995"> Date & Time: Thu, 18 Oct 2018, 10:59:42 ACST Position: 022.804518° S / 132.607003° E Altitude: 569m Datum: WGS-84 Azimuth/Bearing: 145° S35E 2578mils (True) Elevation Angle: -02.1° Horizon Angle: +01.0° Zoom: 1X RMP 1A construction reinstatement negative </p>

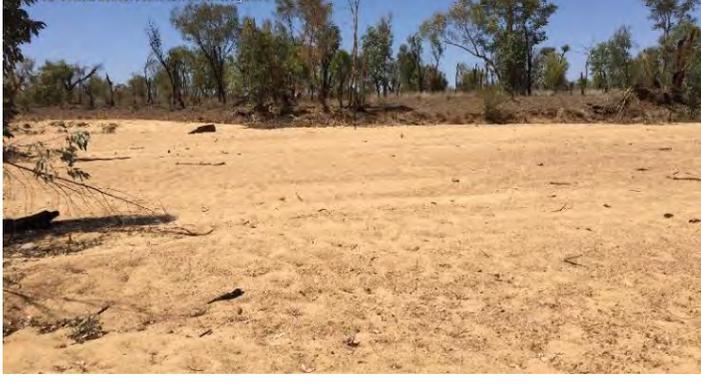
<p data-bbox="1267 837 1536 995"> Date & Time: Thu, 18 Oct 2018, 11:07:44 ACST Position: 022.805533° S / 132.603905° E Altitude: 571m Datum: WGS-84 Azimuth/Bearing: 148° S32E 2631mils (True) Elevation Angle: -01.9° Horizon Angle: +00.3° Zoom: 1X RMP 1B construction reinstatement negative </p>

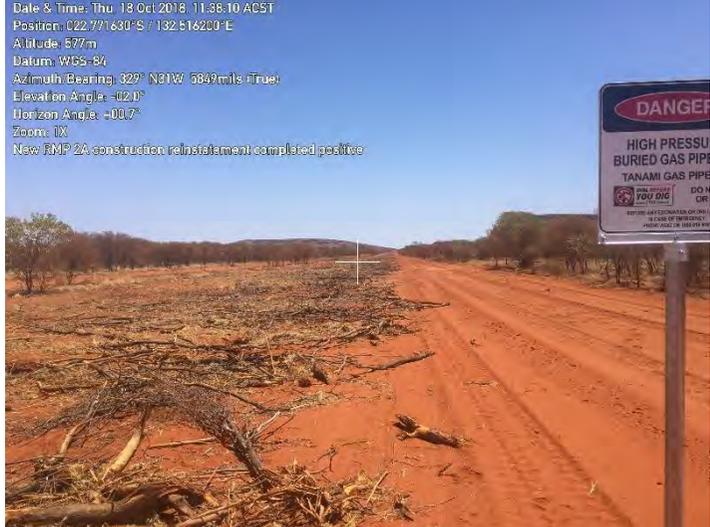
RMP: NEW 2A POSITIVE AND NEGATIVE	RMP: 2B POSITIVE AND NEGATIVE
<p>Date & Time: Thu, 18 Oct 2018, 11:38:10 ACST Position: 022.771630° S / 132.514220° E Altitude: 577m Datum: WGS-84 Azimuth Bearing: 329° N31W 5689mils (True) Elevation Angle: -02.0° Horizon Angle: +00.7° Zoom: 1X New RMP 2A construction reinstatement completed positive</p>

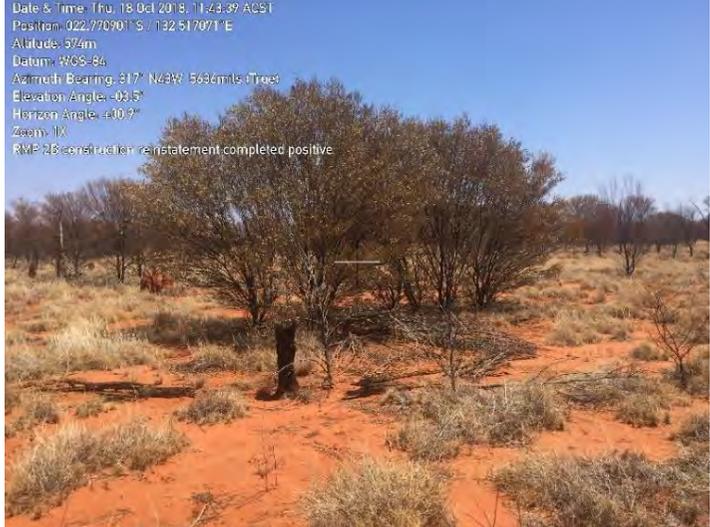
<p>Date & Time: Thu, 18 Oct 2018, 11:43:39 ACST Position: 022.770901° S / 132.517071° E Altitude: 574m Datum: WGS-84 Azimuth Bearing: 317° N43W 5694mils (True) Elevation Angle: -03.5° Horizon Angle: +00.9° Zoom: 1X RMP 2B construction reinstatement completed positive</p>

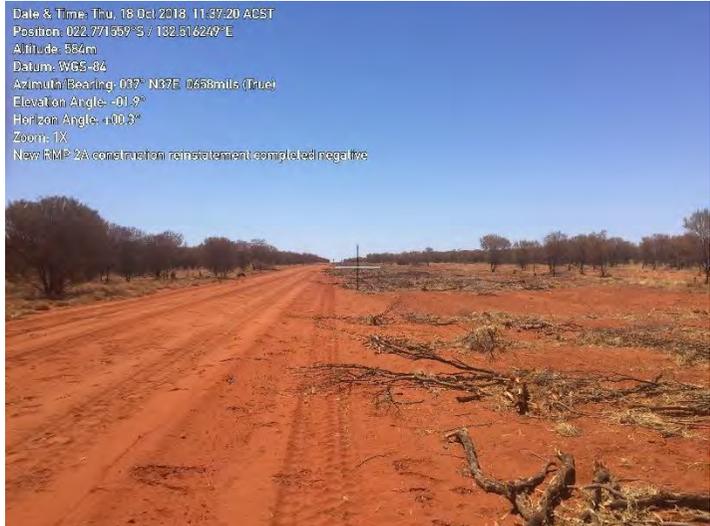
<p>Date & Time: Thu, 18 Oct 2018, 11:37:20 ACST Position: 022.771359° S / 132.516249° E Altitude: 584m Datum: WGS-84 Azimuth Bearing: 037° N37E 0688mils (True) Elevation Angle: -01.9° Horizon Angle: +00.3° Zoom: 1X New RMP 2A construction reinstatement completed negative</p>

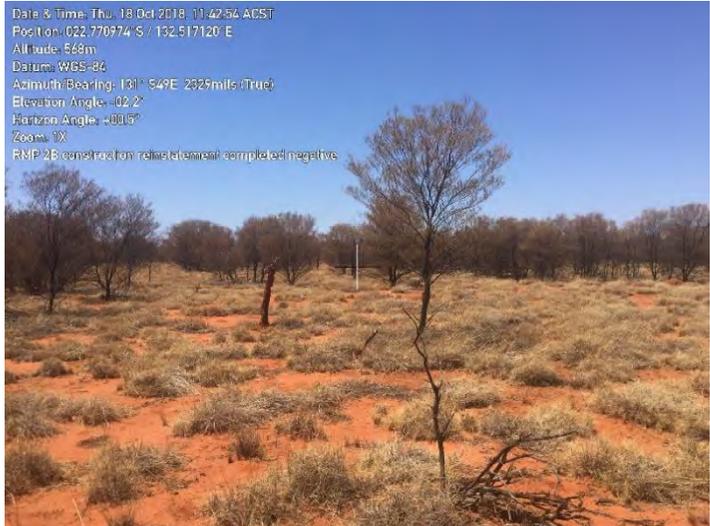
<p>Date & Time: Thu, 18 Oct 2018, 11:42:56 ACST Position: 022.770974° S / 132.517120° E Altitude: 569m Datum: WGS-84 Azimuth Bearing: 131° S49E 2829mils (True) Elevation Angle: -02.2° Horizon Angle: +00.5° Zoom: 1X RMP 2B construction reinstatement completed negative</p>

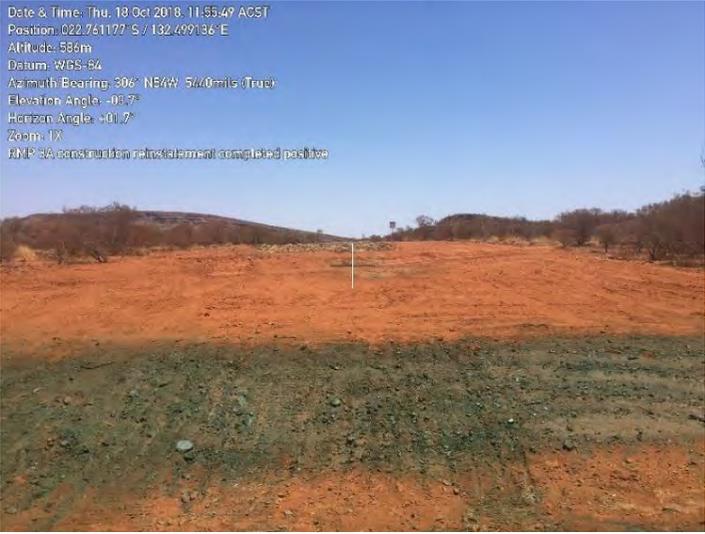
RMP: 3A POSITIVE AND NEGATIVE	RMP: 3B POSITIVE AND NEGATIVE
<p>Date & Time: Thu, 18 Oct 2018, 11:55:49 ACST Position: 022.761177° S / 132.499136° E Altitude: 586m Datum: WGS-84 Azimuth/Bearing: 306° N64W 5740mils (True) Elevation Angle: -03.7° Horizon Angle: +01.2° Zoom: IX RMP 3A construction reinstatement completed positive</p>

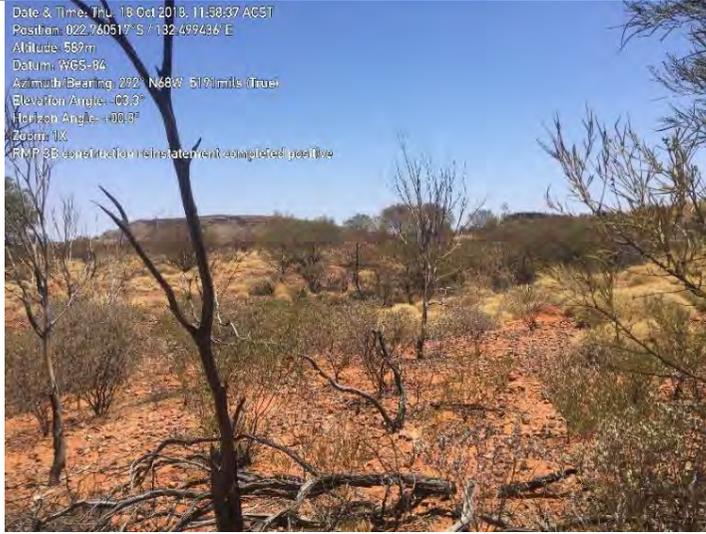
<p>Date & Time: Thu, 18 Oct 2018, 11:58:37 ACST Position: 022.760519° S / 132.499436° E Altitude: 587m Datum: WGS-84 Azimuth/Bearing: 292° N68W 6191mils (True) Elevation Angle: -03.3° Horizon Angle: +00.0° Zoom: IX RMP 3B construction reinstatement completed positive</p>

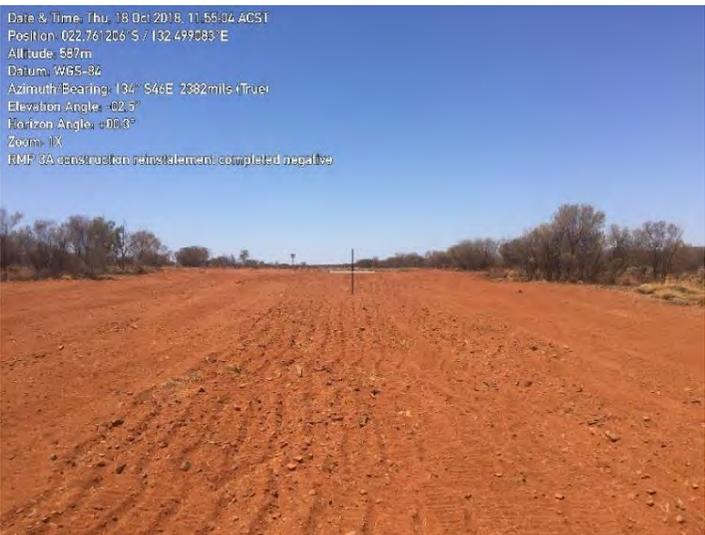
<p>Date & Time: Thu, 18 Oct 2018, 11:55:04 ACST Position: 022.761206° S / 132.499183° E Altitude: 587m Datum: WGS-84 Azimuth/Bearing: 134° S46E 2382mils (True) Elevation Angle: -02.5° Horizon Angle: +00.0° Zoom: IX RMP 3A construction reinstatement completed negative</p>

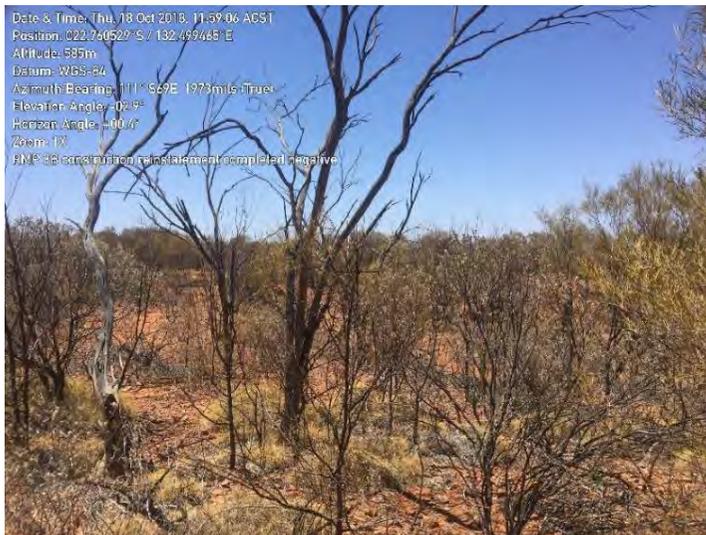
<p>Date & Time: Thu, 18 Oct 2018, 11:59:06 ACST Position: 022.760529° S / 132.499485° E Altitude: 585m Datum: WGS-84 Azimuth/Bearing: 111° S69E 1973mils (True) Elevation Angle: -02.9° Horizon Angle: +00.0° Zoom: IX RMP 3B construction reinstatement completed negative</p>

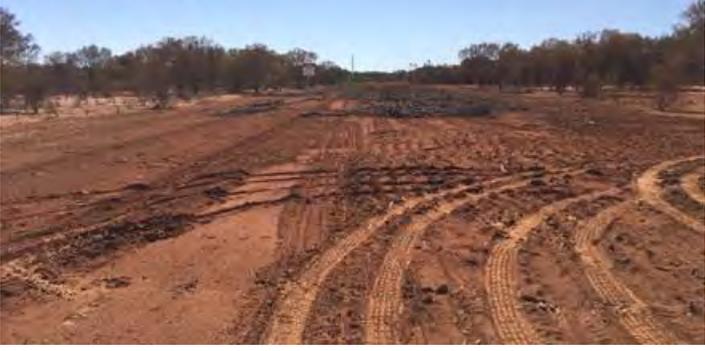
<p data-bbox="336 837 627 1021"> Date & Time: Wed, 12 Dec 2018, 09:41:26 ACST Position: -022.086482° / +131.349137° Altitude: 622m Datum: WGS-84 Azimuth/Bearing: 105° S78E 1067mils (True) Elevation Angle: -00.4° Horizon Angle: +00.2° Zoom: 1X GA pos: 1 Paula Boosamma/MPC KinetiC/Tanami </p>

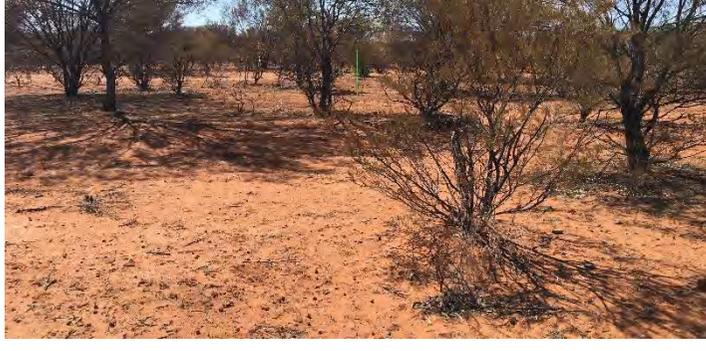
<p data-bbox="1265 837 1556 1021"> Date & Time: Wed, 12 Dec 2018, 09:44:27 ACST Position: -021.802118° / +131.198719° Altitude: 622m Datum: WGS-84 Azimuth/Bearing: 149° S54E 2986mils (True) Elevation Angle: -01.3° Horizon Angle: +01.4° Zoom: 1X GA pos: 1 Paula Boosamma/MPC KinetiC/Tanami </p>

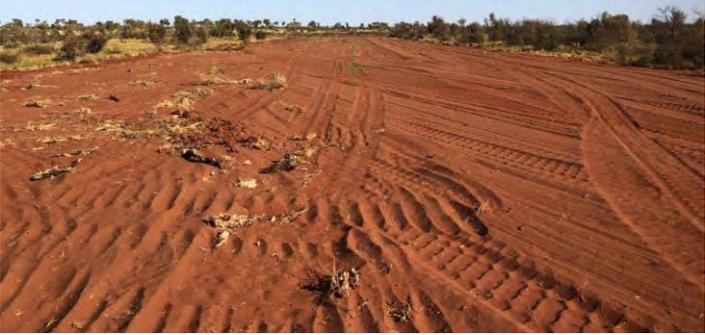
RMP: 7A POSITIVE AND NEGATIVE	RMP: 7B POSITIVE AND NEGATIVE
<p data-bbox="336 279 616 462"> Date & Time: Sat, 08 Dec 2018, 06:01:06 ACST Position: -021.514235° / +130.991703° Altitude: 460m Datum: WGS-84 Azimuth/Bearing: 341° N19W 6642mils (True) Elevation Angle: -02.3° Horizon Angle: +00.9° Zoom: 1X RM Point 7A KP266 Positive 1 Sushil Swami/MPC/Tanami </p>

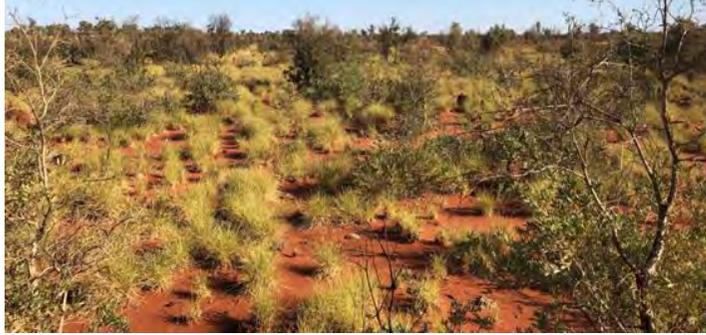
<p data-bbox="1265 279 1545 462"> Date & Time: Sat, 08 Dec 2018, 06:01:06 ACST Position: -021.51441° / +130.991264° Altitude: 460m Datum: WGS-84 Azimuth/Bearing: 353° W57W 6230mils (True) Elevation Angle: -02.1° Horizon Angle: +01.0° Zoom: 1X RM Control Point 7B KP266 Positive 1 Sushil Swami/MPC/Tanami </p>

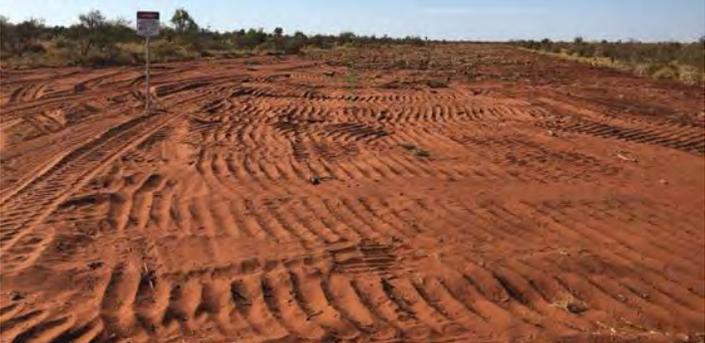
<p data-bbox="336 821 616 1005"> Date & Time: Sat, 08 Dec 2018, 06:00:39 ACST Position: -021.514409° / +130.991834° Altitude: 478m Datum: WGS-84 Azimuth/Bearing: 173° S07E 3076mils (True) Elevation Angle: -02.6° Horizon Angle: +02.8° Zoom: 1X RM Point 7A KP266 Negative 1 Sushil Swami/MPC/Tanami </p>

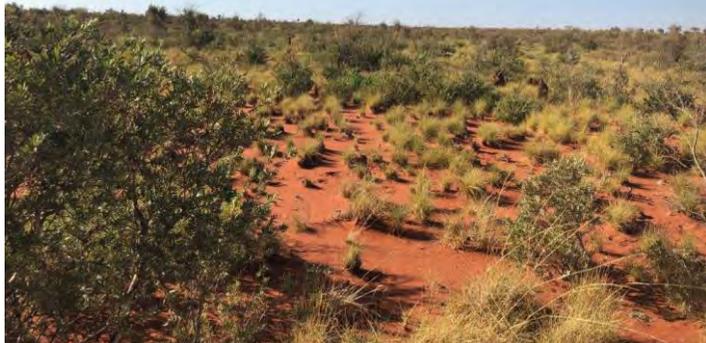
<p data-bbox="1265 821 1545 1005"> Date & Time: Sat, 08 Dec 2018, 06:05:33 ACST Position: -021.514447° / +130.991243° Altitude: 480m Datum: WGS-84 Azimuth/Bearing: 179° S01E 3182mils (True) Elevation Angle: -04.2° Horizon Angle: +03.9° Zoom: 1X RM Control Point 7B KP266 Negative 1 Sushil Swami/MPC/Tanami </p>

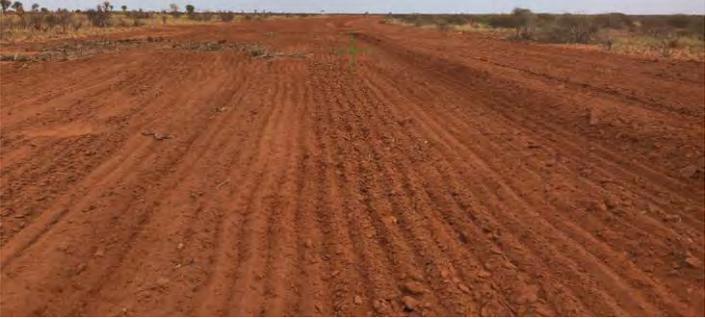
RMP: 9A POSITIVE AND NEGATIVE	RMP: 9B POSITIVE AND NEGATIVE
<p>Date & Time: Sun, 25 Nov 2018, 08:49:30 ACST Position: -020.875594° / +130.606479° Altitude: 361m Datum: WGS-84 Azimuth/Bearing: 306° N54W 5440mils (True) Elevation Angle: -03.0° Horizon Angle: +02.2° Zoom: 1X RM Point 9A Positive 1 Sushil Swami/MPC/Tanami</p>

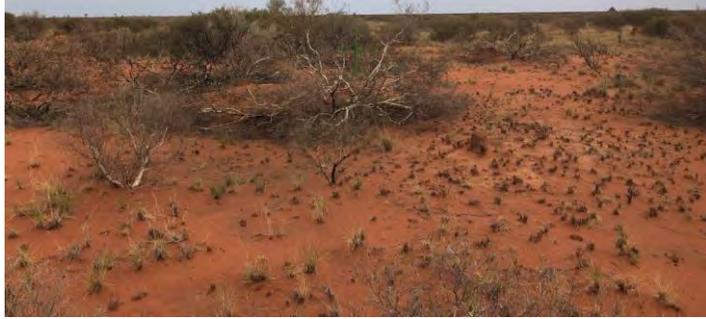
<p>Date & Time: Sun, 25 Nov 2018, 08:52:44 ACST Position: -020.875267° / +130.606768° Altitude: 360m Datum: WGS-84 Azimuth/Bearing: 315° N45W 5600mils (True) Elevation Angle: -02.1° Horizon Angle: +01.6° Zoom: 1X RM Control Point 9B Positive 2 Sushil Swami/MPC/Tanami</p>

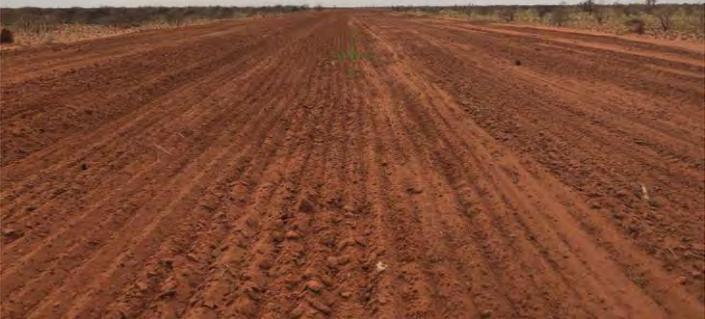
<p>Date & Time: Sun, 25 Nov 2018, 08:48:22 ACST Position: -020.875590° / +130.606493° Altitude: 361m Datum: WGS-84 Azimuth/Bearing: 123° S57E 2187mils (True) Elevation Angle: -04.1° Horizon Angle: +01.9° Zoom: 1X RM Point 9A Negative 1 Sushil Swami/MPC/Tanami</p>

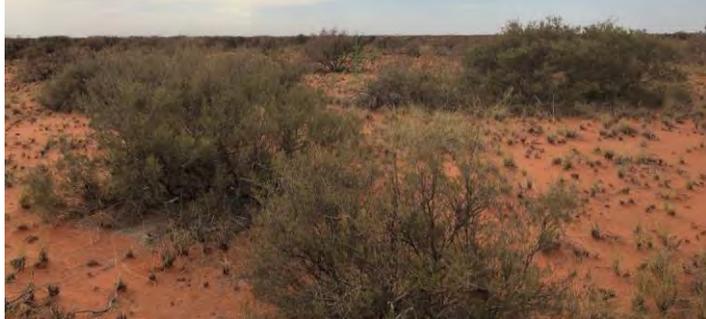
<p>Date & Time: Sun, 25 Nov 2018, 08:52:57 ACST Position: -020.875237° / +130.606729° Altitude: 361m Datum: WGS-84 Azimuth/Bearing: 135° S45E 2400mils (True) Elevation Angle: -00.7° Horizon Angle: +01.5° Zoom: 1X RM Control Point 9B Negative 1 Sushil Swami/MPC/Tanami</p>

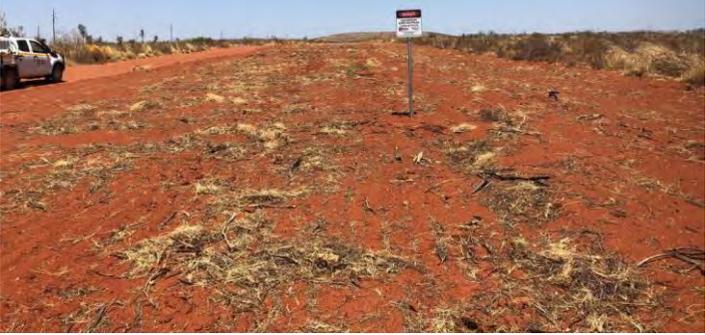
RMP: 10A POSITIVE AND NEGATIVE	RMP: 10B POSITIVE AND NEGATIVE
<p data-bbox="336 284 616 462"> Date & Time: Fri, 23 Nov 2018, 11:17:20 AEST Position: -32.530559° / +129.571362° Altitude: 381m Datum: WGS-84 Azimuth/Bearing: 290° N60W 4275mils (True) Elevation Angle: -01.1° Horizon Angle: +00.6° Zoom: 1X RMP Point 10A Positive 1 Sushil Swami/MPC/Tanami </p>

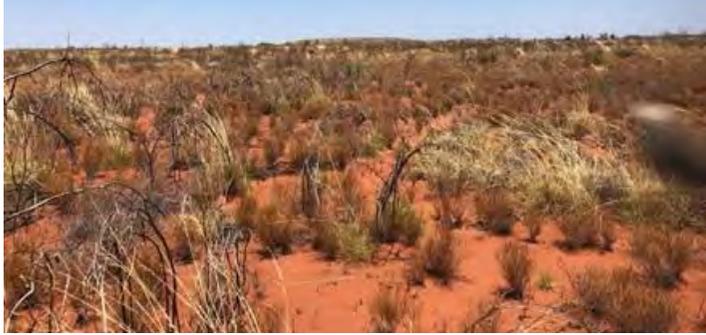
<p data-bbox="1265 284 1545 462"> Date & Time: Fri, 23 Nov 2018, 11:20:00 AEST Position: -32.529922° / +129.571622° Altitude: 381m Datum: WGS-84 Azimuth/Bearing: 180° S00W 1800mils (True) Elevation Angle: -01.1° Horizon Angle: -00.1° Zoom: 1X RMP Control Point 10B Positive 1 Sushil Swami/MPC/Tanami </p>

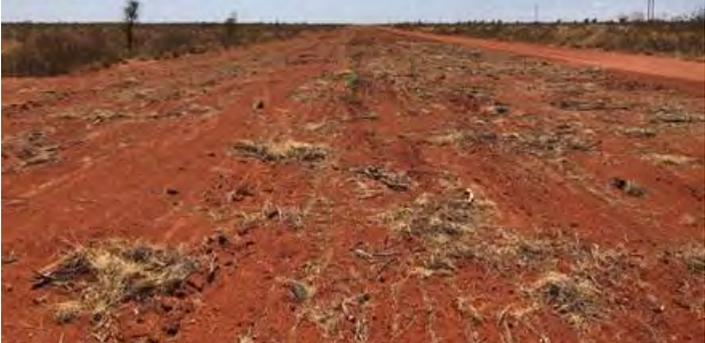
<p data-bbox="336 826 616 1005"> Date & Time: Fri, 23 Nov 2018, 11:16:27 AEST Position: -32.530229° / +129.571362° Altitude: 381m Datum: WGS-84 Azimuth/Bearing: 092° S84E 1700mils (True) Elevation Angle: -04.4° Horizon Angle: +02.0° Zoom: 1X RMP Point 10A Negative 1 Sushil Swami/MPC/Tanami </p>

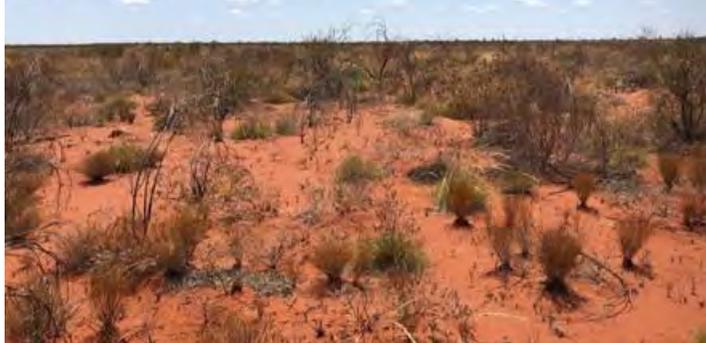
<p data-bbox="1265 826 1545 1005"> Date & Time: Fri, 23 Nov 2018, 11:20:05 AEST Position: -32.529922° / +129.571622° Altitude: 381m Datum: WGS-84 Azimuth/Bearing: 084° S86E 1620mils (True) Elevation Angle: -02.4° Horizon Angle: +01.3° Zoom: 1X RMP Control Point 10B Negative 1 Sushil Swami/MPC/Tanami </p>

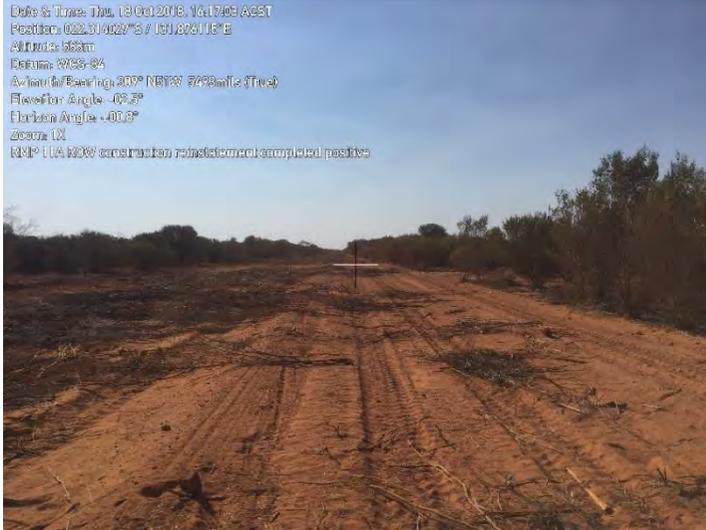
RMP: 11A POSITIVE AND NEGATIVE	RMP: 11B POSITIVE AND NEGATIVE
<p> Date & Time: Thu, 18 Oct 2018, 16:17:03 ACST Position: 022.314027°S / 131.806116°E Altitude: 633m Datum: WGS-84 Azimuth/Bearing: 209° N81W 2763mils (True) Elevation Angle: -09.7° Horizon Angle: +00.6° Zoom: 1X RMP 11A ROW construction reinstatement completed positive </p>

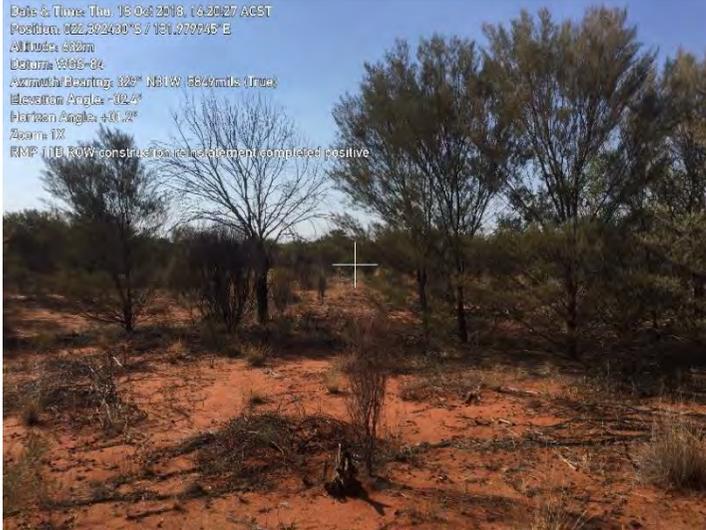
<p> Date & Time: Thu, 18 Oct 2018, 16:20:27 ACST Position: 022.392430°S / 131.979935°E Altitude: 630m Datum: WGS-84 Azimuth/Bearing: 328° N81W 6847mils (True) Elevation Angle: -02.4° Horizon Angle: +01.7° Zoom: 1X RMP 11B ROW construction reinstatement completed positive </p>

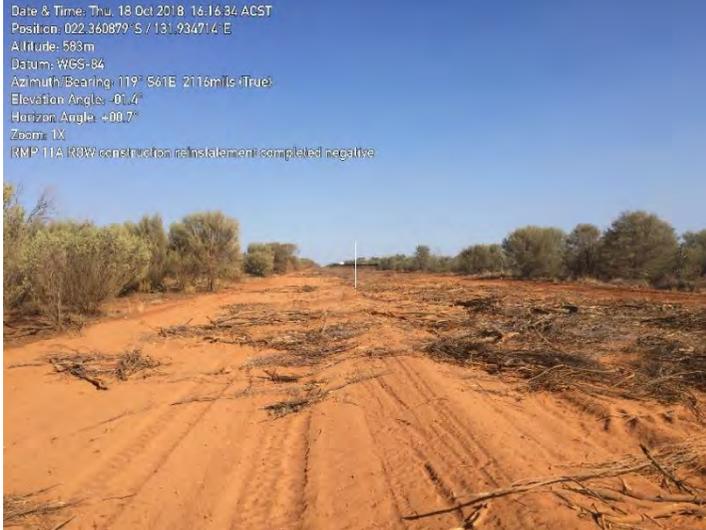
<p> Date & Time: Thu, 18 Oct 2018, 16:16:34 ACST Position: 022.360879°S / 131.934714°E Altitude: 583m Datum: WGS-84 Azimuth/Bearing: 119° S61E 2116mils (True) Elevation Angle: -01.7° Horizon Angle: +00.7° Zoom: 1X RMP 11A ROW construction reinstatement completed negative </p>

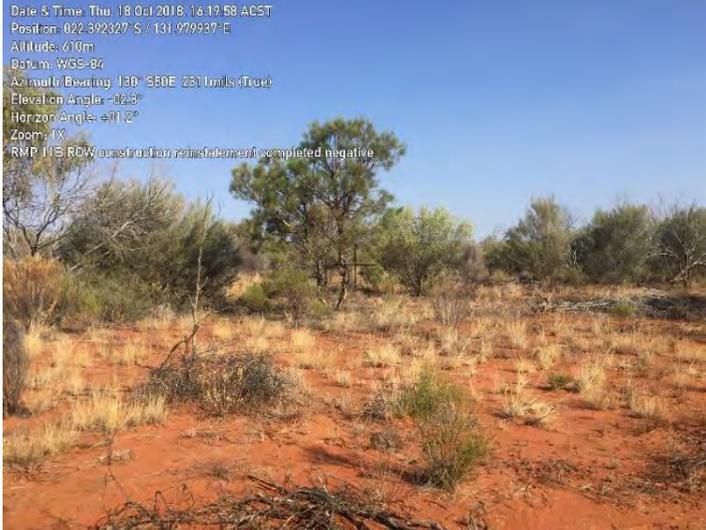
<p> Date & Time: Thu, 18 Oct 2018, 16:19:58 ACST Position: 022.392327°S / 131.979937°E Altitude: 610m Datum: WGS-84 Azimuth/Bearing: 130° S50E 2311mils (True) Elevation Angle: -02.3° Horizon Angle: +01.2° Zoom: 1X RMP 11B ROW construction reinstatement completed negative </p>

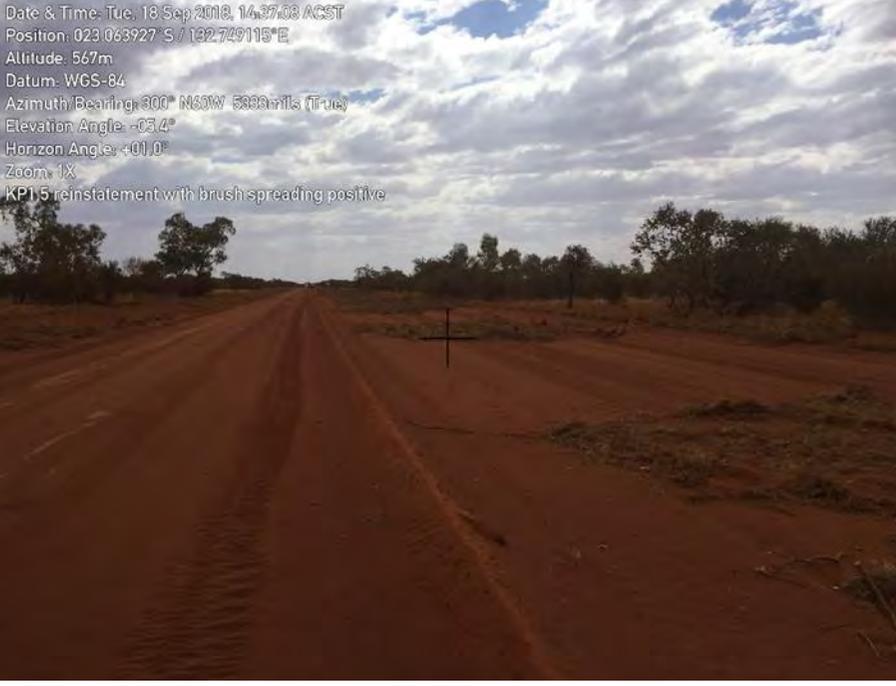
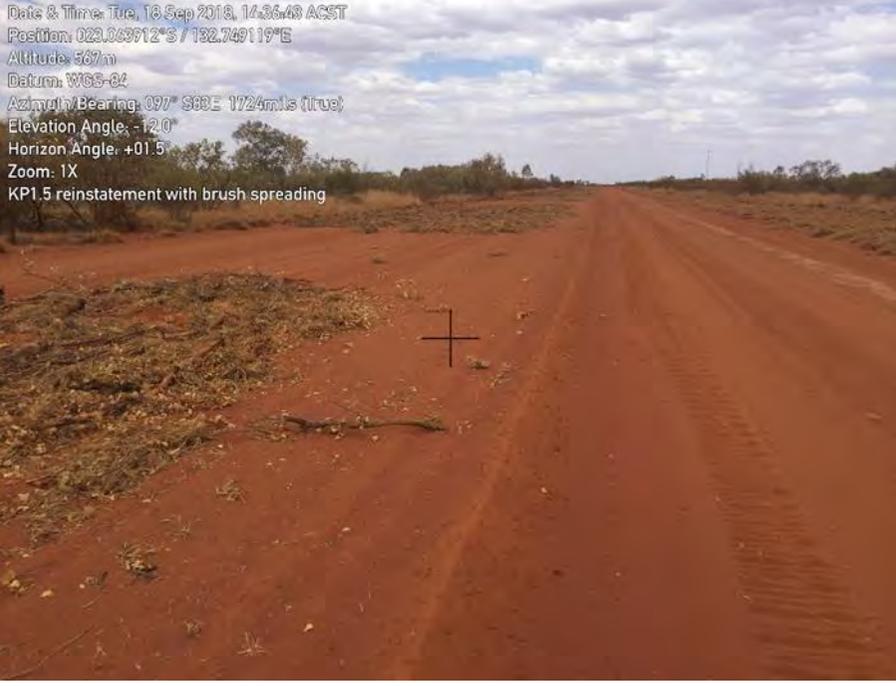
<p data-bbox="1171 443 1559 651"> Date & Time: Tue, 18 Sep 2018, 14:36:48 ACST Position: 023.063912°S / 132.749119°E Altitude: 567m Datum: WGS-84 Azimuth/Bearing: 097° S68E 1724mils (true) Elevation Angle: -12.0° Horizon Angle: +01.5° Zoom: 1X KP1.5 reinstatement with brush spreading </p>

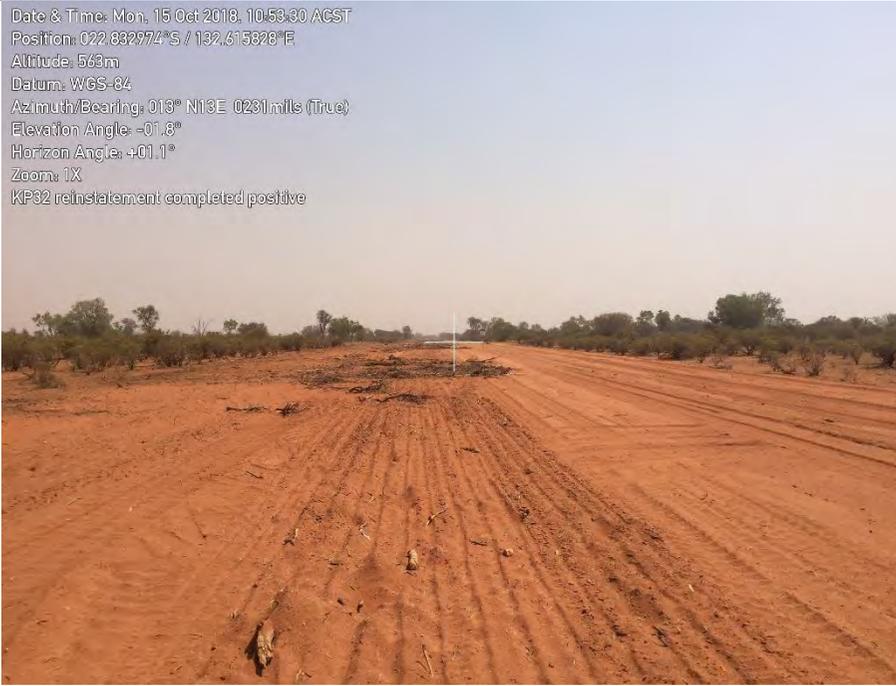
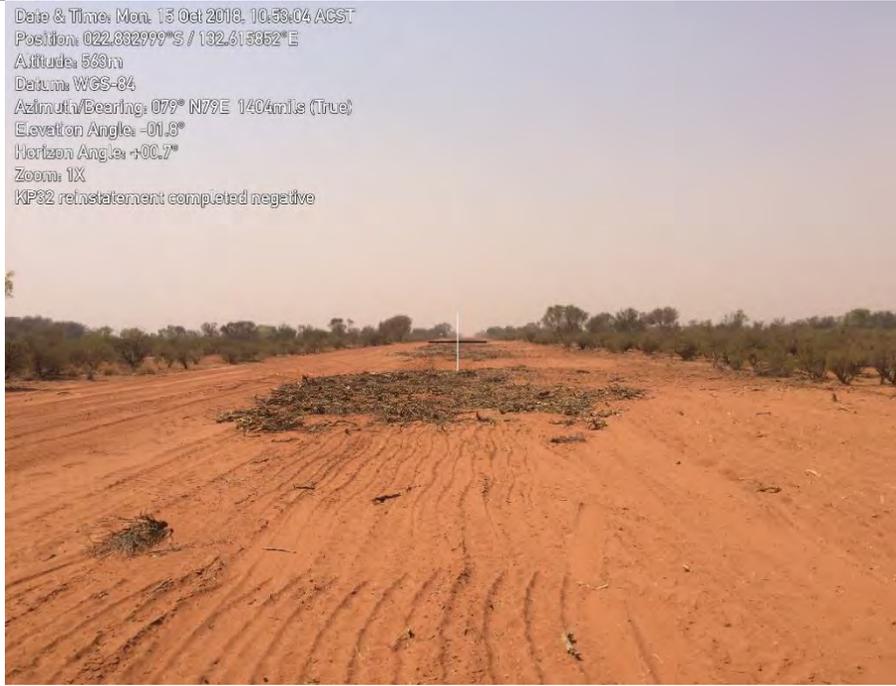
KP:32 POSITIVE	KP: 32 NEGATIVE
<p> Date & Time: Mon, 15 Oct 2018, 10:53:30 ACST Position: 022.832974°S / 132.615828°E Altitude: 563m Datum: WGS-84 Azimuth/Bearing: 013° N13E 0231mils (True) Elevation Angle: -01.8° Horizon Angle: +01.1° Zoom: 1X KP32 reinstatement completed positive </p>

<p> Date & Time: Mon, 15 Oct 2018, 10:53:04 ACST Position: 022.832999°S / 132.615852°E Altitude: 563m Datum: WGS-84 Azimuth/Bearing: 079° N79E 1404mils (True) Elevation Angle: -01.8° Horizon Angle: +00.7° Zoom: 1X KP32 reinstatement completed negative </p>

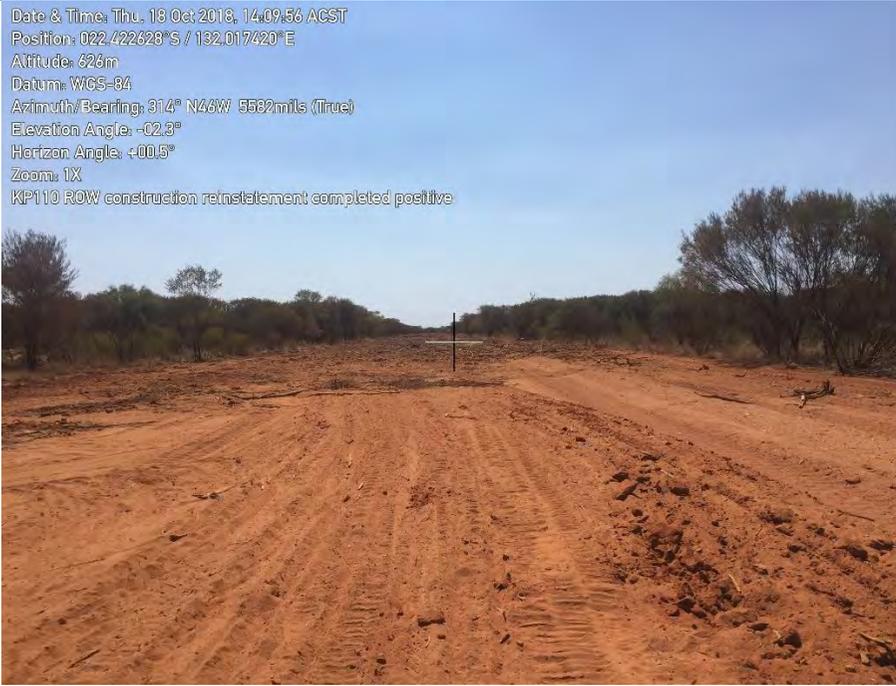
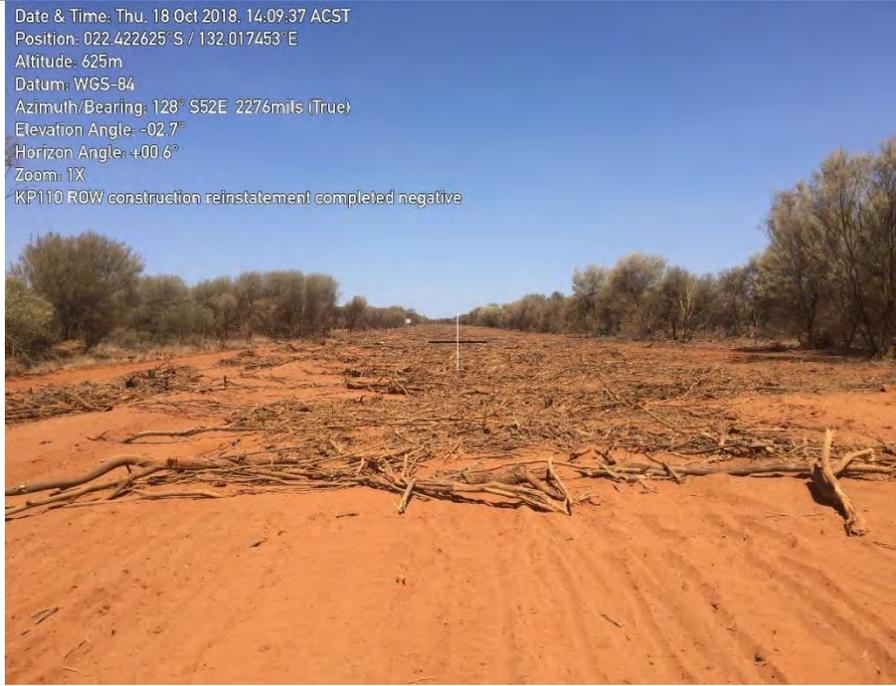
<p> Date & Time: Thu, 18 Oct 2018, 14:09:37 ACST Position: 022.422625°S / 132.017453°E Altitude: 625m Datum: WGS-84 Azimuth/Bearing: 128° S52E 2276mils (True) Elevation Angle: -02.7° Horizon Angle: +00.6° Zoom: 1X KP110 ROW construction reinstatement completed negative </p>

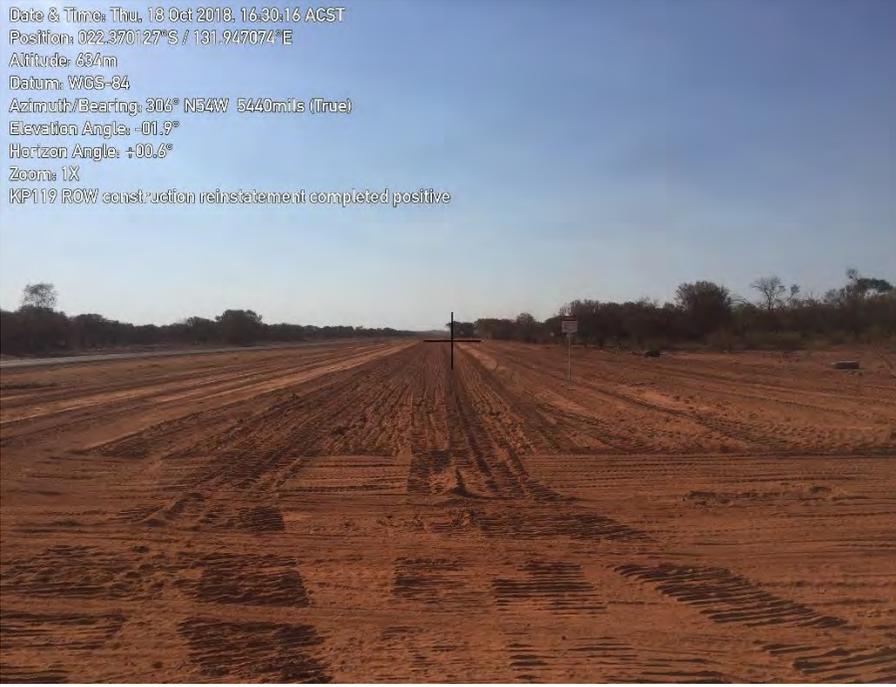
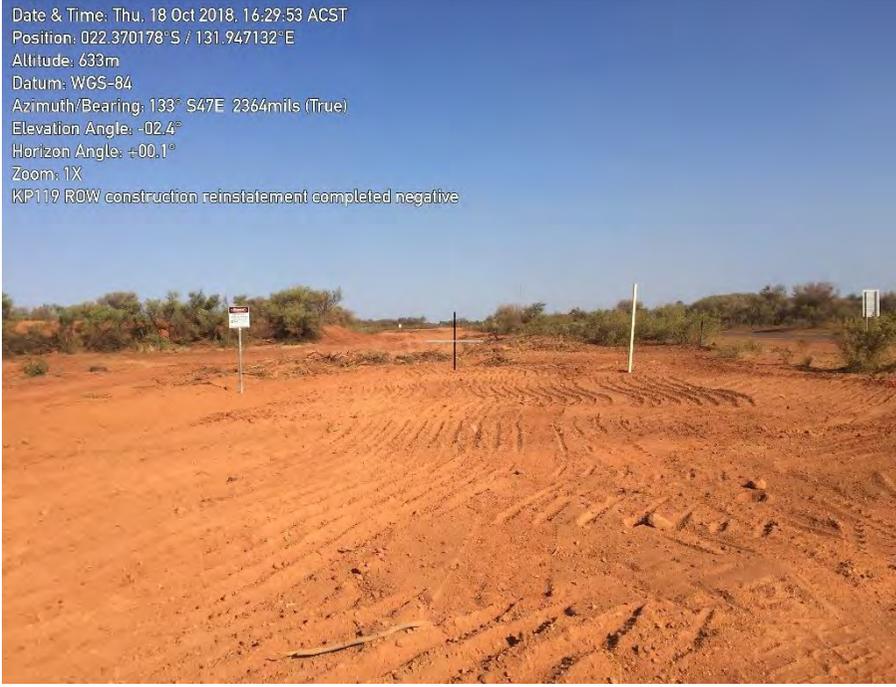
<p> Date & Time: Thu, 18 Oct 2018, 16:29:53 ACST Position: 022.370178°S / 131.947132°E Altitude: 633m Datum: WGS-84 Azimuth/Bearing: 133° S47E 2364mils (True) Elevation Angle: -02.4° Horizon Angle: +00.1° Zoom: 1X KP119 ROW construction reinstatement completed negative </p>

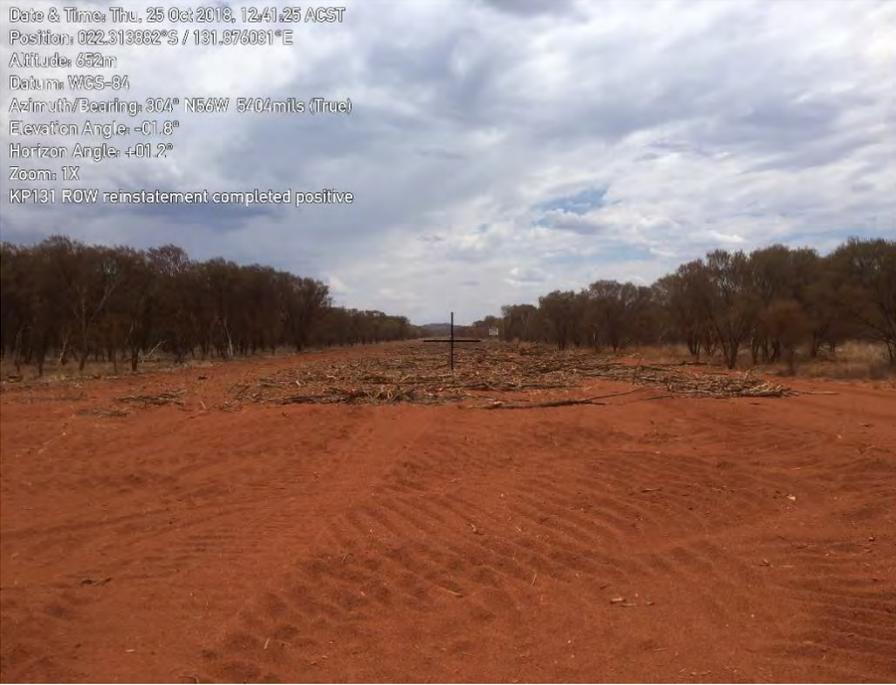
KP:130 POSITIVE	KP: 130 NEGATIVE
<p> Date & Time: Thu, 25 Oct 2018, 12:41:25 ACST Position: 022.313862°S / 131.874081°E Altitude: 652m Datum: WGS-84 Azimuth/Bearing: 304° N56W 5404mils (True) Elevation Angle: -01.8° Horizon Angle: +01.2° Zoom: 1X KP131 ROW reinstatement completed positive </p>

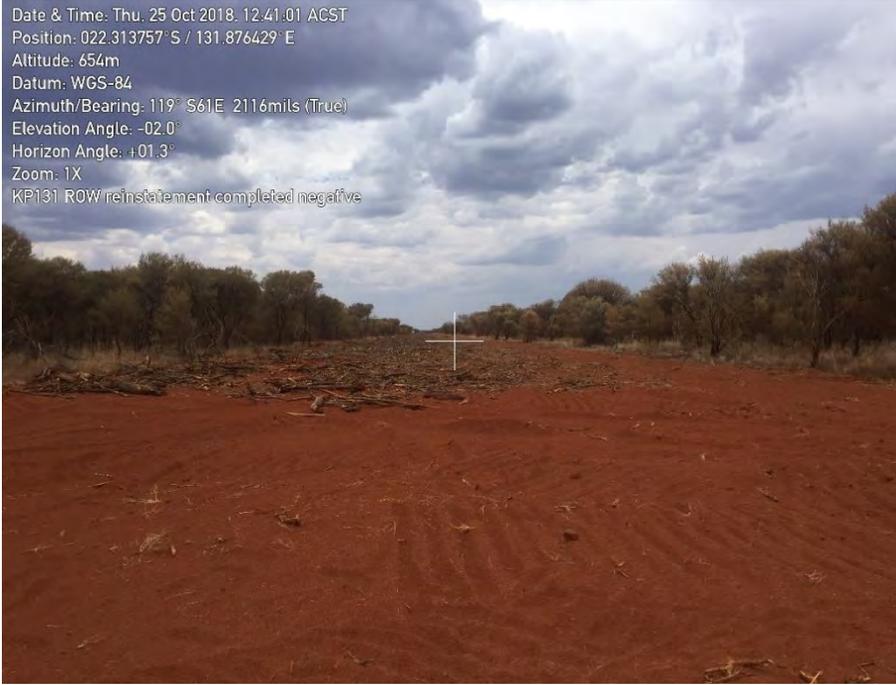
<p> Date & Time: Thu, 25 Oct 2018, 12:41:01 ACST Position: 022.313757°S / 131.876429°E Altitude: 654m Datum: WGS-84 Azimuth/Bearing: 119° S61E 2116mils (True) Elevation Angle: -02.0° Horizon Angle: +01.3° Zoom: 1X KP131 ROW reinstatement completed negative </p>

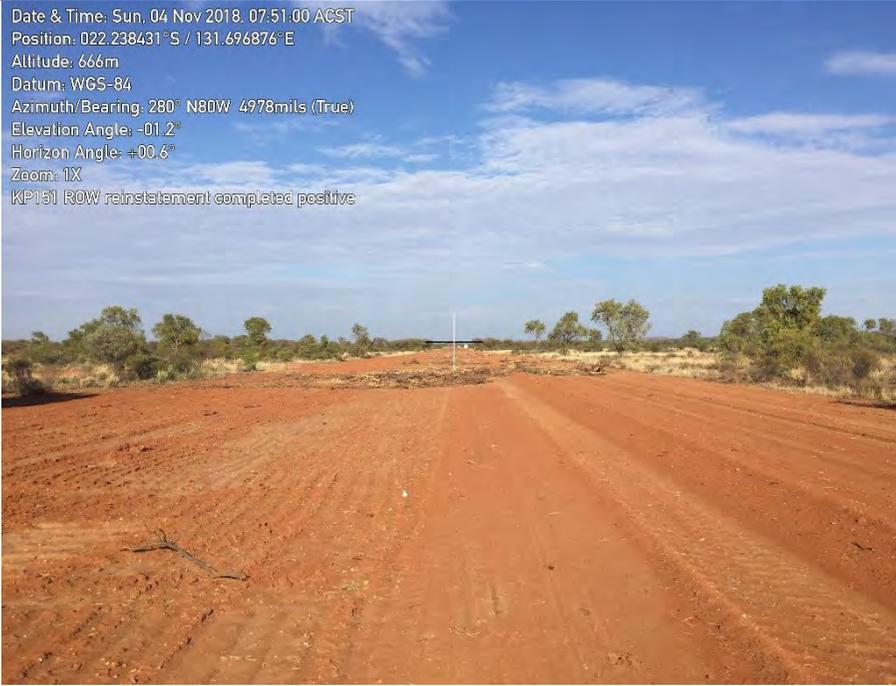
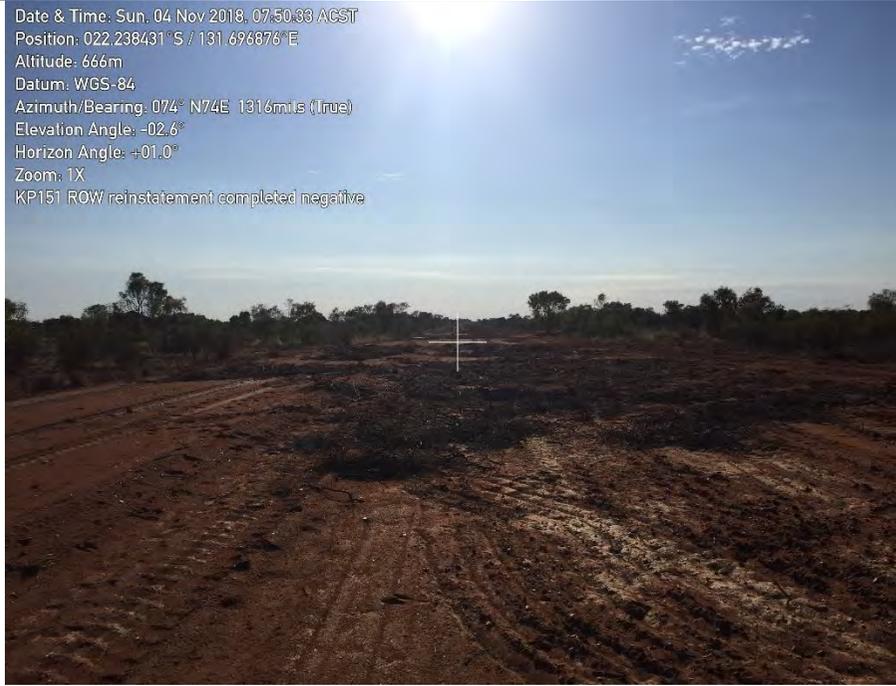
KP:151 POSITIVE	KP: 151 NEGATIVE
<p> Date & Time: Sun, 04 Nov 2018, 07:51:00 ACST Position: 022.238431°S / 131.696876°E Altitude: 666m Datum: WGS-84 Azimuth/Bearing: 280° N80W 4978mils (True) Elevation Angle: -01.2° Horizon Angle: +00.6° Zoom: 1X KP151 ROW reinstatement completed positive </p>

<p> Date & Time: Sun, 04 Nov 2018, 07:50:33 ACST Position: 022.238431°S / 131.696876°E Altitude: 666m Datum: WGS-84 Azimuth/Bearing: 074° N74E 1316mils (True) Elevation Angle: -02.6° Horizon Angle: +01.0° Zoom: 1X KP151 ROW reinstatement completed negative </p>

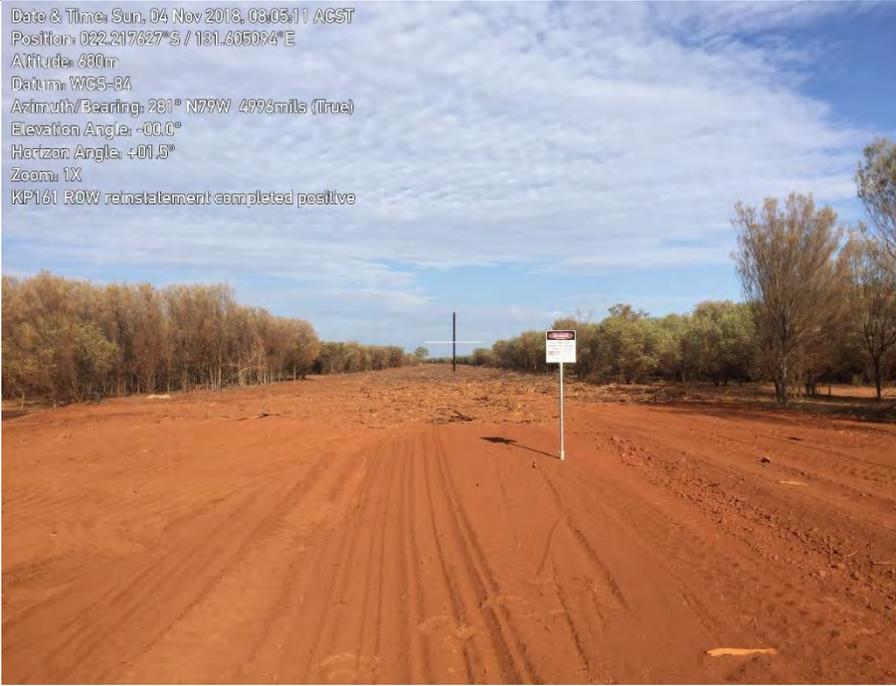
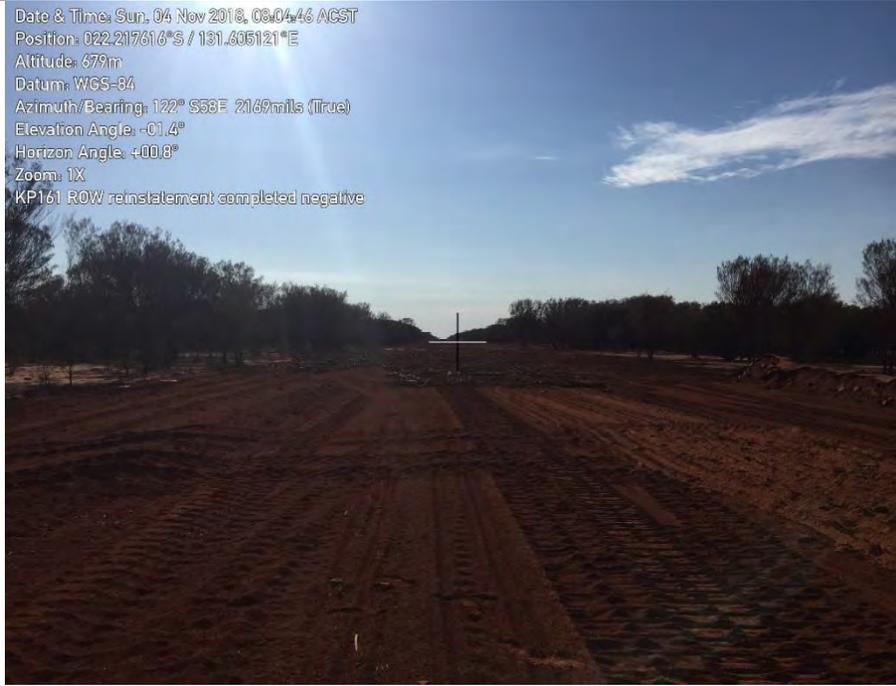
KP:161 POSITIVE	KP:161 NEGATIVE
<p> Date & Time: Sun, 04 Nov 2018, 08:05:11 ACST Position: 022.217627°S / 131.605094°E Altitude: 690m Datum: WGS-84 Azimuth/Bearing: 281° N79W 4996mils (True) Elevation Angle: -00.0° Horizon Angle: +01.5° Zoom: 1X KP161 ROW reinstatement completed positive </p>

<p> Date & Time: Sun, 04 Nov 2018, 08:04:46 ACST Position: 022.217616°S / 131.605121°E Altitude: 679m Datum: WGS-84 Azimuth/Bearing: 122° S58E 2169mils (True) Elevation Angle: -01.4° Horizon Angle: +00.8° Zoom: 1X KP161 ROW reinstatement completed negative </p>
