Tanami Gas Pipeline

EPBC 2017/7997

COMPLIANCE ASSESSMENT REPORT 2018-2019

E-REP-035

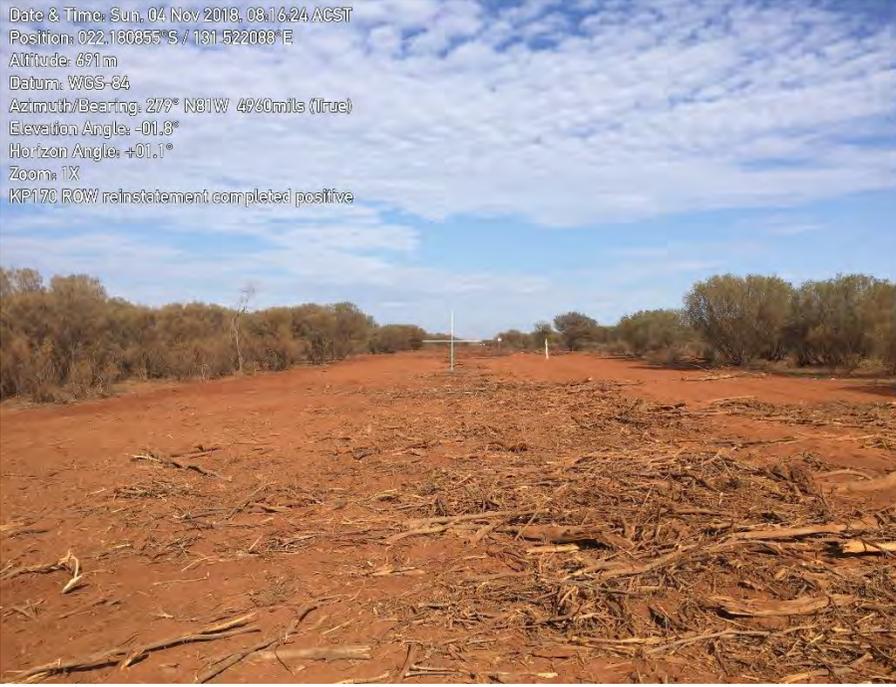
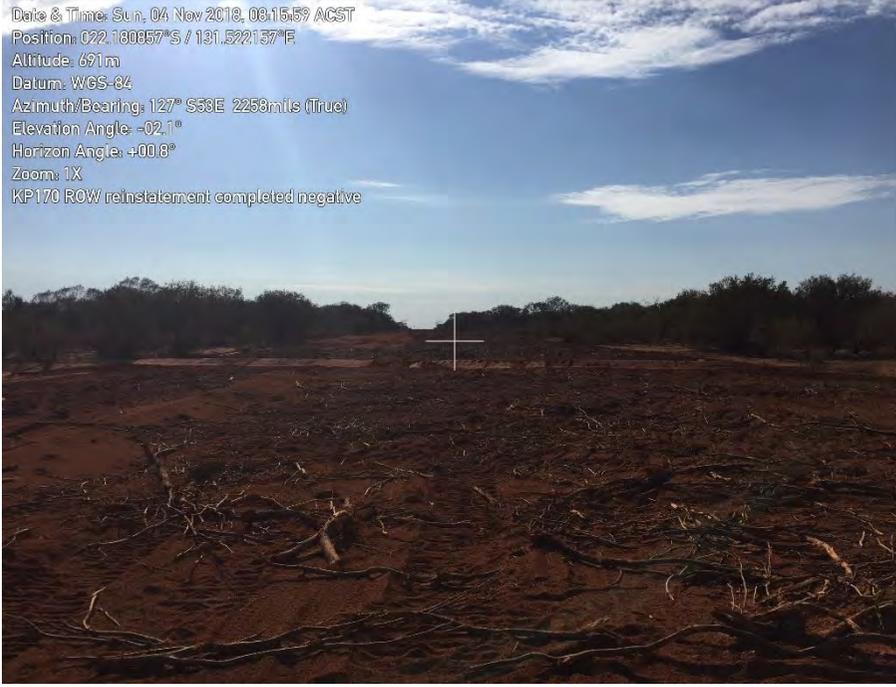
KP: 170 POSITIVE	KP: 170 NEGATIVE
<p> Date & Time: Sun, 04 Nov 2018, 08:16:24 ACST Position: 022.180855° S / 131.522088° E Altitude: 691m Datum: WGS-84 Azimuth/Bearing: 279° N81W 4940mils (True) Elevation Angle: -01.8° Horizon Angle: +01.1° Zoom: 1X KP170 ROW reinstatement completed positive </p>

<p> Date & Time: Sun, 04 Nov 2018, 08:15:59 ACST Position: 022.180857° S / 131.522137° E Altitude: 691m Datum: WGS-84 Azimuth/Bearing: 127° S53E 2258mils (True) Elevation Angle: -02.1° Horizon Angle: +00.8° Zoom: 1X KP170 ROW reinstatement completed negative </p>

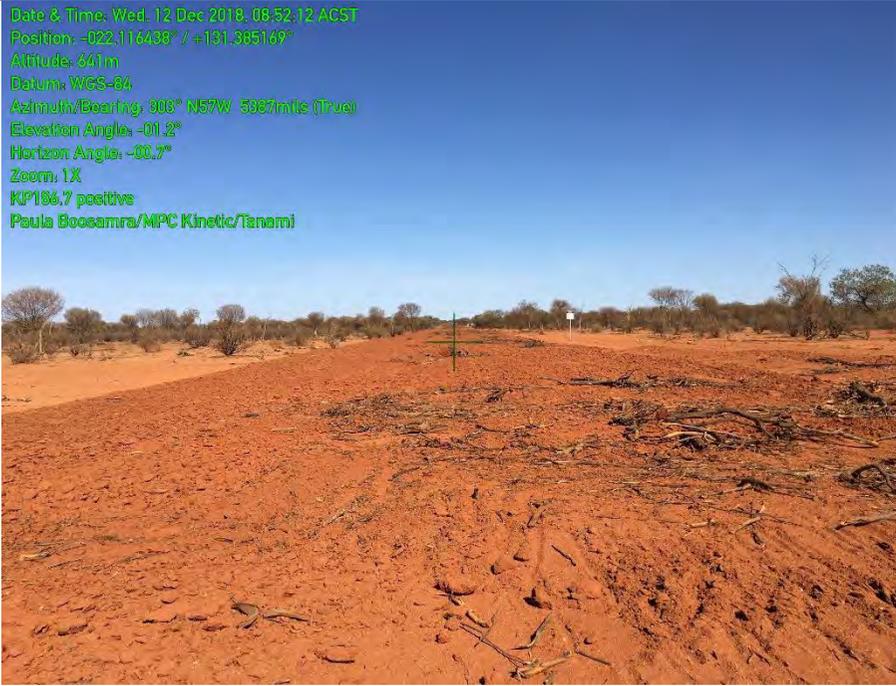
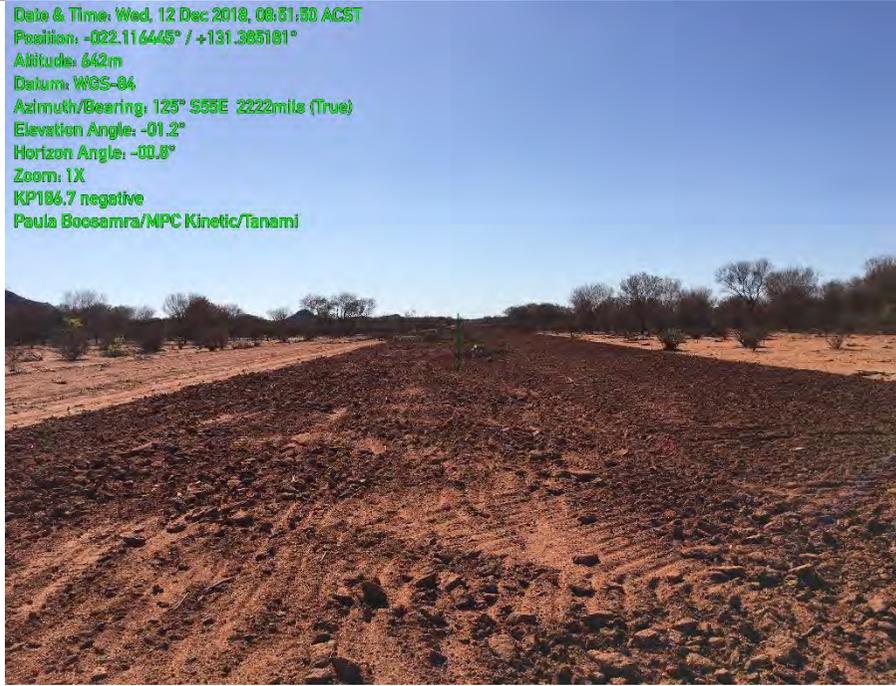
<p> Date & Time: Wed, 12 Dec 2018, 08:51:50 ACST Position: -022.116445° / +131.385181° Altitude: 642m Datum: WGS-84 Azimuth/Bearing: 125° S55E 2222mils (True) Elevation Angle: -01.2° Horizon Angle: -00.8° Zoom: 1X KP186.7 negative Paula Boosamra/MPC Kinetic/Tanami </p>

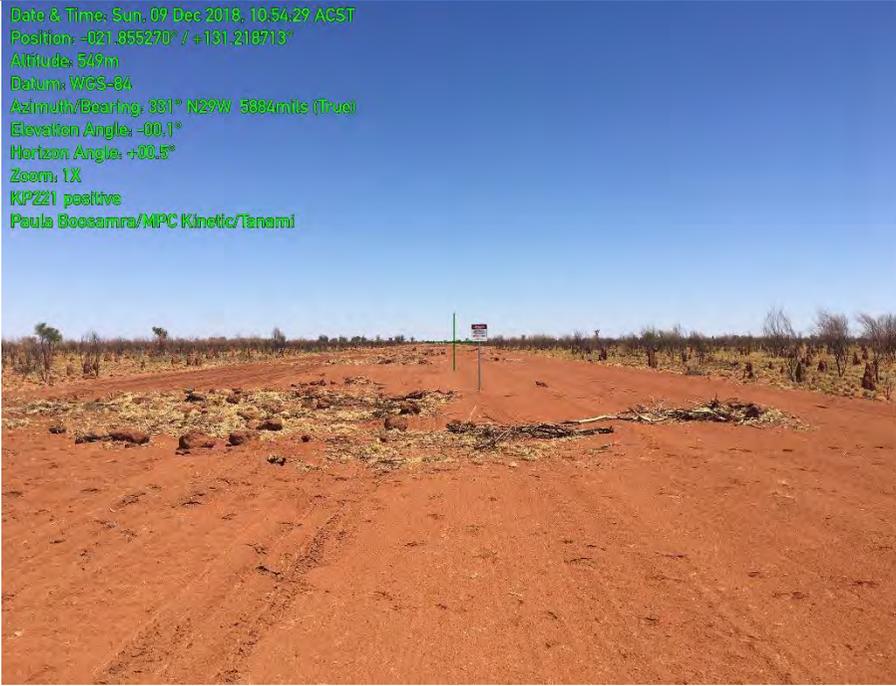
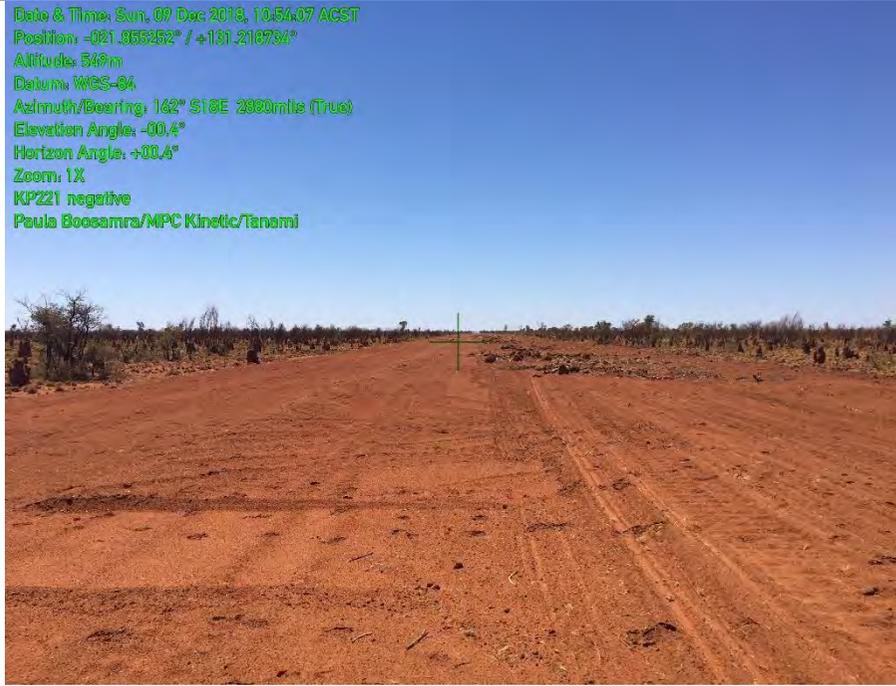
<p> Date & Time: Sun, 09 Dec 2018, 10:54:07 ACST Position: -021.855252° / +131.218734° Altitude: 549m Datum: WGS-84 Azimuth/Bearing: 142° S18°E 2880mils (True) Elevation Angle: -00.4° Horizon Angle: +00.4° Zoom: 1X KP221 negative Paula Boosamra/MPC Kinetic/Tanami </p>

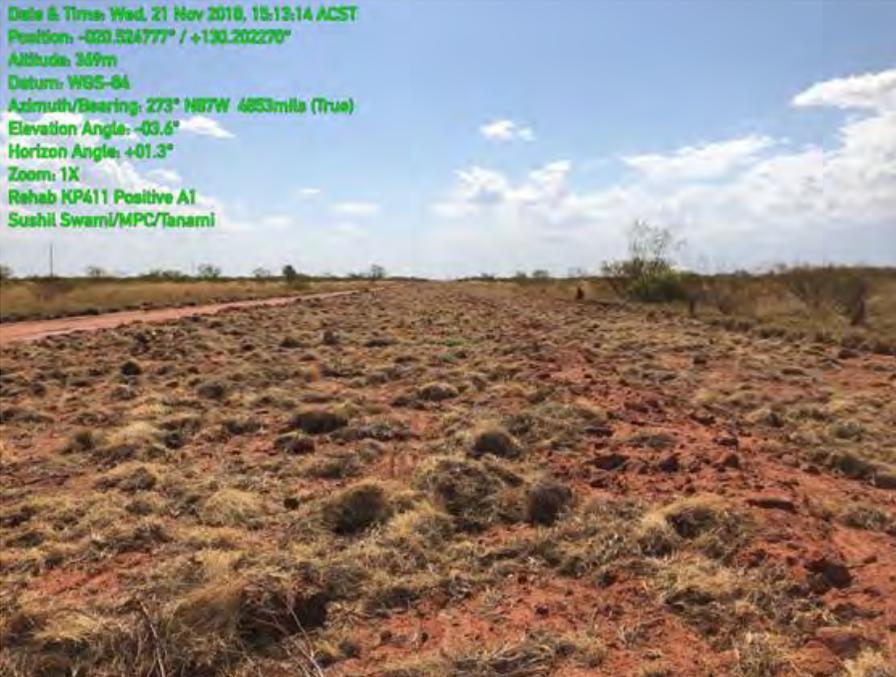
KP: 411 POSITIVE	KP: 411 NEGATIVE
<p> Date & Time: Wed, 21 Nov 2018, 15:13:14 ACST Position: -020.524777° / +130.202270° Altitude: 369m Datum: WGS-84 Azimuth/Bearing: 273° N87W 4853mils (True) Elevation Angle: -03.6° Horizon Angle: +01.3° Zoom: 1X Rehab KP411 Positive A1 Sushil Swami/MPC/Tanami </p>

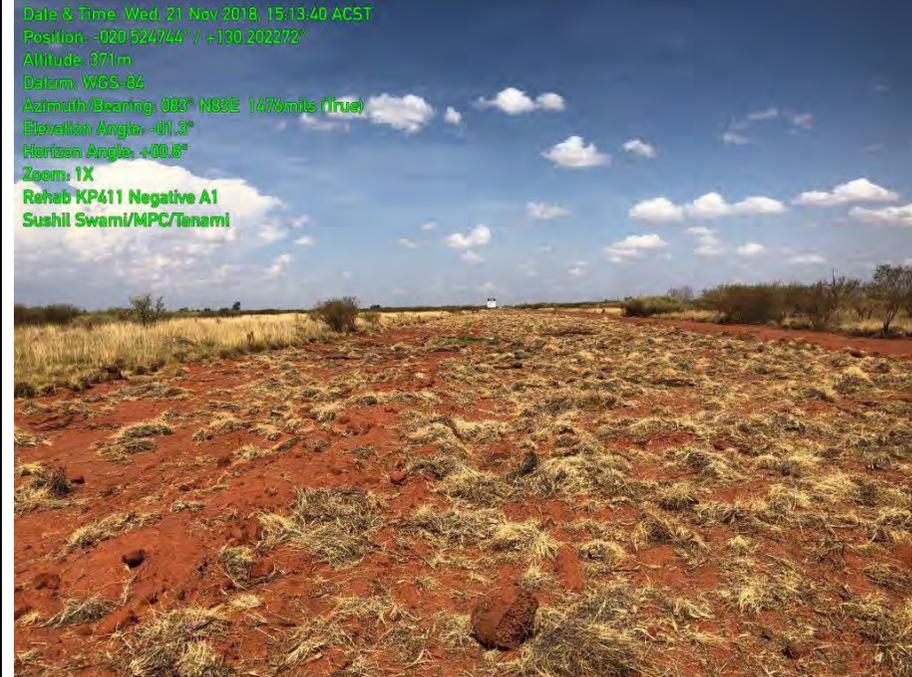
<p> Date & Time: Wed, 21 Nov 2018, 15:13:40 ACST Position: -020.524744° / +130.202272° Altitude: 371m Datum: WGS-84 Azimuth/Bearing: 088° N88E 1476mils (True) Elevation Angle: -01.3° Horizon Angle: +00.6° Zoom: 1X Rehab KP411 Negative A1 Sushil Swami/MPC/Tanami </p>

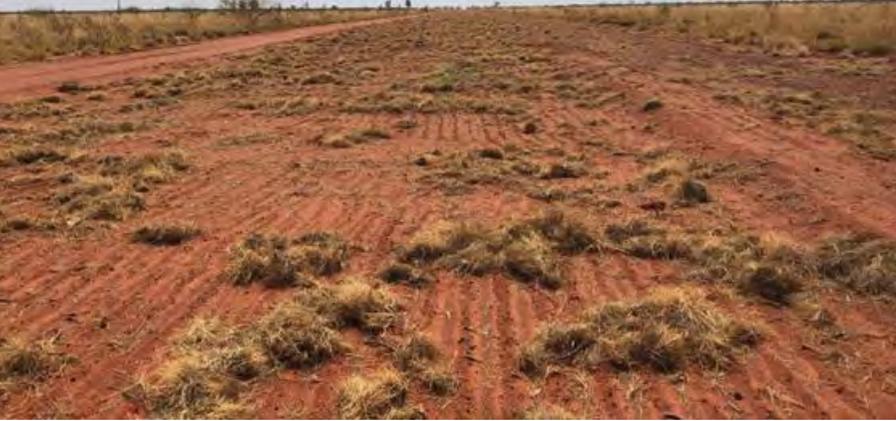
KP: 421	POSITIVE	KP: 421	NEGATIVE
<p data-bbox="241 284 593 512"> Date & Time: Wed, 21 Nov 2018, 14:52:57 AEST Position: -33.538457° / +130.107522° Altitude: 359m Datum: WGS-84 Azimuth/Bearing: 252° 57'W 4480mils (True) Elevation Angle: -04.2° Horizon Angle: +01.1° Zoom: 1X Rehab KP421 Positive A1 Sushil Swami/MPC/Tanami </p>

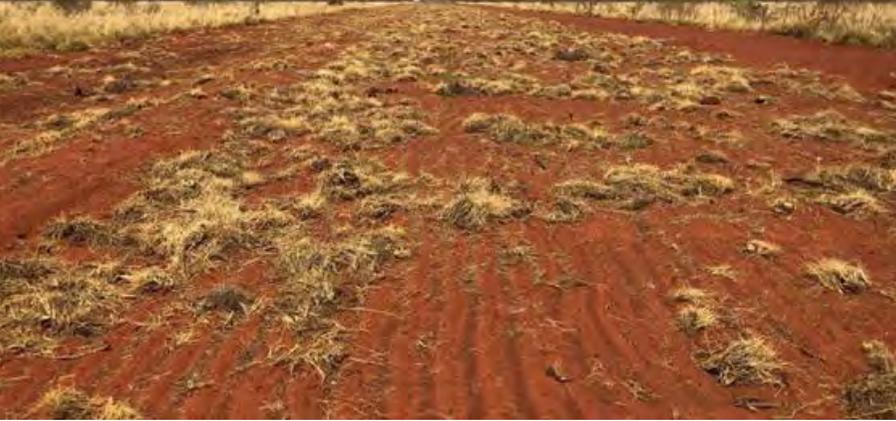
<p data-bbox="1173 284 1525 512"> Date & Time: Wed, 21 Nov 2018, 14:53:28 AEST Position: -33.538457° / +130.107522° Altitude: 371m Datum: WGS-84 Azimuth/Bearing: 271° 40'W 1344mils (True) Elevation Angle: -04.7° Horizon Angle: +01.5° Zoom: 1X Rehab KP421 Negative A1 Sushil Swami/MPC/Tanami </p>

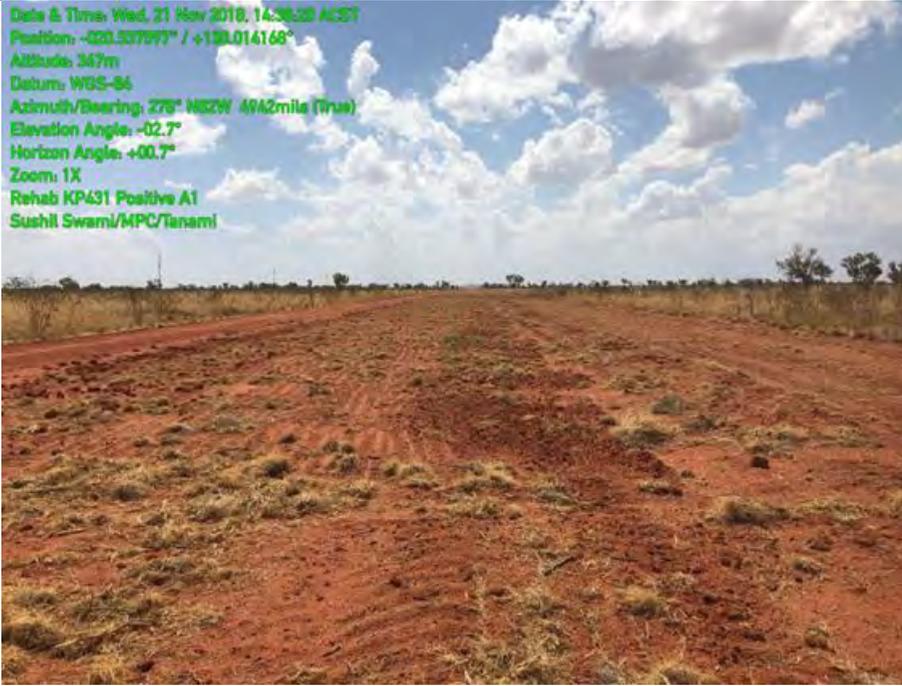
KP: 431	POSITIVE	KP: 431	NEGATIVE
<p data-bbox="241 284 593 512"> Date & Time: Wed, 21 Nov 2018, 14:36:28 ACST Position: -32.537997° / +130.014168° Altitude: 367m Datum: WGS-84 Azimuth/Bearing: 278° NSZW 4942mils (True) Elevation Angle: -02.7° Horizon Angle: +00.7° Zoom: 1X Rehab: KP431 Positive A1 Sushil Swami/MPC/Tanami </p>

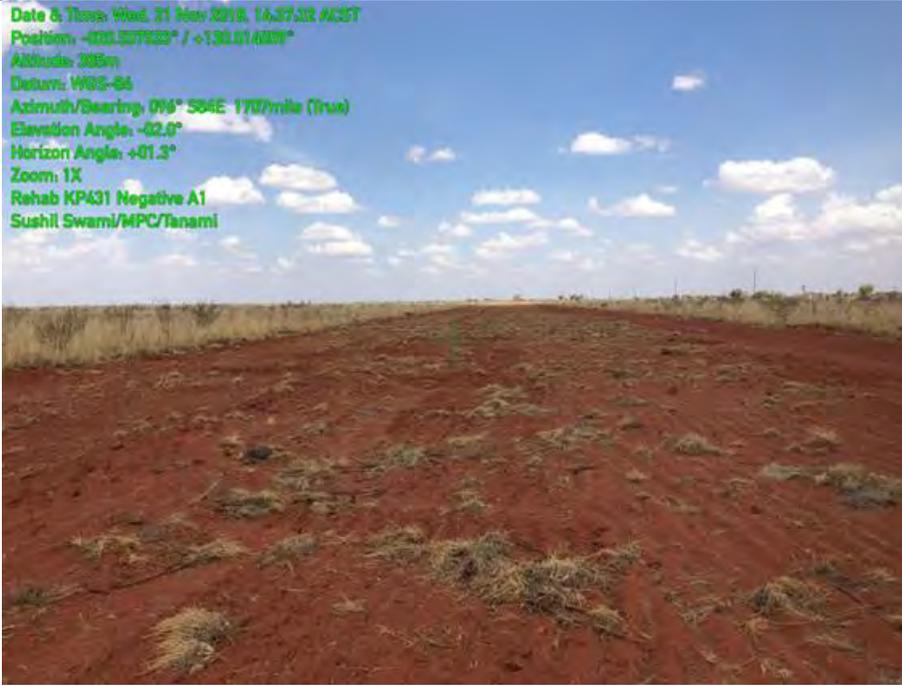
<p data-bbox="1173 284 1525 512"> Date & Time: Wed, 21 Nov 2018, 14:37:32 ACST Position: -32.537933° / +130.014089° Altitude: 365m Datum: WGS-84 Azimuth/Bearing: 096° SE4E 1707mils (True) Elevation Angle: -02.0° Horizon Angle: +01.3° Zoom: 1X Rehab: KP431 Negative A1 Sushil Swami/MPC/Tanami </p>

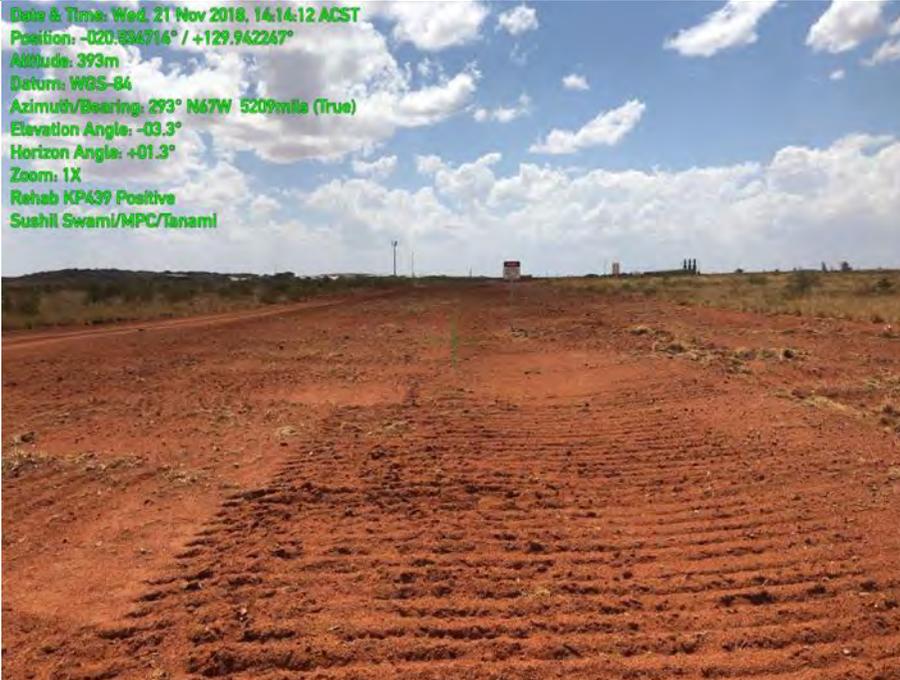
KP: 439	POSITIVE	KP: 439	NEGATIVE
<p> Date & Time: Wed, 21 Nov 2018, 14:14:12 ACST Position: -020.534714° / +129.942267° Altitude: 393m Datum: WGS-84 Azimuth/Bearing: 293° N67W 5209mils (True) Elevation Angle: -03.3° Horizon Angle: +01.3° Zoom: 1X Rehab KP439 Positive Sushil Swami/MPC/Tanami </p>

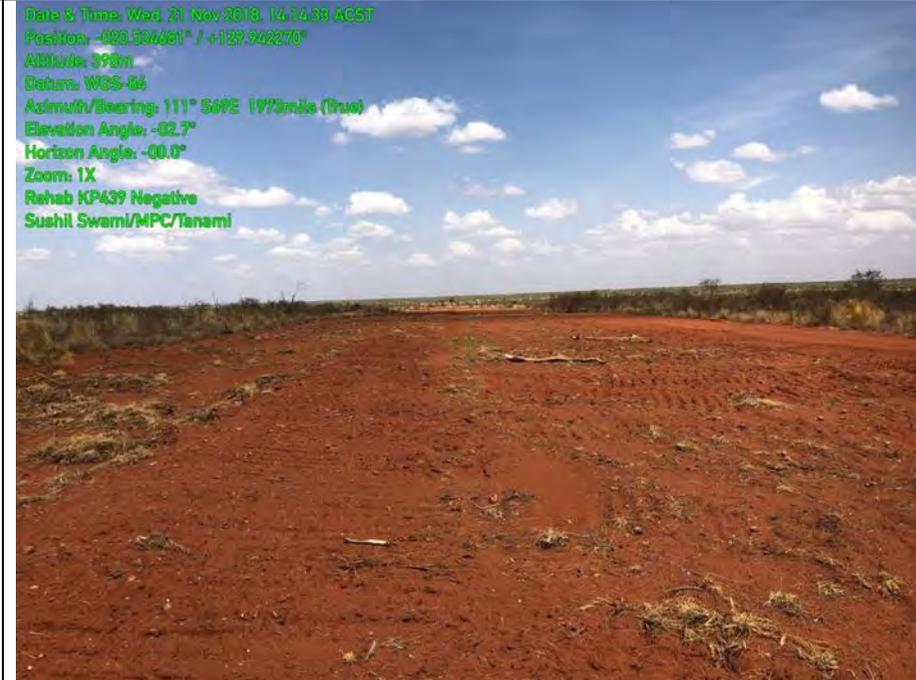
<p> Date & Time: Wed, 21 Nov 2018, 14:14:39 ACST Position: -020.534661° / +129.942270° Altitude: 393m Datum: WGS-84 Azimuth/Bearing: 111° S69E 1973mils (True) Elevation Angle: -02.7° Horizon Angle: -00.0° Zoom: 1X Rehab KP439 Negative Sushil Swami/MPC/Tanami </p>

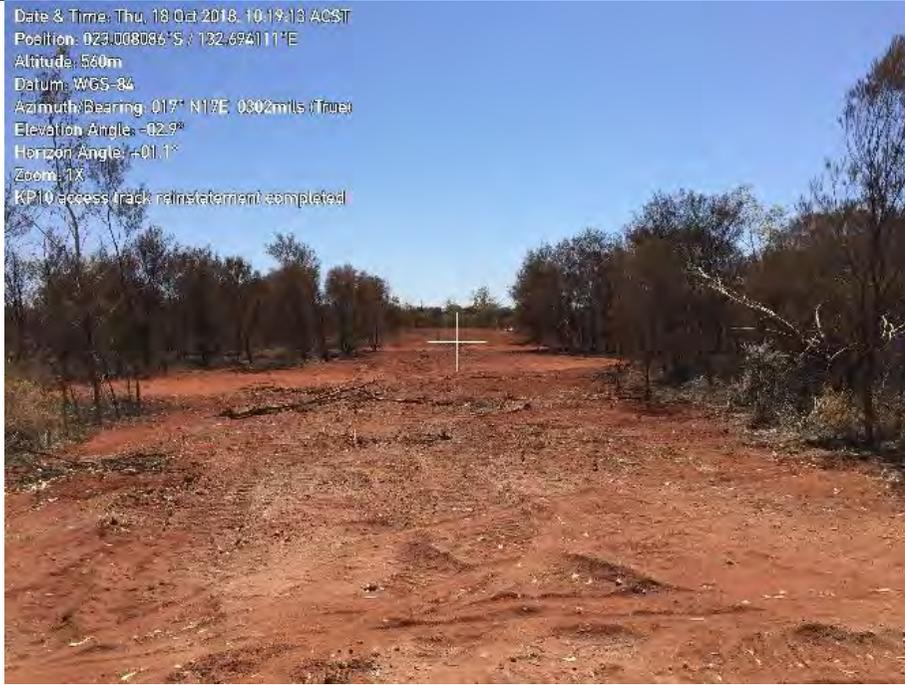
KP10	KP32
<p> Date & Time: Thu, 18 Oct 2018, 10:19:13 ACST Position: 023.008086°S, 132.694111°E Altitude: 560m Datum: WGS-84 Azimuth/Bearing: 019° N19E 0.302mils (True) Elevation Angle: -02.9° Horizon Angle: -01.1° Zoom: 1X KP10 access track reinstatement completed </p>

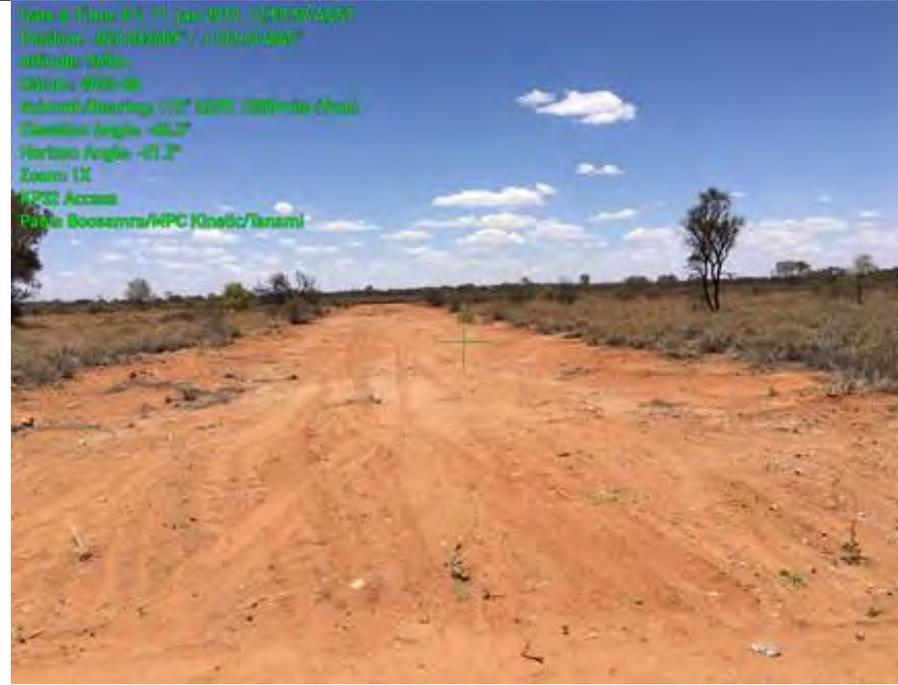
<p> Date & Time: Fri, 19 Oct 2018, 12:40:55 ACST Position: 023.008086°S, 132.694111°E Altitude: 560m Datum: WGS-84 Azimuth/Bearing: 019° N19E 0.302mils (True) Elevation Angle: -02.9° Horizon Angle: -01.1° Zoom: 1X MPC Access Photo: Boosamma/MPC Kinetic/Janani </p>

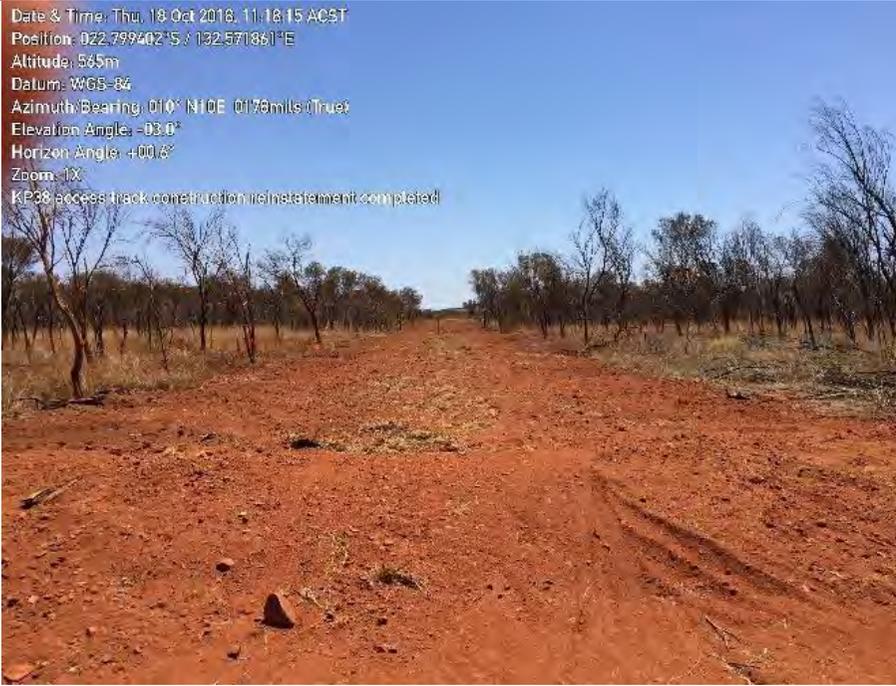
KP38	KP50
<p> Date & Time: Thu, 18 Oct 2018, 11:18:15 ACST Position: 022.799402°S / 132.571861°E Altitude: 565m Datum: WGS-84 Azimuth/Bearing: 010° N10E 0178mils (True) Elevation Angle: -03.0° Horizon Angle: +00.8° Zoom: 1X KP38 access track construction (re)statement completed </p>

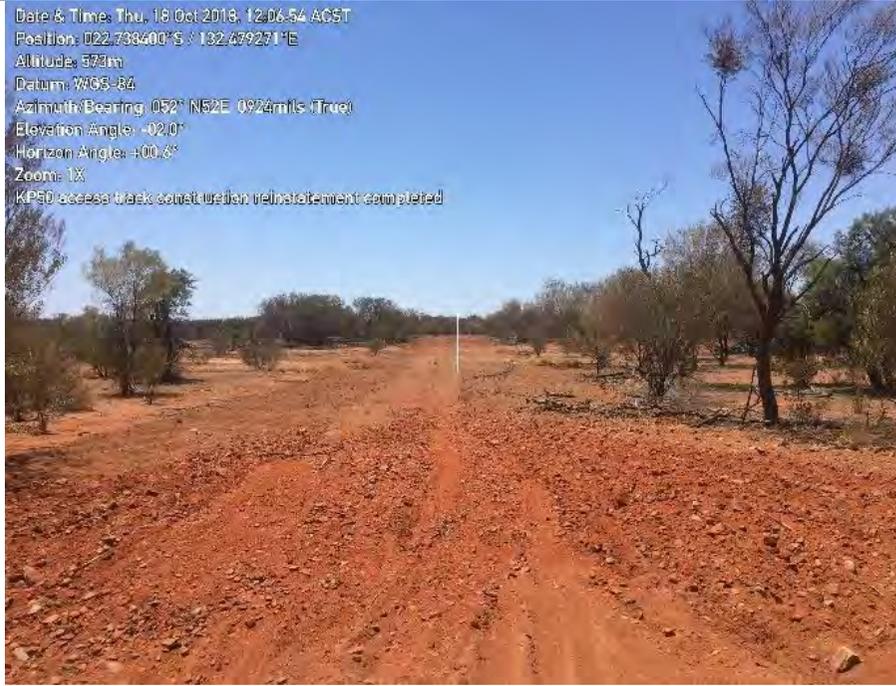
<p> Date & Time: Thu, 18 Oct 2018, 12:06:54 ACST Position: 022.798400°S / 132.679271°E Altitude: 573m Datum: WGS-84 Azimuth/Bearing: 052° N52E 0924mils (True) Elevation Angle: -02.0° Horizon Angle: +00.8° Zoom: 1X KP50 access track construction (re)statement completed </p>

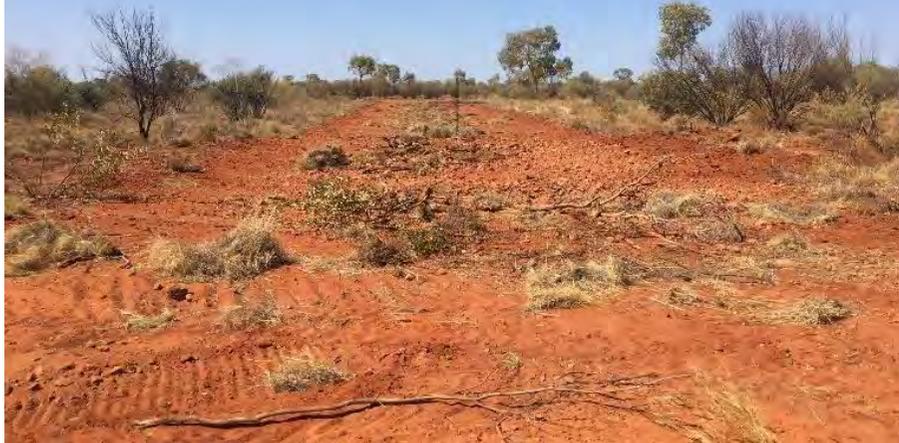
Date & Time: Thu, 18 Oct 2018, 14:45:06 ACST
 Position: 022.574161°S / 132.263896°E
 Altitude: 586m
 Datum: WGS-84
 Azimuth/Bearing: 042° N42E 0747mils (True)
 Elevation Angle: -01.9°
 Horizon Angle: +00.3°
 Zoom: 1X
 KP80 access track construction reinstatement completed

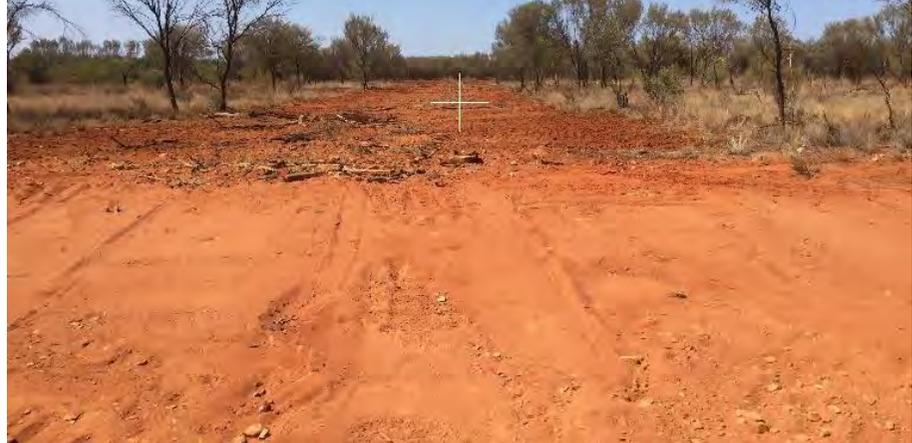
Date & Time: Thu, 18 Oct 2018, 14:32:39 ACST
 Position: 022.516957°S / 132.179486°E
 Altitude: 604m
 Datum: WGS-84
 Azimuth/Bearing: 036° N36E 0640mils (True)
 Elevation Angle: -03.4°
 Horizon Angle: +00.8°
 Zoom: 1X
 KP90 access track construction reinstatement completed

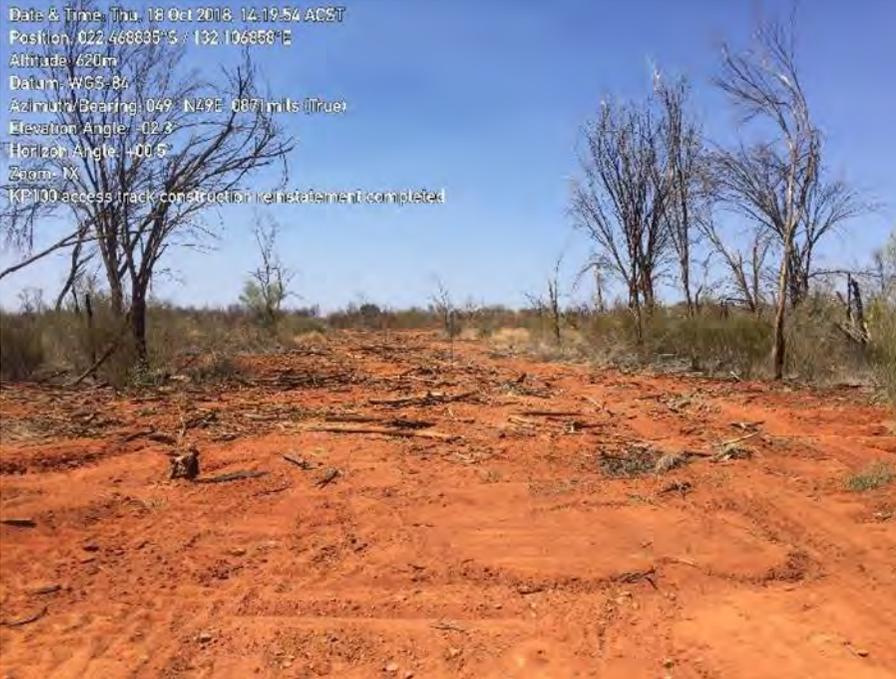
KP100	KP110
<p> Date & Time: Thu, 18 Oct 2018, 14:19:54 ACST Position: 022.468635°S / 132.106856°E Altitude: 620m Datum: WGS-84 Azimuth/Bearing: 049° N49E 087mils (True) Elevation Angle: -02.3° Horizon Angle: +00.5° Zoom: 1X KP100 access track construction reinstatement completed </p>

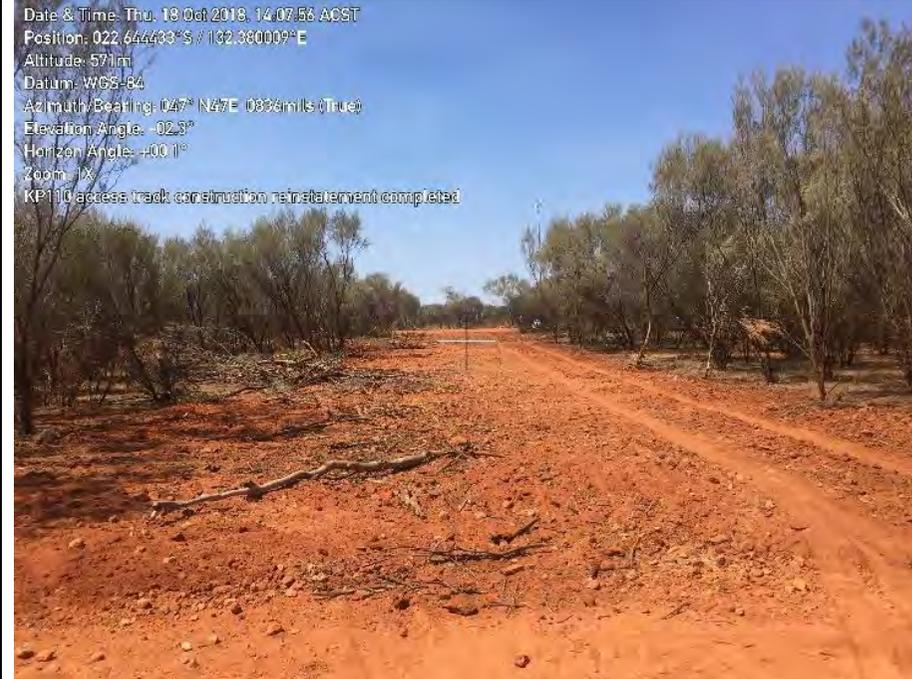
<p> Date & Time: Thu, 18 Oct 2018, 14:07:58 ACST Position: 022.644433°S / 132.380009°E Altitude: 571m Datum: WGS-84 Azimuth/Bearing: 047° N47E 083mils (True) Elevation Angle: -02.3° Horizon Angle: +00.1° Zoom: 1X KP110 access track construction reinstatement completed </p>

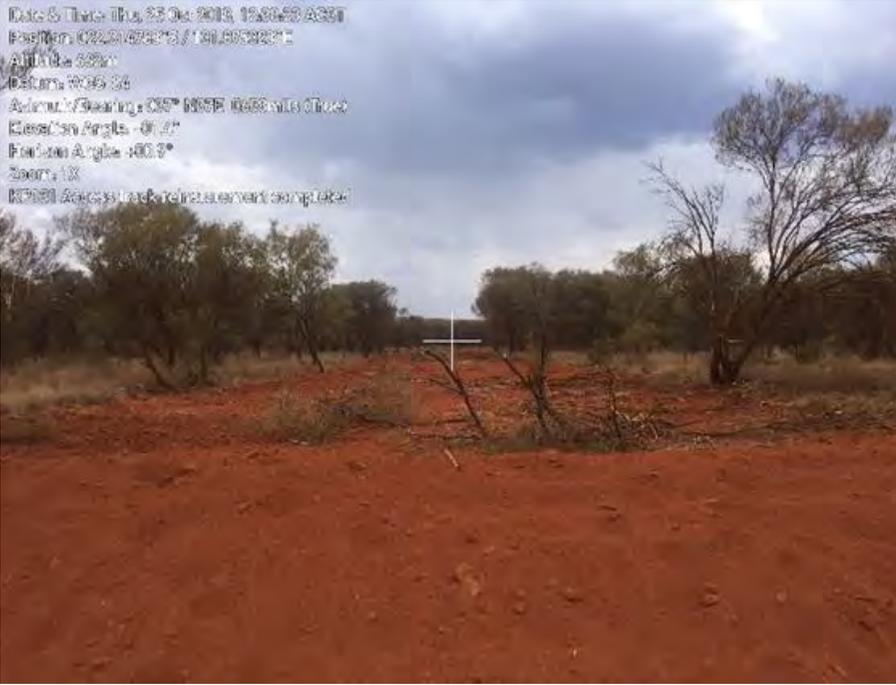
KP131	KP151
<p> Date & Time: Thu, 02 Oct 2018, 19:01:59 ACST Position: 022.50473°S / 131.69632°E Altitude: 667m Datum: WGS-84 Azimuth/Bearing: 355° N055W 6311mla (True) Elevation Angle: -01.0° Horizon Angle: +00.5° Zoom: 1X KP131 Access track reinstatement completed </p>

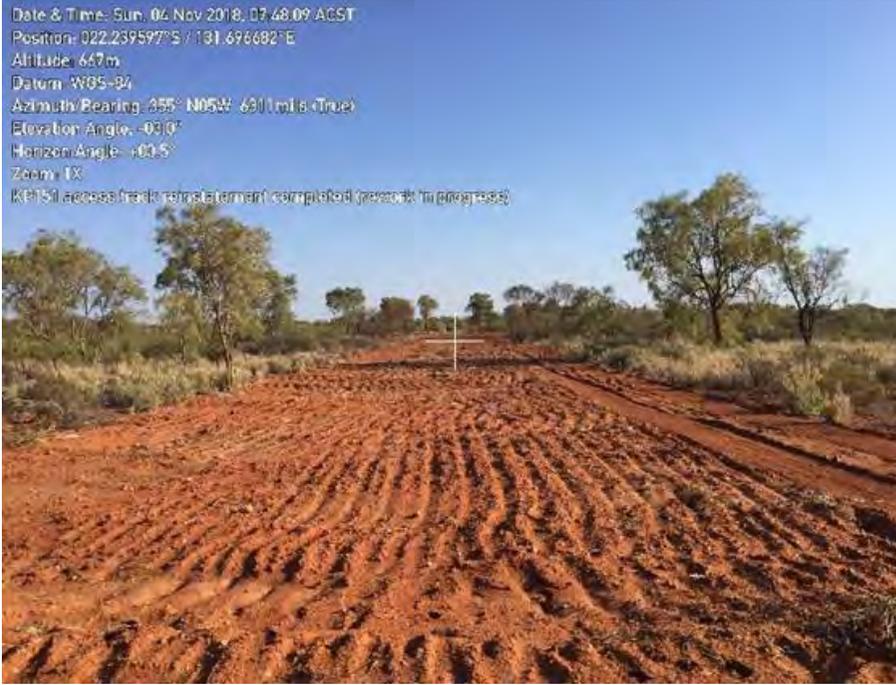
<p> Date & Time: Sun, 04 Nov 2018, 07:48:09 ACST Position: 022.239597°S / 131.696682°E Altitude: 667m Datum: WGS-84 Azimuth/Bearing: 355° N05W 6311mla (True) Elevation Angle: -01.0° Horizon Angle: +00.5° Zoom: 1X KP151 access track reinstatement completed (pavement in progress) </p>

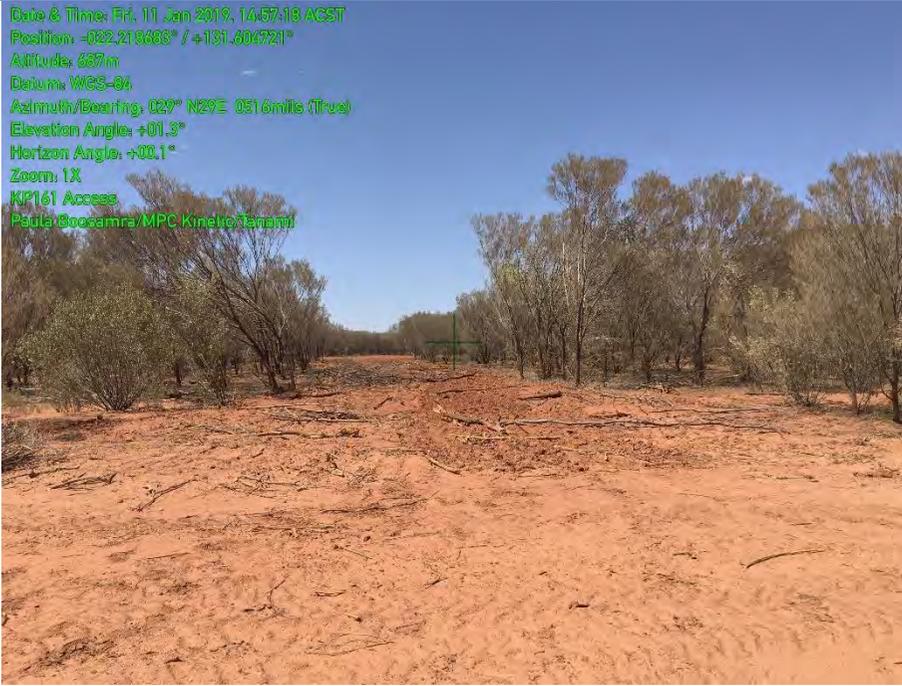
<p> Access to Camp 2 still intact as @ 21/02/2019 and is included in a separate report. Refer to 874 ENV FRM 344.. </p>

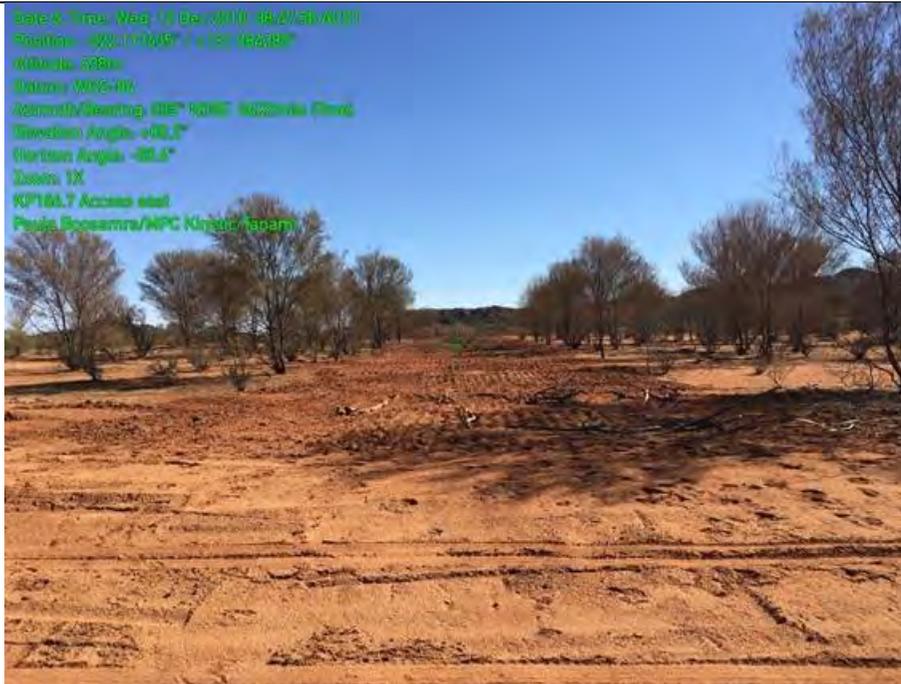
Date & Time: Wed 11 Dec 2014 14:26:40
Position: -32.177687° / 152.166587°
Altitude: 528m
Station: WPC-19
Camera/Setting: 485° 4000 10240x6768
Tilt/Lean Angle: +08.2°
Roll Angle: -82.5°
Down TX
KP186.7 Access road
Paula Boocanna/MPC Kinetic/Mapam

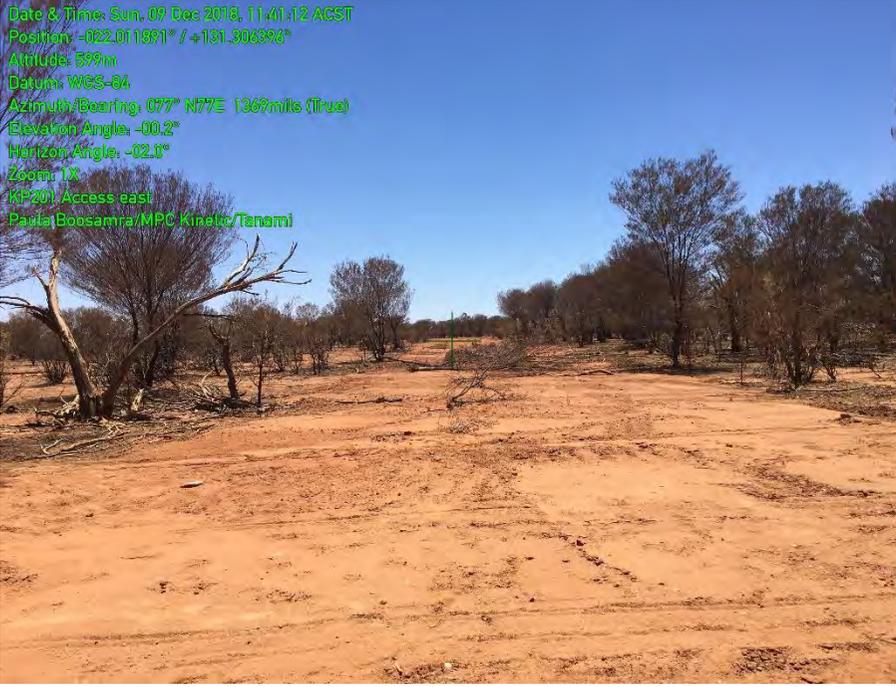
<p>The access track at KP211 is still intact as at 21/02/2019 and is subject to a separate report. Refer to 874 ENV FRM 344.</p>

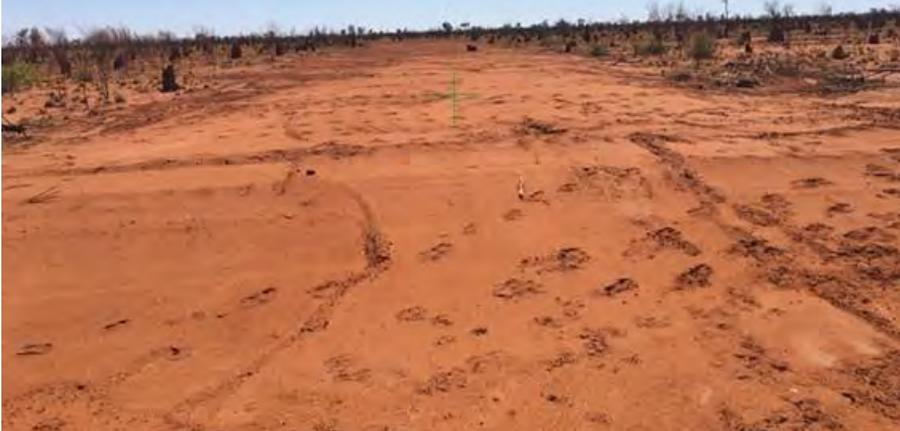
KP221	KP233
<p> Date & Time: Sun, 07 Dec 2018 10:48:03 AEST Position: -33.83227° / +131.81762° Altitude: 555m Datum: WGS-84 Azimuth/Bearing: 071° NPT E 1382m (True) Elevation Angle: -64.4° Horizon Angle: -01.5° Zoom: 1X KP221 Access track east Paula Boosamra/MPC Kinetic/Tanami </p>

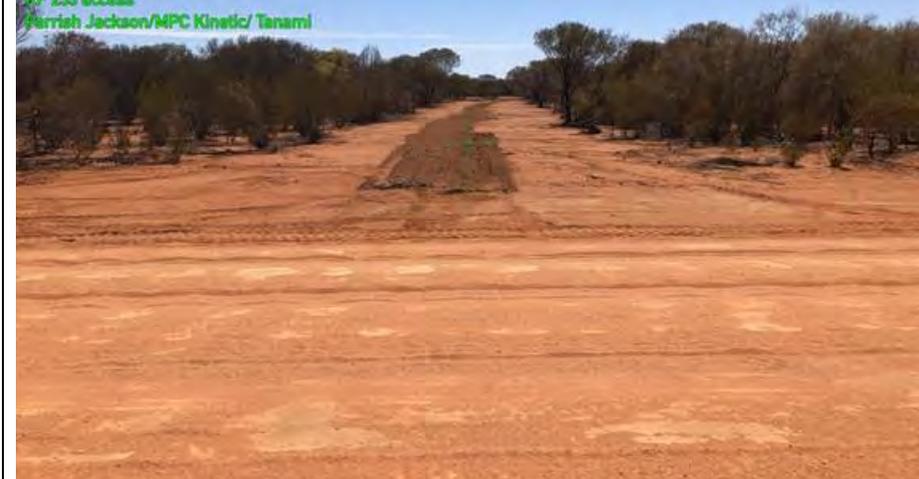
<p> Date & Time: Mon, 01 Dec 2018 11:04:57 AEST Position: -33.779211° / +131.146328° Altitude: 1187m Datum: WGS-84 Azimuth/Bearing: 071° NPT E 1382m (True) Elevation Angle: -63.7° Horizon Angle: +00.3° Zoom: 1X KP 233 access Farrisah Jackson/MPC Kinetic/ Tanami </p>

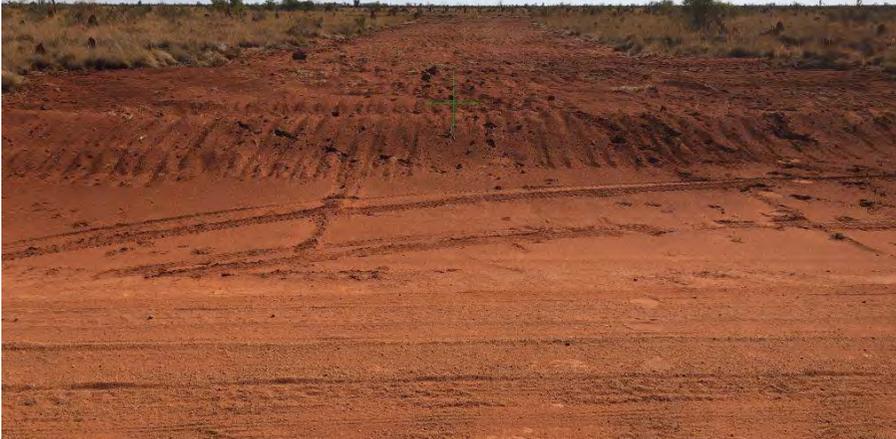
KP241	KP251
<p> Date & Time: Sat, 08 Dec 2018, 09:07:35 ACST Position: -021.710785° / +131.110481° Altitude: 519m Datum: WGS-84 Azimuth/Bearing: 069° N69E 1227mils (True) Elevation Angle: -06.5° Horizon Angle: +01.3° Zoom: 1X Rehabbed Access Track KP241 A Sushil Swami/MPC/Tanami </p>

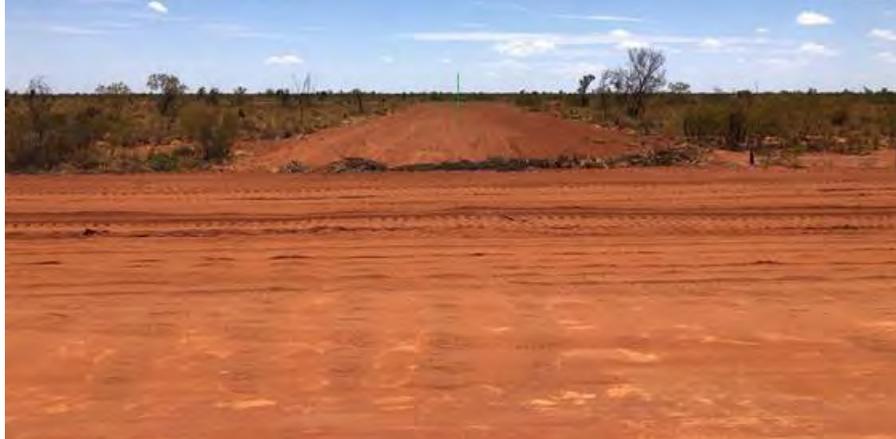
<p> Date & Time: Mon, 21 Jan 2019, 11:58:25 AEST Position: -021.632762° / +131.062215° Altitude: 1658ft Datum: WGS-84 Azimuth/Bearing: 158° 088E 1097mils (True) Elevation Angle: -04.7° Horizon Angle: +03.0° Zoom: 1X KP 251 access entry Parriah Jackson/MPC Kinetic/ Tanami </p>

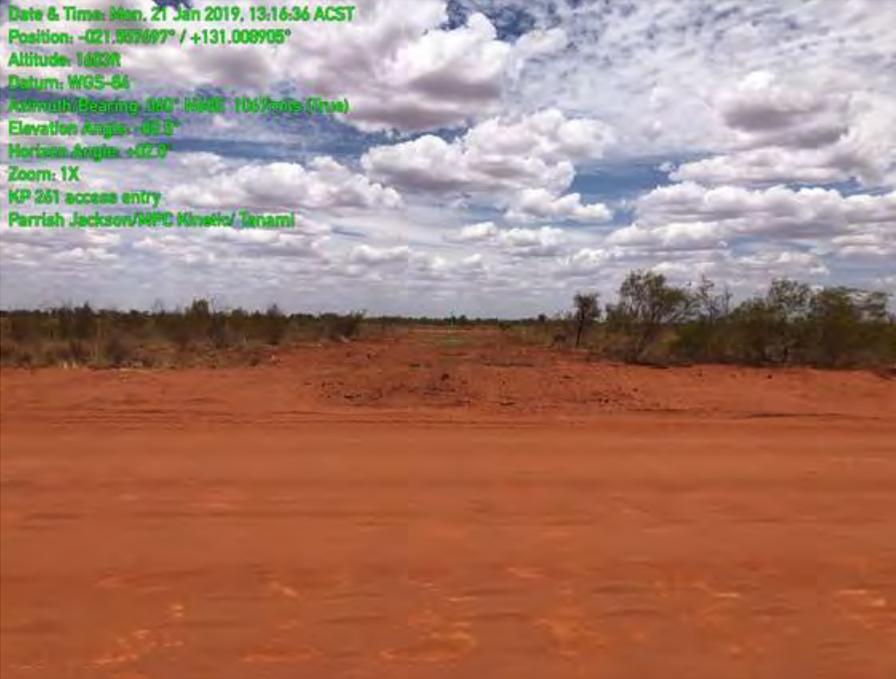
KP261	KP272
<p> Date & Time: Mon, 21 Jan 2019, 13:16:36 ACST Position: -021.937697° / +131.008905° Altitude: 1603m Datum: WGS-84 Azimuth/Bearing: 040° N540E 1067mils (True) Elevation Angle: -05.3° Horizon Angle: +02.0° Zoom: 1X KP 261 access entry Parriah Jackson/MPC Kinetic/ Tanami </p>

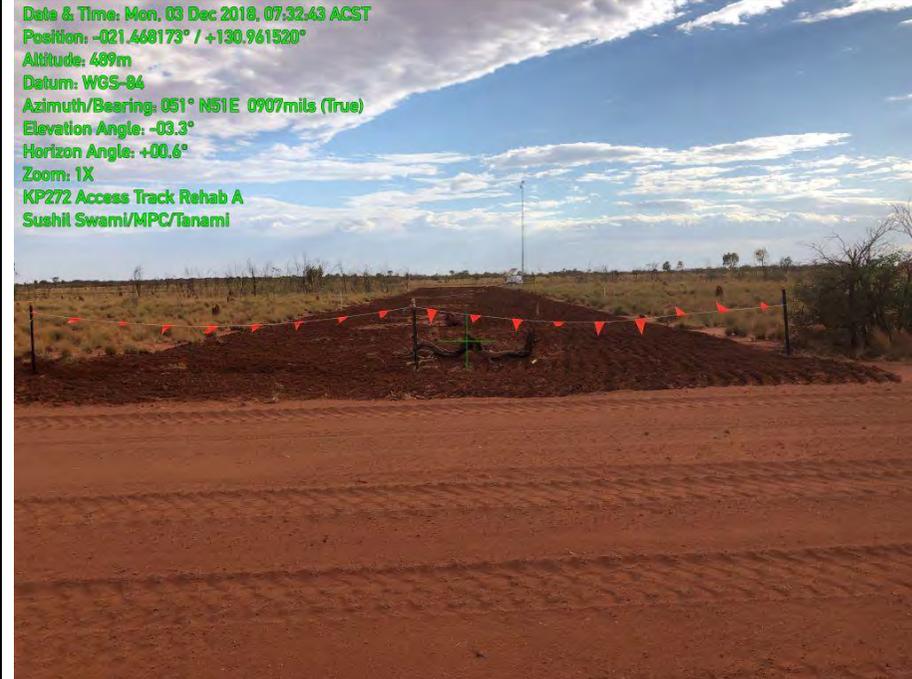
<p> Date & Time: Mon, 03 Dec 2018, 07:32:43 ACST Position: -021.468173° / +130.961520° Altitude: 489m Datum: WGS-84 Azimuth/Bearing: 051° N51E 0907mils (True) Elevation Angle: -03.3° Horizon Angle: +00.6° Zoom: 1X KP272 Access Track Rehab A Sushil Swami/MPC/Tanami </p>

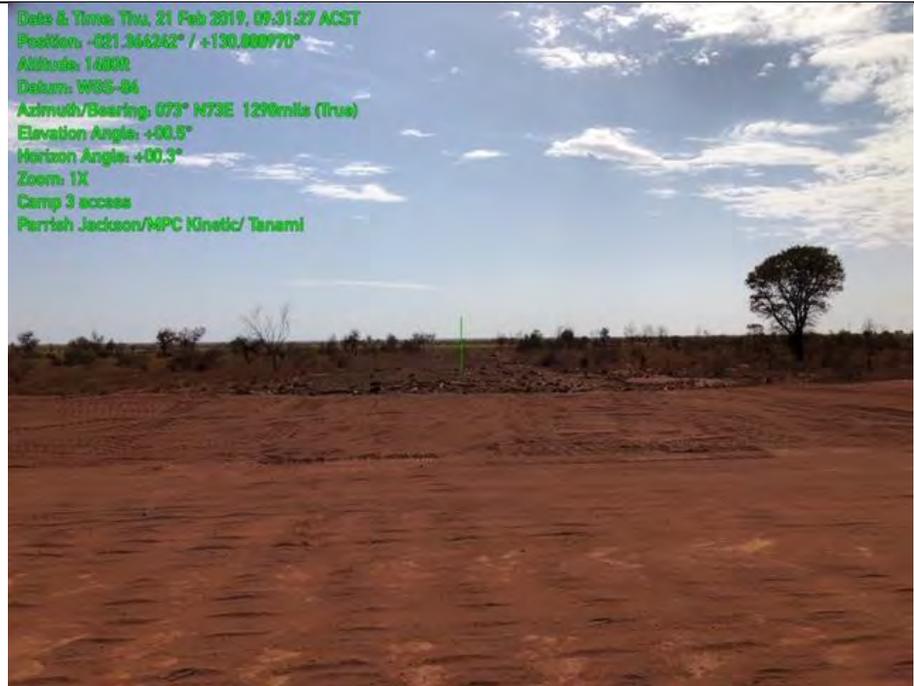
KP279 – Facilities	KP286 – Camp 3
<p>Access track to facilities at KP279 was in still intact as @ 21/02/2019 and is included in a separate report. Refer to 874 ENV FRM 344.</p>	<p> Date & Time: Thu, 21 Feb 2019, 09:31:27 ACST Position: -321.346242° / +130.888970° Altitude: 14800 Datum: WGS-84 Azimuth/Bearing: 073° N73E 1290mils (True) Elevation Angle: +00.5° Horizon Angle: +00.3° Zoom: 1X Camp 3 access Parrish Jackson/MPC Kinetic/ Tanami </p>

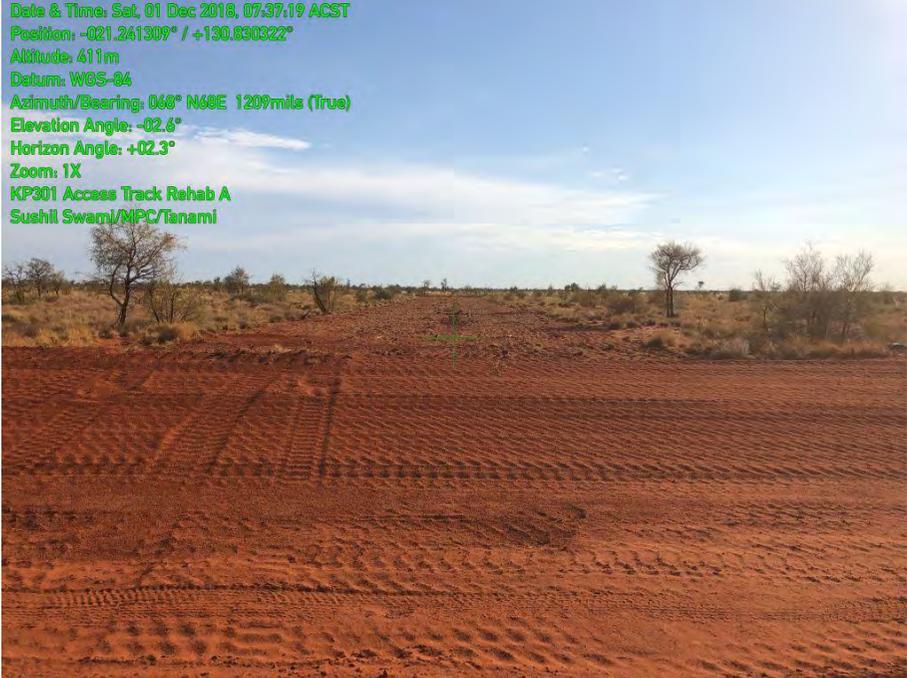
KP301	KP311
<p>Date & Time: Sat, 01 Dec 2018, 07:37:19 ACST Position: -021.241309° / +130.830322° Altitude: 411m Datum: WGS-84 Azimuth/Bearing: 068° N68E 1209mils (True) Elevation Angle: -02.6° Horizon Angle: +02.3° Zoom: 1X KP301 Access Track Rehab A Sushil Swami/MPC/Tanami</p>

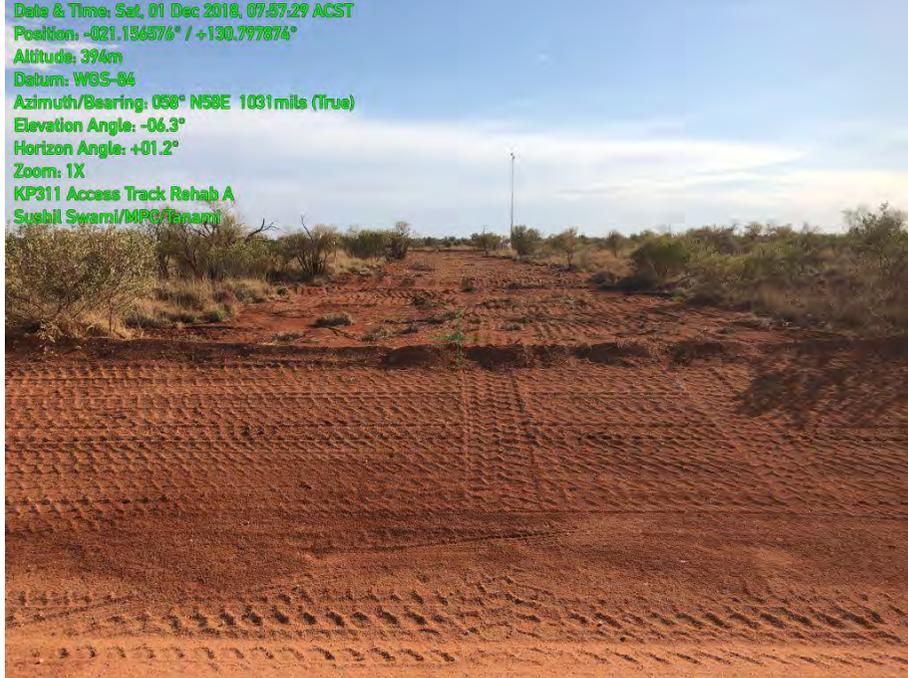
<p>Date & Time: Sat, 01 Dec 2018, 07:57:29 ACST Position: -021.154576° / +130.797874° Altitude: 394m Datum: WGS-84 Azimuth/Bearing: 058° N58E 1031mils (True) Elevation Angle: -04.3° Horizon Angle: +01.2° Zoom: 1X KP311 Access Track Rehab A Sushil Swami/MPC/Tanami</p>
