Tanami Gas Pipeline

EPBC 2017/7997

COMPLIANCE ASSESSMENT REPORT 2018-2019

E-REP-035

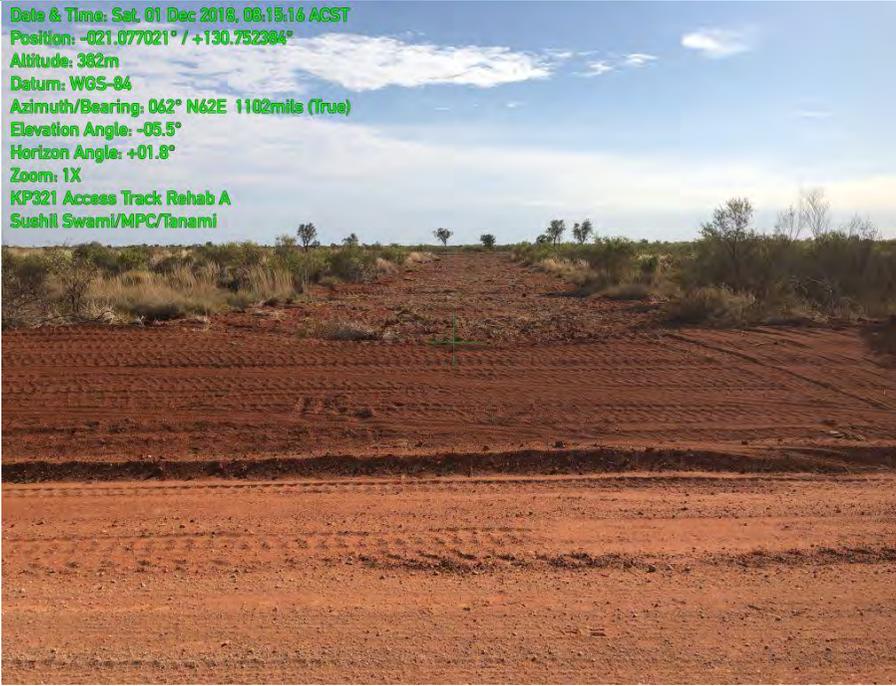
KP321	KP331
<p>Date & Time: Sat, 01 Dec 2016, 08:15:16 ACST Position: -021.077021° / +130.752384° Altitude: 382m Datum: WGS-84 Azimuth/Bearing: 062° N62E 1102mils (True) Elevation Angle: -05.5° Horizon Angle: +01.8° Zoom: 1X KP321 Access Track Rehab A Sushil Swami/MPC/Tanami</p>

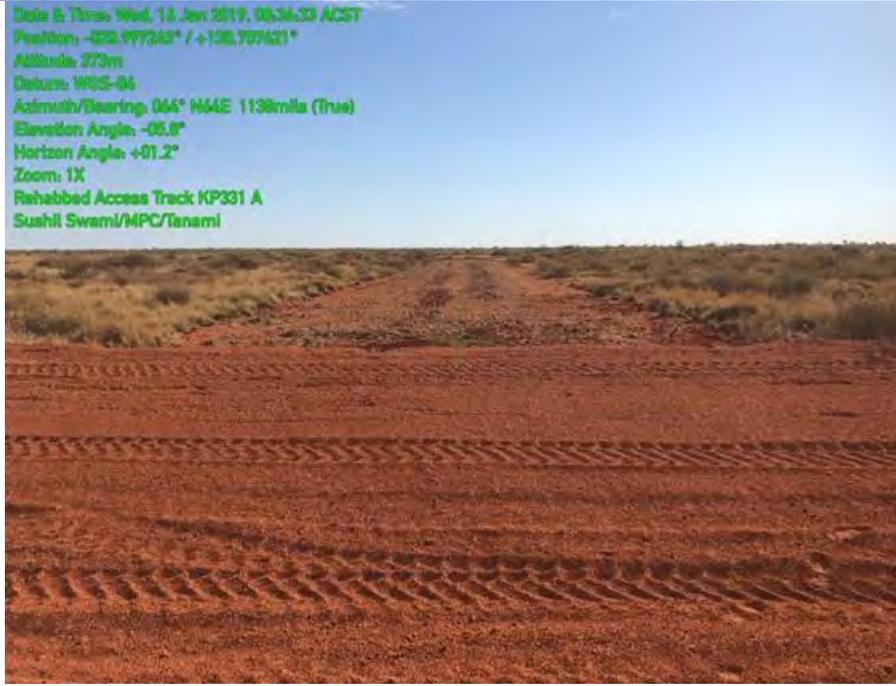
<p>Date & Time: Wed, 14 Jan 2017, 08:34:33 ACST Position: -022.977249° / +130.707621° Altitude: 273m Datum: WGS-84 Azimuth/Bearing: 064° N64E 1138mils (True) Elevation Angle: -05.8° Horizon Angle: +01.2° Zoom: 1X Rehabbed Access Track KP331 A Sushil Swami/MPC/Tanami</p>

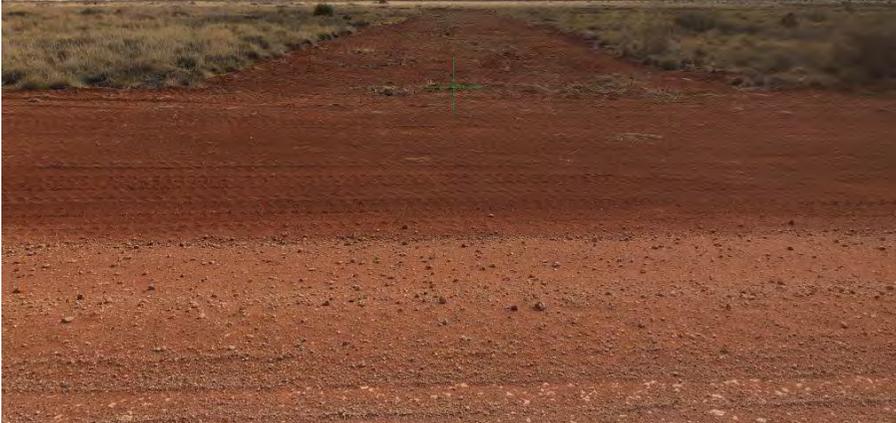
KP341	KP351
<p>Date & Time: Sat, 01 Dec 2018, 06:39:53 ACST Position: -020.917486° / +130.662587° Altitude: 369m Datum: WGS-84 Azimuth/Bearing: 062° N62E 1102mils (True) Elevation Angle: -04.9° Horizon Angle: +01.7° Zoom: 1X KP341 Access Track Rehab A Sushil Swami/MPC/Tanami</p>

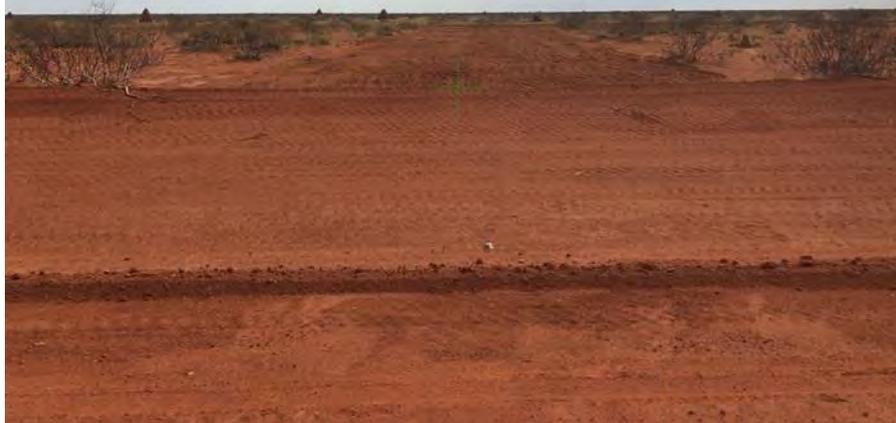
<p>Date & Time: Sat, 01 Dec 2018, 06:55:38 ACST Position: -020.660073° / +130.591399° Altitude: 359m Datum: WGS-84 Azimuth/Bearing: 054° N54E 0960mils (True) Elevation Angle: -04.8° Horizon Angle: +01.1° Zoom: 1X KP351 Access Track Rehab A Sushil Swami/MPC/Tanami</p>

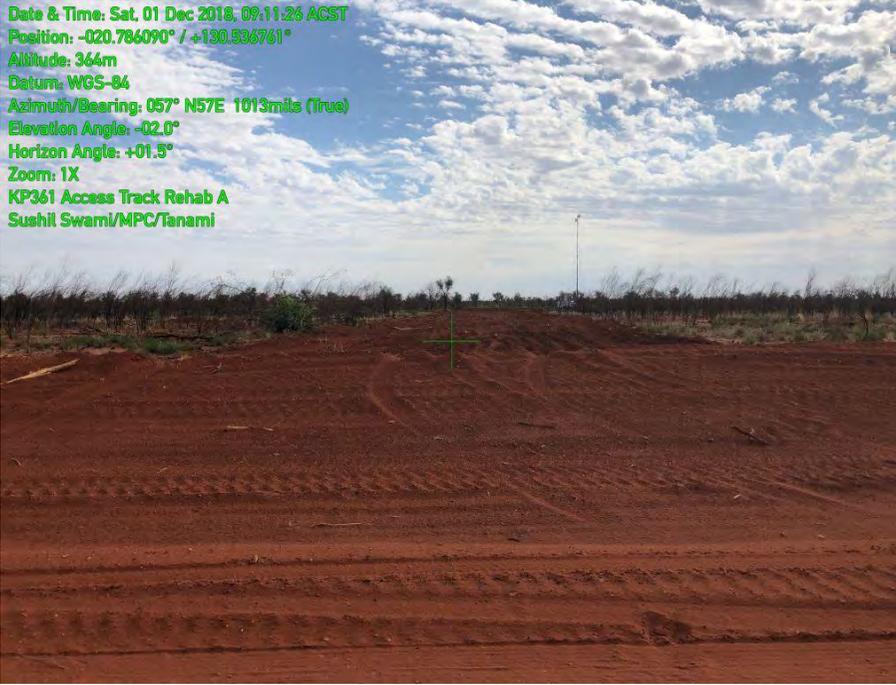
KP361	KP371
<p> Date & Time: Sat, 01 Dec 2018, 09:11:26 ACST Position: -020.786090° / +130.536761° Altitude: 364m Datum: WGS-84 Azimuth/Bearing: 057° N57E 1013mils (True) Elevation Angle: -02.0° Horizon Angle: +01.5° Zoom: 1X KP361 Access Track Rehab A Sushil Swami/MPC/Tanami </p>

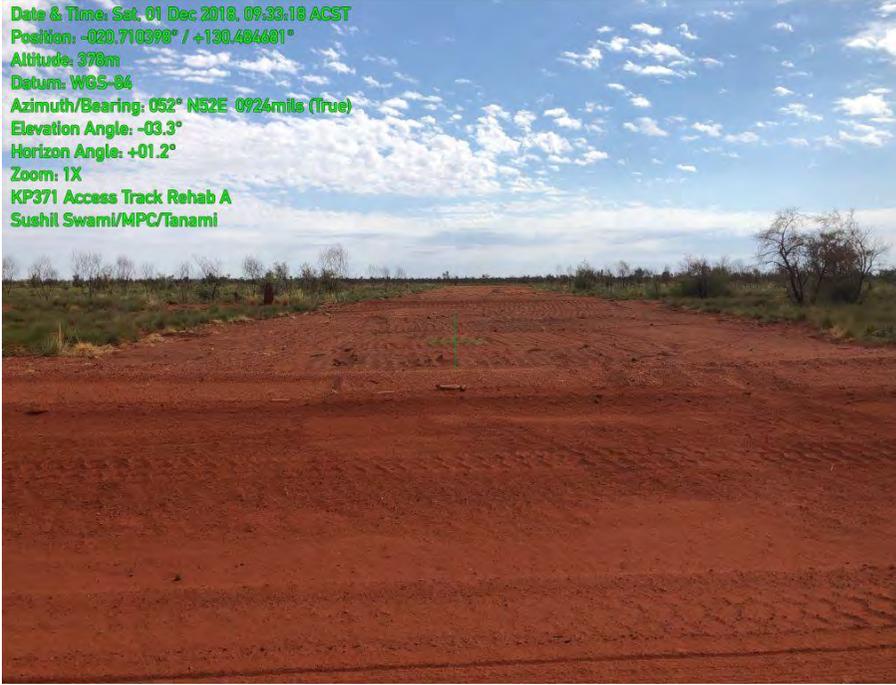
<p> Date & Time: Sat, 01 Dec 2018, 09:33:18 ACST Position: -020.710398° / +130.484681° Altitude: 378m Datum: WGS-84 Azimuth/Bearing: 052° N52E 0924mils (True) Elevation Angle: -03.3° Horizon Angle: +01.2° Zoom: 1X KP371 Access Track Rehab A Sushil Swami/MPC/Tanami </p>

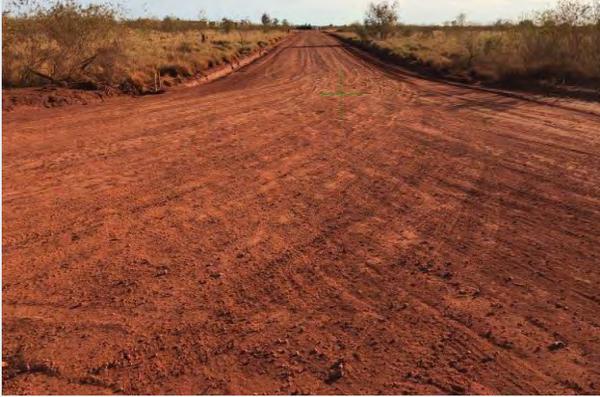
CAMP ACCESS

Date & Time: Mon, 21 Jan 2019, 07:40:06 ACST
 Position: -020.609440° / +130.402458°
 Altitude: 390m
 Datum: WGS-84
 Azimuth/Bearing: 057° N57E 1013mils (True)
 Elevation Angle: -04.2°
 Horizon Angle: +01.2°
 Zoom: 1X
 Camp 4 - Access
 Sushil Swami/MPC/Tanami

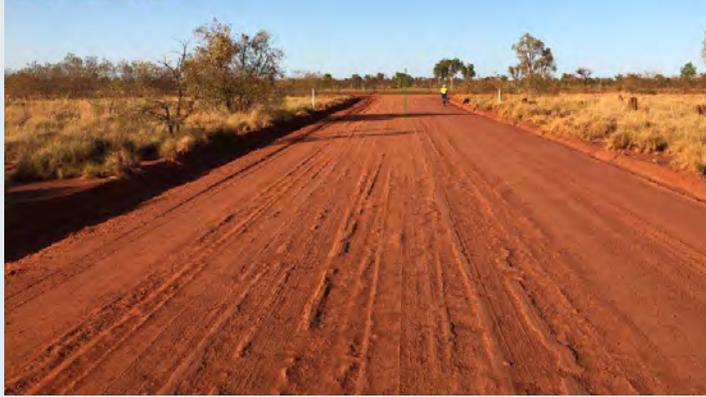
CAMP ACCESS

Date & Time: Mon, 21 Jan 2019, 07:42:28 ACST
 Position: -020.609995° / +130.403159°
 Altitude: 392m
 Datum: WGS-84
 Azimuth/Bearing: 230° S30W 4689mils (True)
 Elevation Angle: +06.3°
 Horizon Angle: +01.9°
 Zoom: 1X
 Camp 4 - Access B
 Sushil Swami/MPC/Tanami

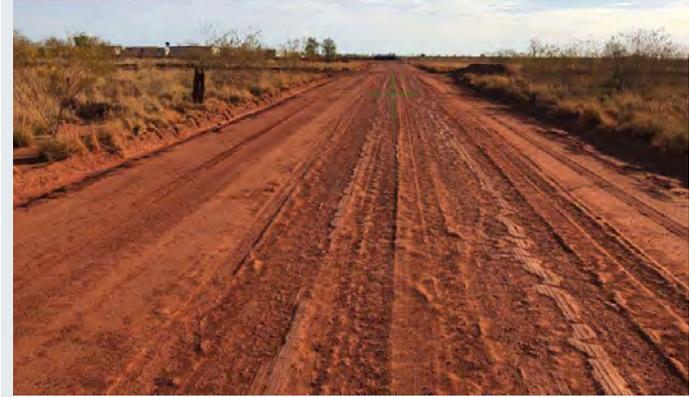
CAMP ACCESS

Date & Time: Mon, 21 Jan 2019, 07:42:48 ACST
 Position: -020.609908° / +130.403278°
 Altitude: 393m
 Datum: WGS-84
 Azimuth/Bearing: 057° N57E 1013mils (True)
 Elevation Angle: -02.1°
 Horizon Angle: +01.8°
 Zoom: 1X
 Camp 4 - Access C
 Sushil Swami/MPC/Tanami

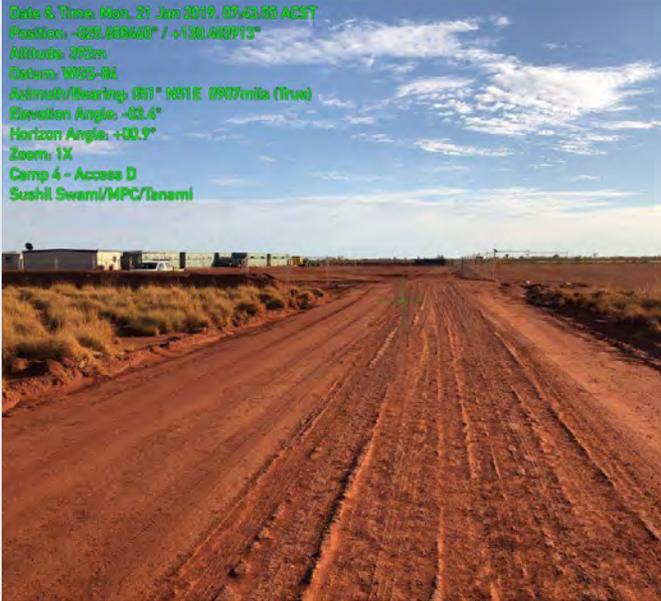
CAMP ACCESS

Date & Time: Mon, 21 Jan 2019, 07:43:25 ACST
 Position: -020.608660° / +130.403713°
 Altitude: 392m
 Datum: WGS-84
 Azimuth/Bearing: 051° N51E 0907mils (True)
 Elevation Angle: -03.6°
 Horizon Angle: +00.9°
 Zoom: 1X
 Camp 4 - Access D
 Sushil Swami/MPC/Tanami

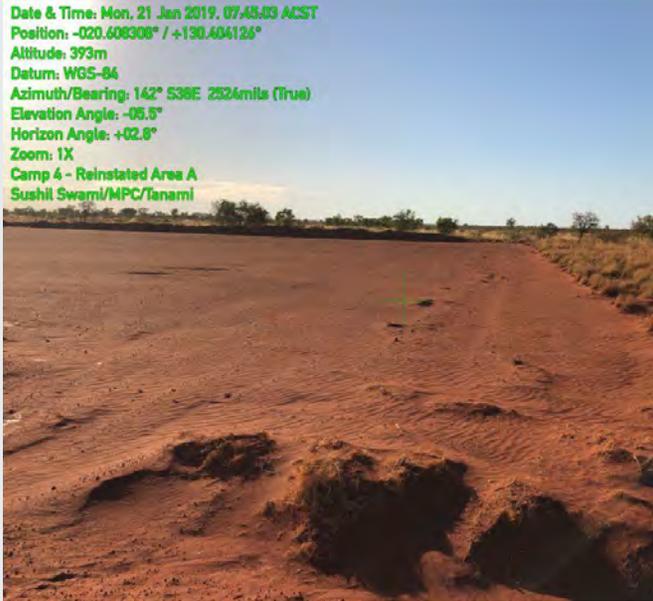
CAMP REINSTATEMENT

Date & Time: Mon, 21 Jan 2019, 07:45:25 ACST
 Position: -020.608278° / +130.404157°
 Altitude: 392m
 Datum: WGS-84
 Azimuth/Bearing: 101° S79E 1794mils (True)
 Elevation Angle: -04.1°
 Horizon Angle: +01.8°
 Zoom: 1X
 Camp 4 - Reinstated Area B
 Sushil Swami/MPC/Tanami

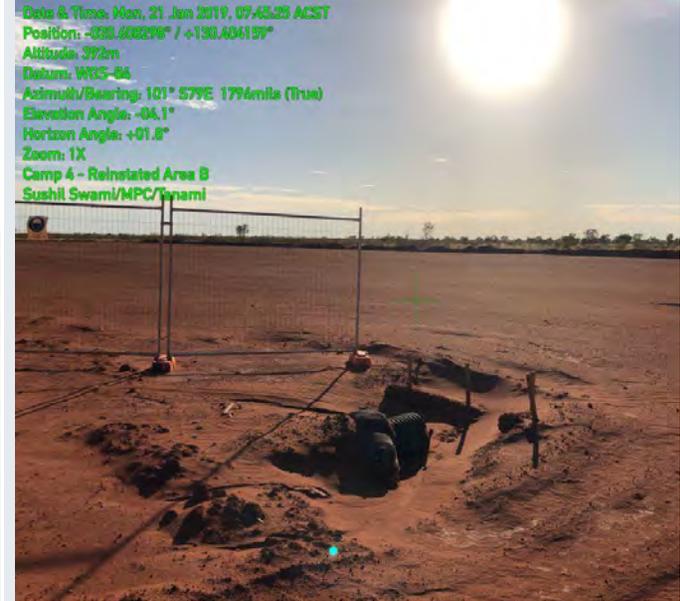
CAMP REINSTATEMENT

Date & Time: Mon, 21 Jan 2019, 07:45:44 ACST
Position: -020.606207° / +130.404247°
Altitude: 393m
Datum: WGS-84
Azimuth/Bearing: 163° S17E 2898mils (True)
Elevation Angle: -03.0°
Horizon Angle: +01.9°
Zoom: 1X
Camp 4 - Reinstated Area C
Sushil Swami/MPC/Tanami

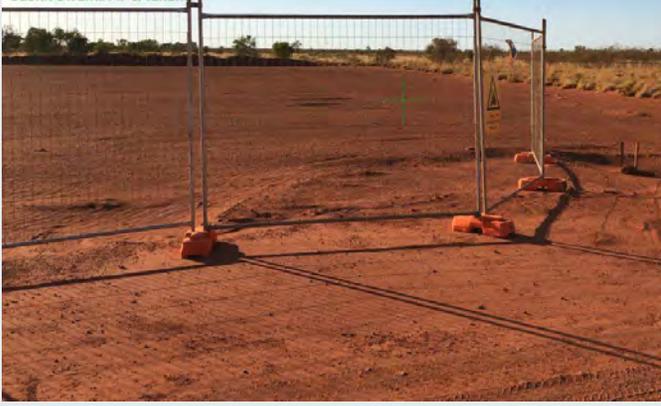
CAMP REINSTATEMENT

Date & Time: Mon, 21 Jan 2019, 07:45:54 ACST
Position: -020.606230° / +130.404274°
Altitude: 392m
Datum: WGS-84
Azimuth/Bearing: 058° N58E 1031mils (True)
Elevation Angle: -01.3°
Horizon Angle: +00.4°
Zoom: 1X
Camp 4 - Reinstated Area D
Sushil Swami/MPC/Tanami

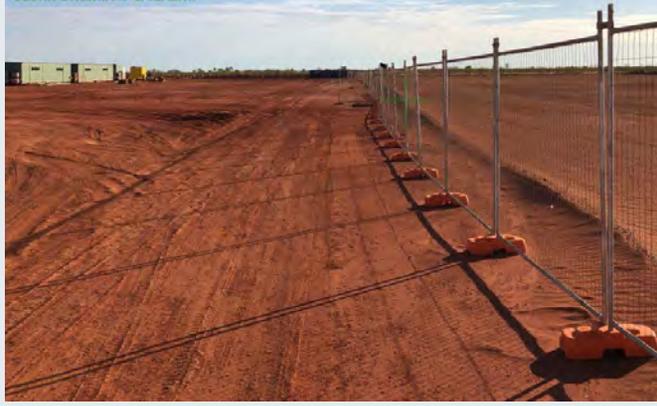
CAMP REINSTATEMENT

Date & Time: Mon, 21 Jan 2019, 07:55:40 ACST
Position: -020.607495° / +130.406279°
Altitude: 390m
Datum: WGS-84
Azimuth/Bearing: 230° S30W 6231mils (True)
Elevation Angle: -01.1°
Horizon Angle: +01.6°
Zoom: 1X
Camp 4 - Reinstated Area E
Sushil Swami/MPC/Tanami

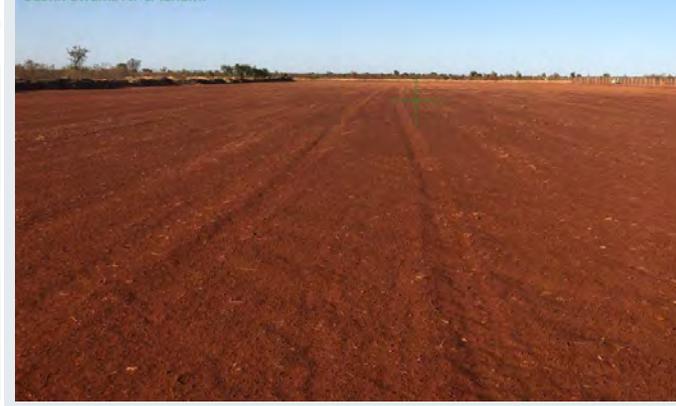
CAMP REINSTATEMENT

Date & Time: Mon, 21 Jan 2019, 07:54:05 ACST
Position: -020.607383° / +130.406147°
Altitude: 392m
Datum: WGS-84
Azimuth/Bearing: 200° S20W 3954mils (True)
Elevation Angle: -02.9°
Horizon Angle: +02.5°
Zoom: 1X
Camp 4 - Reinstated Area F
Sushil Swami/MPC/Tanami

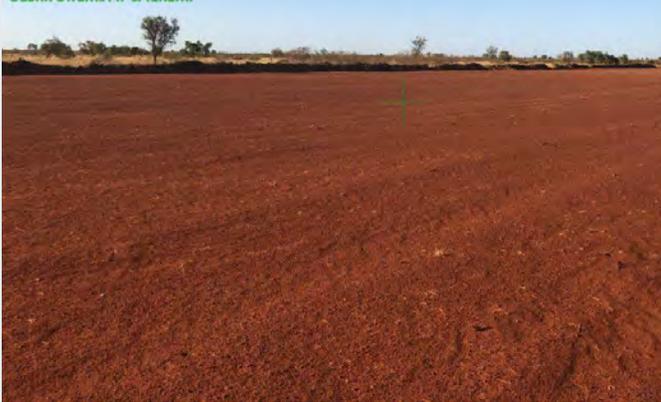
CAMP REINSTATEMENT

Date & Time: Mon, 21 Jan 2019, 07:54:05 ACST
Position: -020.607383° / +130.406147°
Altitude: 392m
Datum: WGS-84
Azimuth/Bearing: 200° S20W 3954mils (True)
Elevation Angle: -02.9°
Horizon Angle: +02.5°
Zoom: 1X
Camp 4 - Reinstated Area F
Sushil Swami/MPC/Tanami

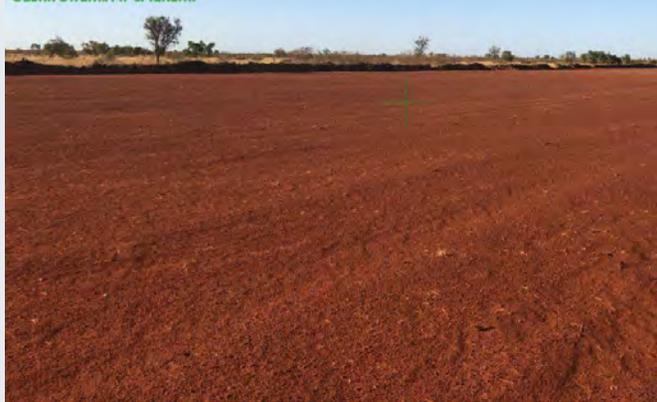
VEGETATION WINDROW

Date & Time: Mon, 21 Jan 2019, 07:53:43 ACST
Position: -020.607670° / +130.406545°
Altitude: 384m
Datum: WGS-84
Azimuth/Bearing: 236° S56W 4194mils (True)
Elevation Angle: -04.1°
Horizon Angle: +02.3°
Zoom: 1X
Camp 4 - Reinstated Area
Sushil Swami/MPC/Tanami

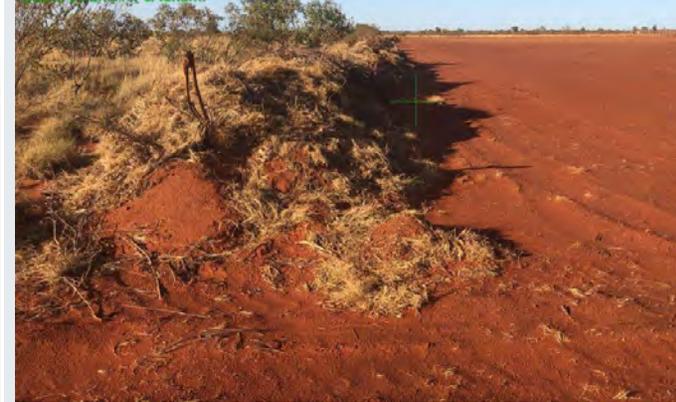
VEGETATION WINDROW

Date & Time: Mon, 21 Jan 2019, 07:58:08 ACST
Position: -020.6077932° / +130.406486°
Altitude: 397m
Datum: WGS-84
Azimuth/Bearing: 219° S39W 3893mils (True)
Elevation Angle: -03.4°
Horizon Angle: +02.3°
Zoom: 1X
Camp 4 - Veg B
Sushil Swami/MPC/Tanami

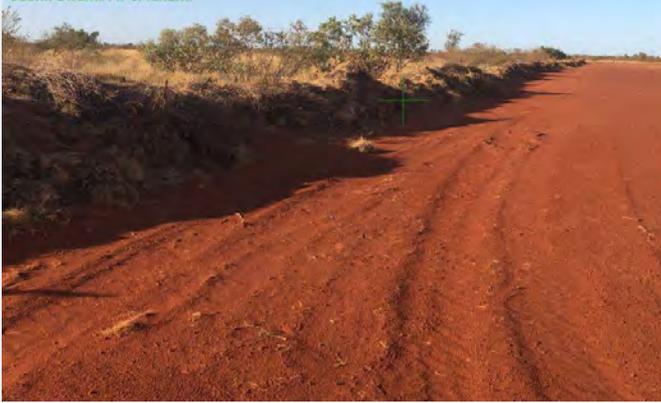
ACCESS DRAINAGE

Date & Time: Mon, 21 Jan 2019, 07:59:29 ACST
Position: -020.608330° / +130.404271°
Altitude: 396m
Datum: WGS-84
Azimuth/Bearing: 338° N22W 6009mils (True)
Elevation Angle: -12.6°
Horizon Angle: +02.6°
Zoom: 1X
Camp 4 - Access Drainage
Sushil Swami/MPC/Tanami

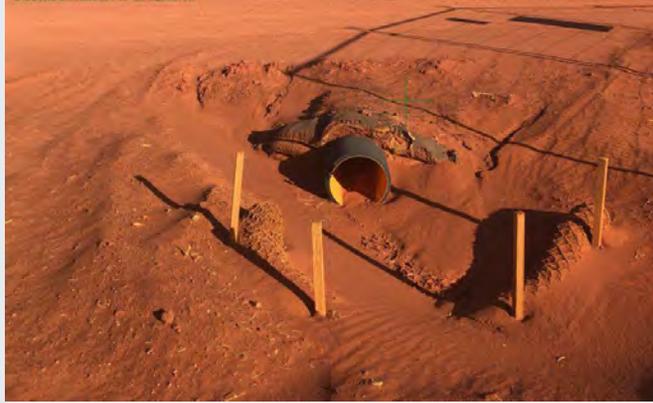
SEDIMENT TRAP

Date & Time: Mon, 21 Jan 2019, 08:04:38 ACST
Position: -020.607194° / +130.403444°
Altitude: 393m
Datum: WGS-84
Azimuth/Bearing: 230° S60W 4089mils (True)
Elevation Angle: -08.7°
Horizon Angle: +01.9°
Zoom: 1X
Camp 4 - Sediment Trap A
Sushil Swami/MPC/Tanami

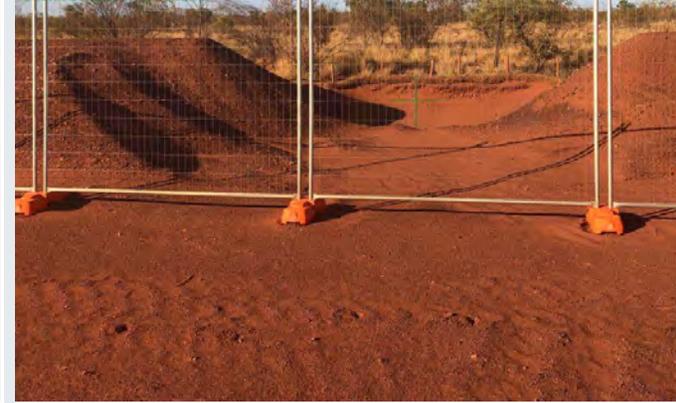
SEDIMENT TRAP

Date & Time: Mon, 21 Jan 2019, 08:08:08 ACST
Position: -020.606926° / +130.403725°
Altitude: 393m
Datum: WGS-84
Azimuth/Bearing: 209° N01W 3485mils (True)
Elevation Angle: -01.9°
Horizon Angle: +01.9°
Zoom: 1X
Camp 4 - Sediment Trap B
Sushil Swami/MPC/Tanami

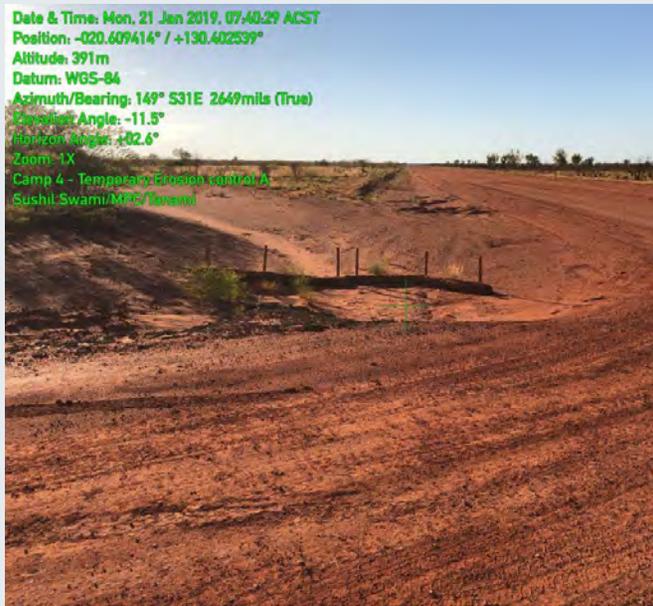
TEMPORARY EROSION CONTROL

Date & Time: Mon, 21 Jan 2019, 07:40:58 ACST
Position: -020.609395° / +130.402536°
Altitude: 393m
Datum: WGS-84
Azimuth/Bearing: 326° N34W 5796mils (True)
Elevation Angle: -08.5°
Horizon Angle: +02.3°
Zoom: 1X
Camp 4 - Temporary Erosion control B
Sushil Swami/MPC/Tanami

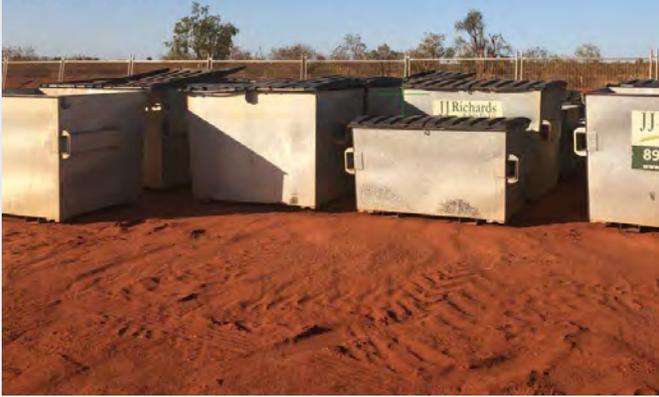
WASTE MANAGEMENT

Date & Time: Mon, 21 Jan 2019, 08:02:56 ACST
Position: -020.407620° / +130.403908°
Altitude: 391m
Datum: WGS-84
Azimuth/Bearing: 231° S51W 4107mils (True)
Elevation Angle: -08.0°
Horizon Angle: +00.3°
Zoom: 1X
Camp 4 - Waste management D
Sushil Swami/MPC/Tanami

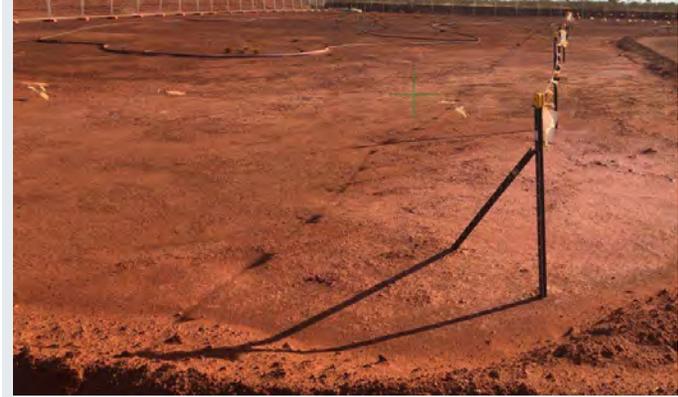
IRRIGATION AREA

Date & Time: Mon, 21 Jan 2019, 08:10:53 ACST
Position: -020.404361° / +130.404531°
Altitude: 394m
Datum: WGS-84
Azimuth/Bearing: 007° N07E 0124mils (True)
Elevation Angle: -03.7°
Horizon Angle: +01.5°
Zoom: 1X
Camp 4 - Irrigation Area B
Sushil Swami/MPC/Tanami

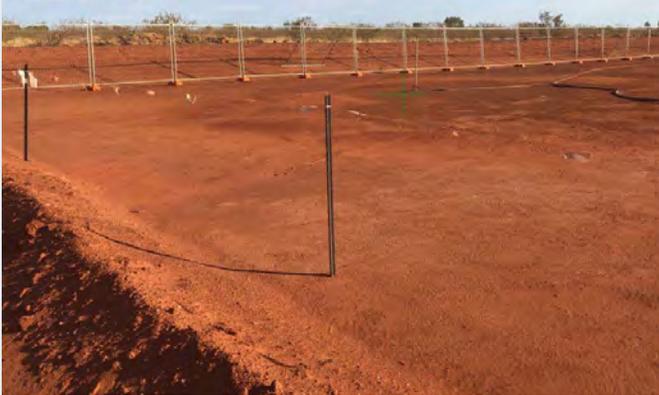
IRRIGATION AREA

Date & Time: Mon, 21 Jan 2019, 08:11:19 ACST
Position: -020.404307° / +130.404791°
Altitude: 394m
Datum: WGS-84
Azimuth/Bearing: 090° S90E 1600mils (True)
Elevation Angle: -03.8°
Horizon Angle: +02.2°
Zoom: 1X
Camp 4 - Irrigation Area C
Sushil Swami/MPC/Tanami

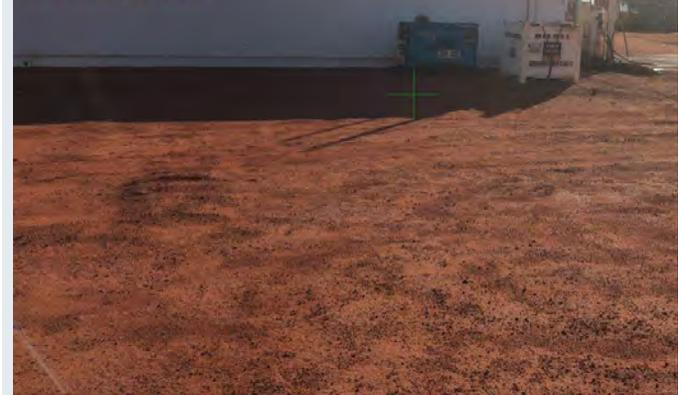
FUEL CELL

Date & Time: Mon, 21 Jan 2019, 08:09:06 ACST
Position: -020.606690° / +130.404167°
Altitude: 393m
Datum: WGS-84
Azimuth/Bearing: 081° N81E 1440mils (True)
Elevation Angle: -13.4°
Horizon Angle: +03.0°
Zoom: 1X
Camp 4 - Fuel Cell B
Sushil Swami/MPC/Tanami

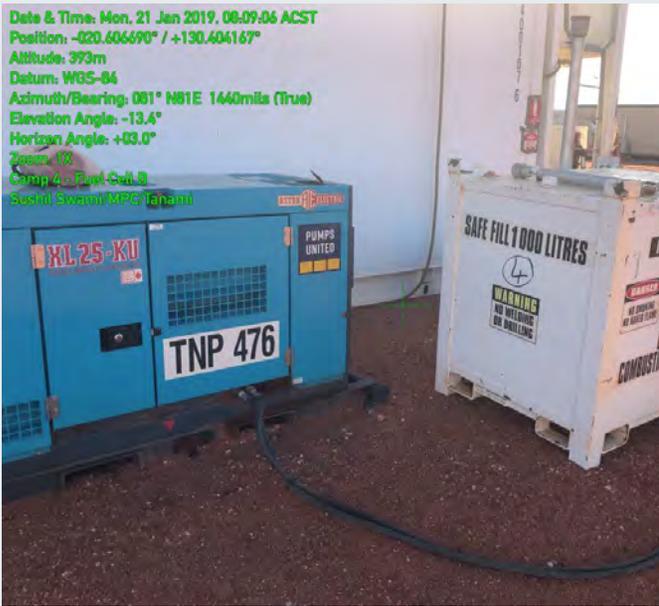
FUEL CELL

Date & Time: Mon, 21 Jan 2019, 08:09:23 ACST
Position: -020.606752° / +130.404285°
Altitude: 392m
Datum: WGS-84
Azimuth/Bearing: 339° N21W 6027mils (True)
Elevation Angle: -01.2°
Horizon Angle: +01.4°
Zoom: 1X
Camp 4 - Fuel Cell C
Sushil Swami/MPC/Tanami

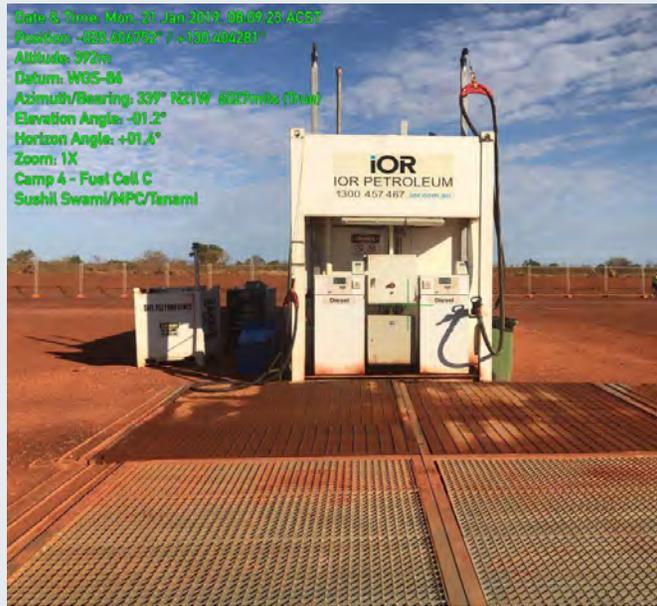
FUEL CELL

Date & Time: Mon, 21 Jan 2019, 08:09:38 ACST
Position: -020.606897° / +130.404285°
Altitude: 393m
Datum: WGS-84
Azimuth/Bearing: 305° N55W 5422mils (True)
Elevation Angle: -00.0°
Horizon Angle: +00.0°
Zoom: 1X
1300 457 467 ior.com.au
Camp 4 - Fuel Cell D
Sushil Swami/MPC/Tanami

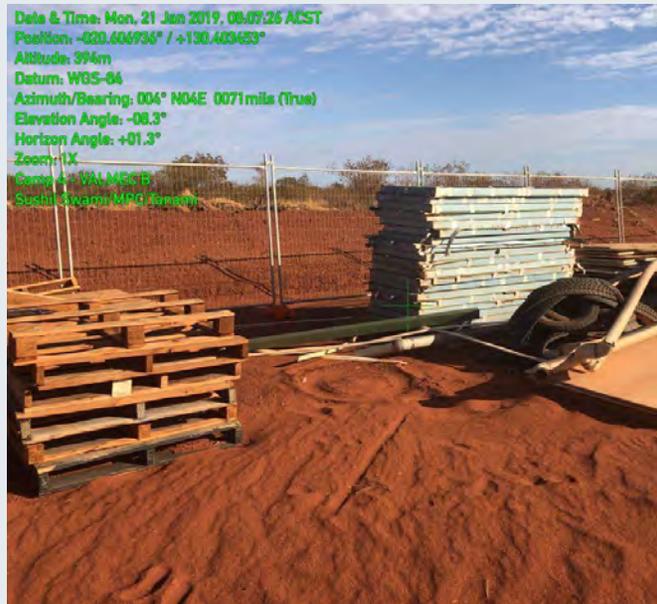
Date & Time: Mon, 21 Jan 2019, 08:07:37 ACST
Position: -020.606890° / +130.403549°
Altitude: 394m
Datum: WGS-84
Azimuth/Bearing: 003° N03E 0063mils (True)
Elevation Angle: +13.4°
Horizon Angle: +02.5°
Zoom: 1X
Camp 4 - VALMEC C
Sushil Swami/MPC/Tanami

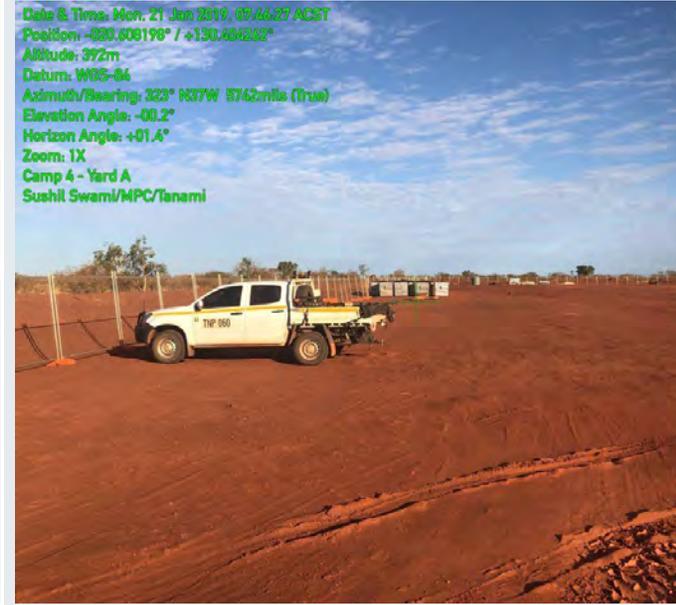
CAMP YARD

Date & Time: Mon, 21 Jan 2019, 07:54:37 ACST
Position: -020.607229° / +130.405867°
Altitude: 394m
Datum: WGS-84
Azimuth/Bearing: 348° N12W 6187mils (True)
Elevation Angle: -00.3°
Horizon Angle: +01.7°
Zoom: 1X
Camp 4 - Yard C
Sushil Swami/MPC/Tanami

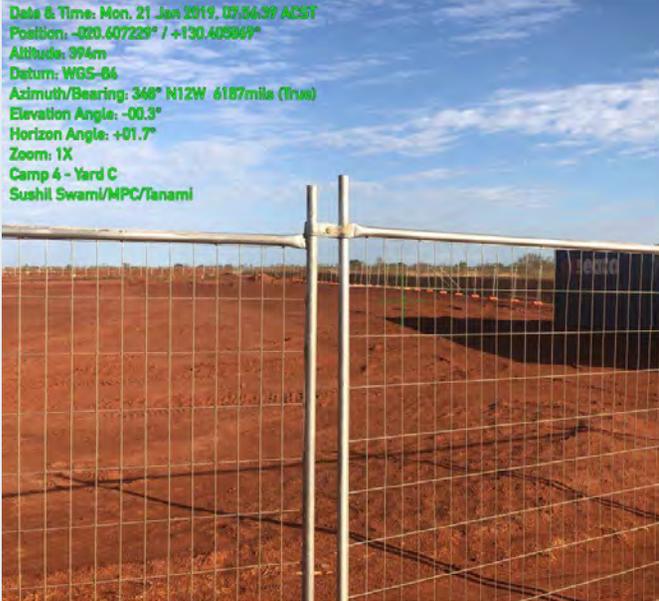
CAMP YARD

Date & Time: Mon, 21 Jan 2019, 08:05:36 ACST
Position: -020.607081° / +130.404000°
Altitude: 394m
Datum: WGS-84
Azimuth/Bearing: 167° S13E 2769mils (True)
Elevation Angle: -04.2°
Horizon Angle: +01.2°
Zoom: 1X
Camp 4 - Yard F
Sushil Swami/MPC/Tanami

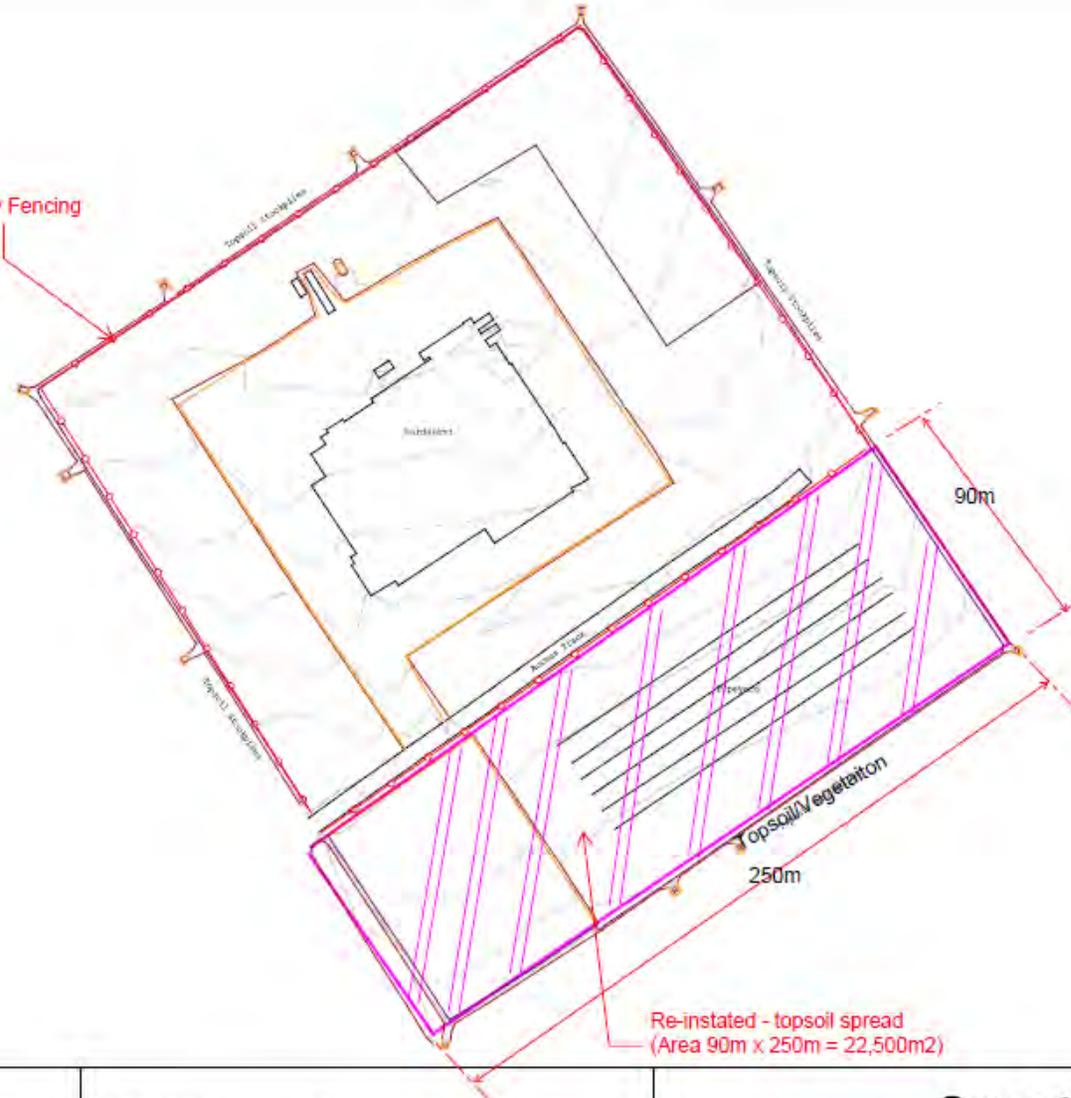
Re-instated - topsoil spread
(Area 90m x 250m = 22,500m²)
