Pluto North West Shelf Interconnector Pipeline

Australian Gas Infrastructure Group

2024 Compliance Assessment Report – Ministerial Statement 1117

31 January 2025

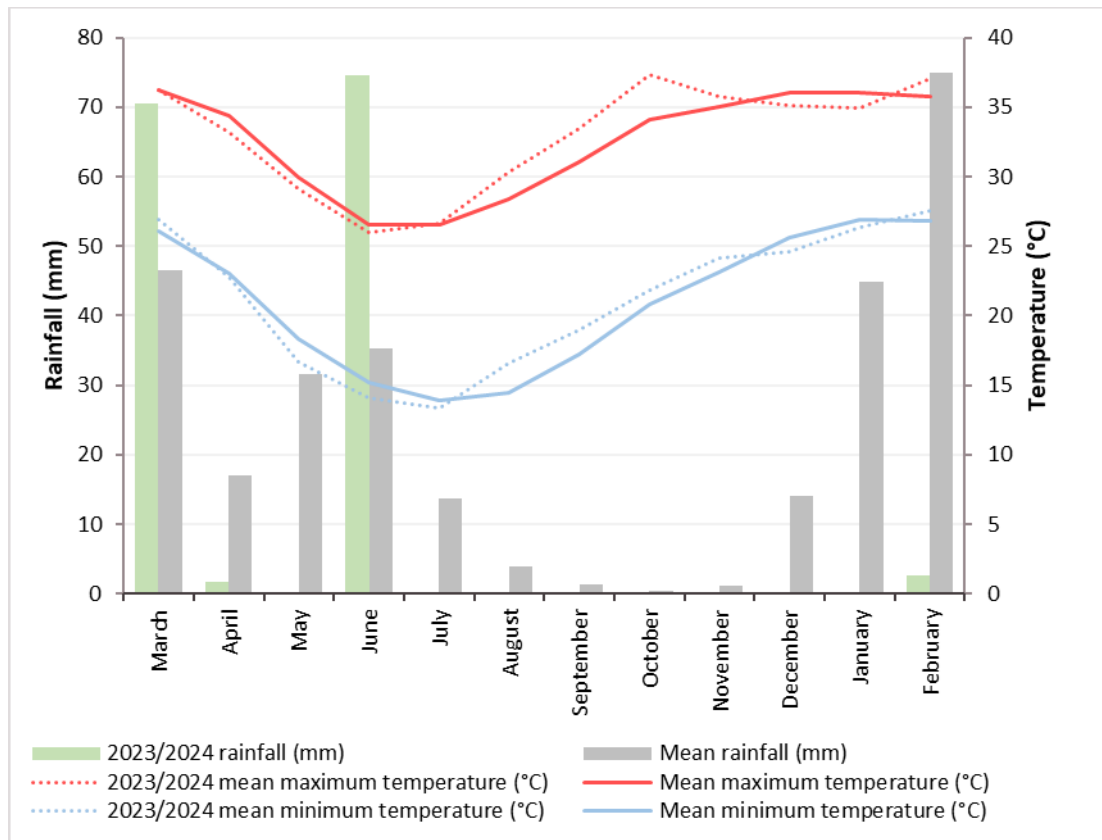
Figure 2: Climate data (BoM 2024)

In the 12 months preceding the field survey, Karratha Aero weather station received a total of 149.9 mm of rainfall which is less than the long-term average for the area (284.9 mm). A total of 2.6 mm was recorded in the three months prior to the field survey, the entirety of which fell in the month directly preceding the survey (February; **Figure 2**). This is significantly lower than the long-term average for the same period (133.8 mm).

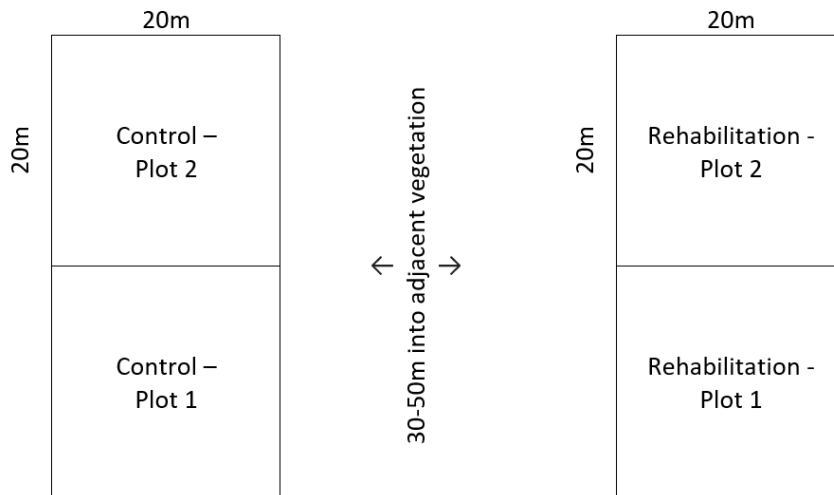
Figure 3: Design of individual vegetation monitoring sites

Each vegetation monitoring site consisted of two adjoining 20 x 20 metre (m) plots, established within representative rehabilitated areas within the right-of-way (ROW) and within adjacent, undisturbed vegetation (control areas; **Figure 3**). The northwest corner of each control site was permanently demarcated with a metal fence dropper. Rehabilitation plots were not permanently demarcated with metal fence droppers, but rather demarcated with GPS coordinates and reference photos only, due to safety reasons associated with the nature and depth of the high-pressure gas pipeline.

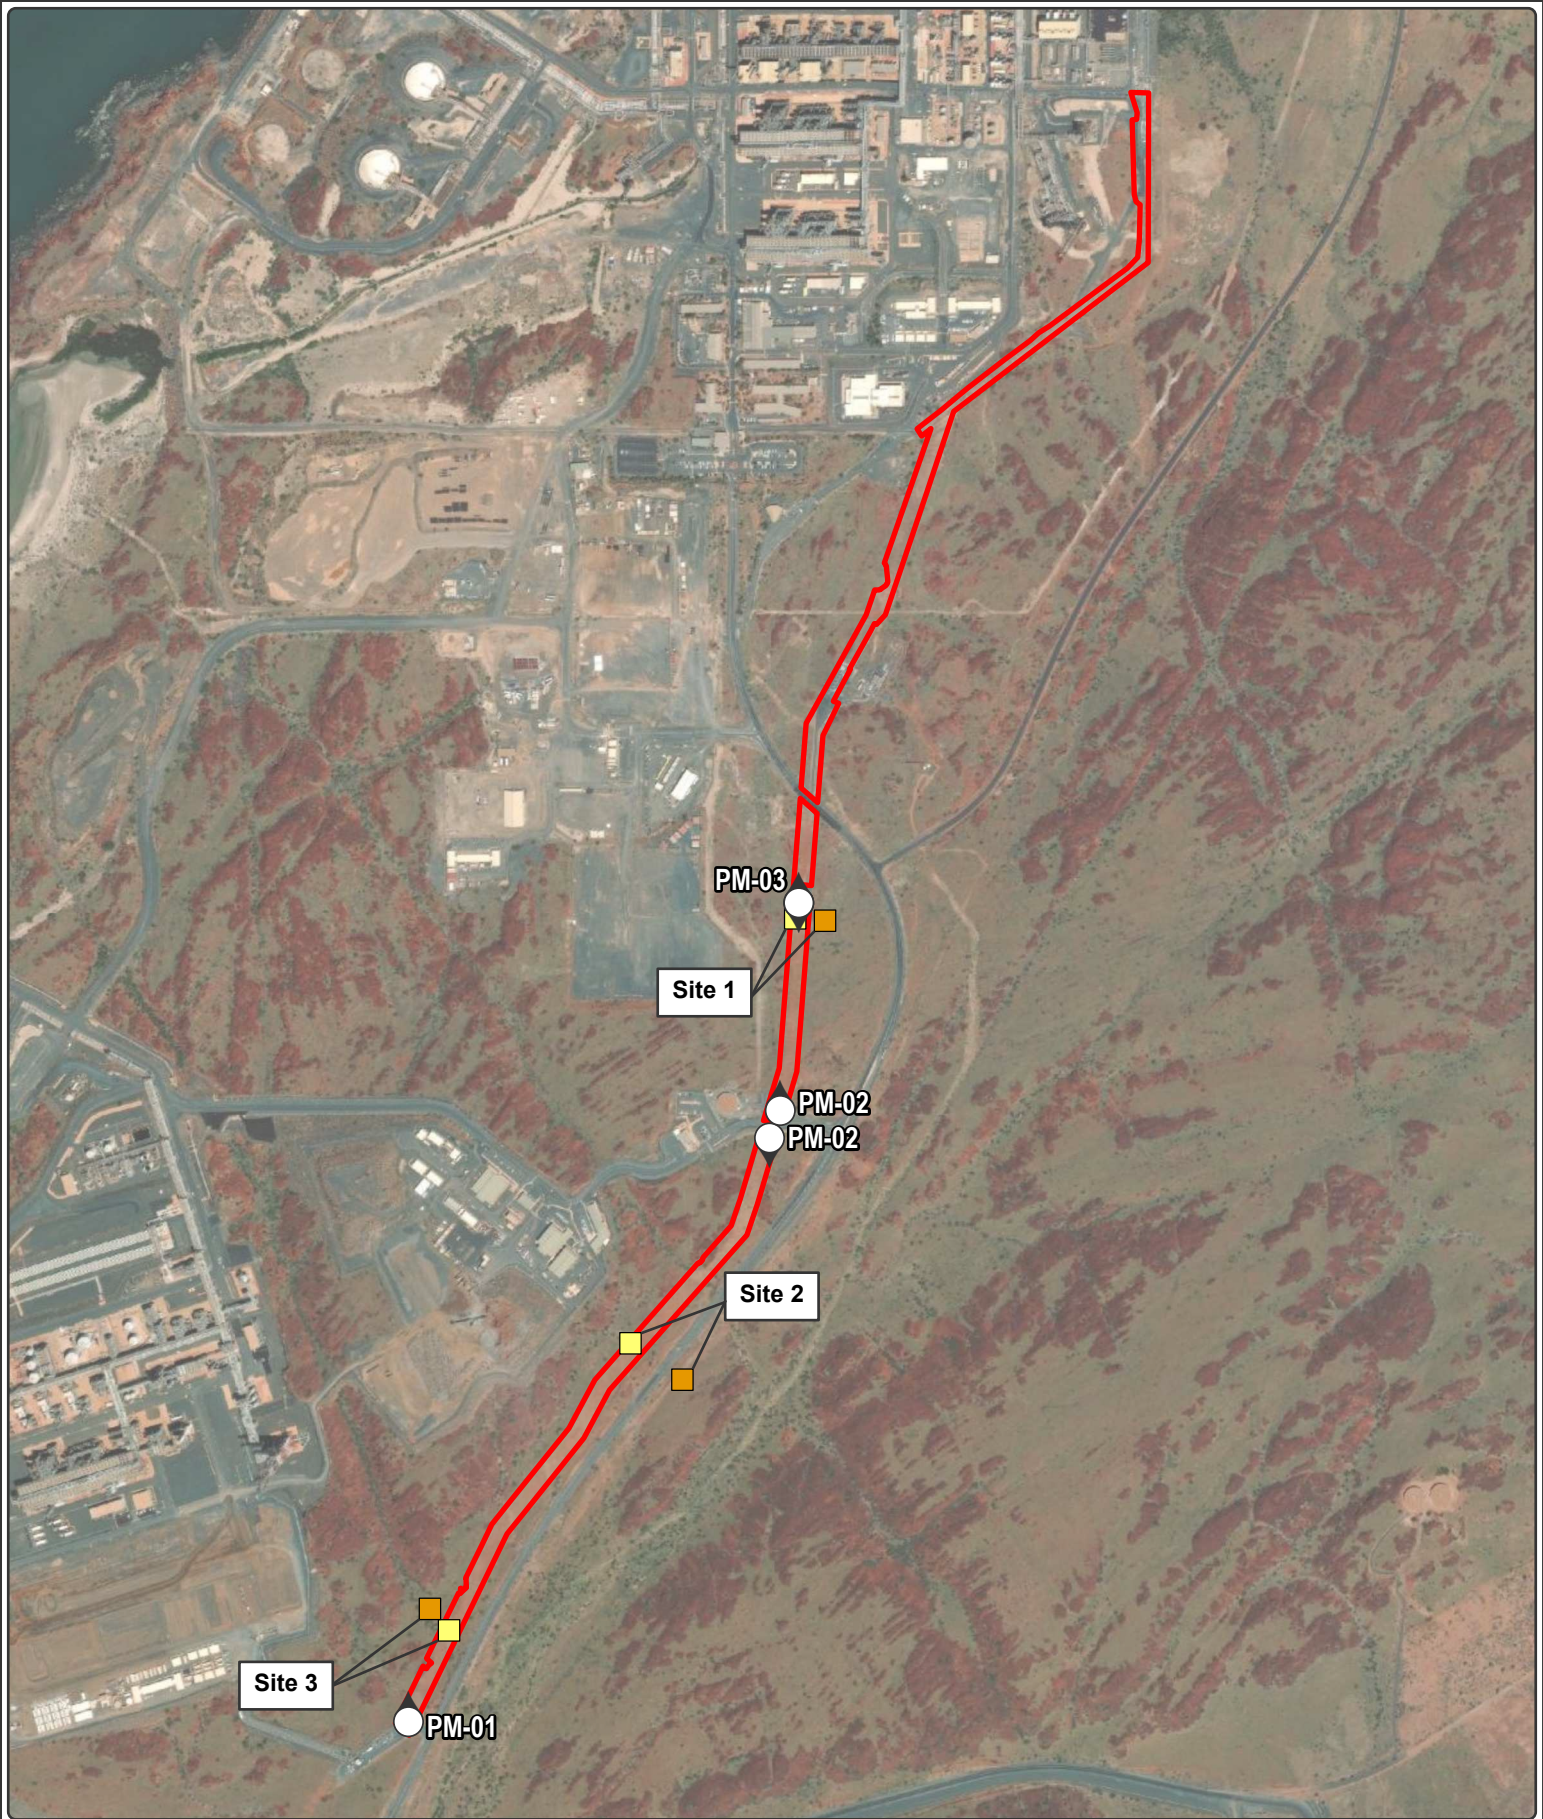
Figure 4: Location of vegetation monitoring sites and photo monitoring points

The 11 vegetation communities delineated by Astron Environmental Services Pty Ltd (Astron 2018) were grouped into three broad vegetation complexes for the purposes of monitoring, as outlined in **Table 4**. One monitoring site was established in each of these broad vegetation complexes (**Figure 4; Appendix A**). It is noted that the northmost section of the survey corridor was inaccessible (refer to limitations in **Table 5**).

Four photo monitoring sites were re-monitored along the corridor, with an additional point established in 2024. Monitoring sites are located along accessible areas of the pipeline in view of the PNI Construction Environmental Management Plan (AGIG 2019; **Figure 4**). Photo monitoring sites consisted of photographs taken facing along survey corridor. All photos were date stamped and the photo number recorded with appropriate details (monitoring site number and direction of photo). It is noted that PNI Construction Environmental Management Plan (AGIG 2019) states that 'photographs shall be established every 5 km', however the survey corridor is only 3.6 km in length. Noting issues with access

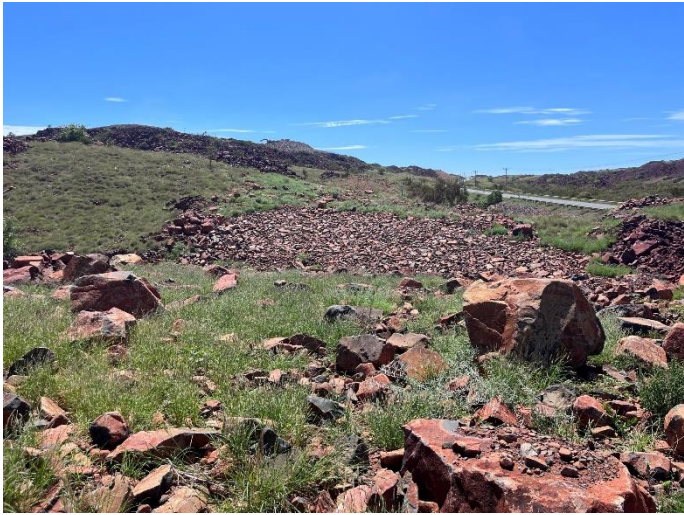
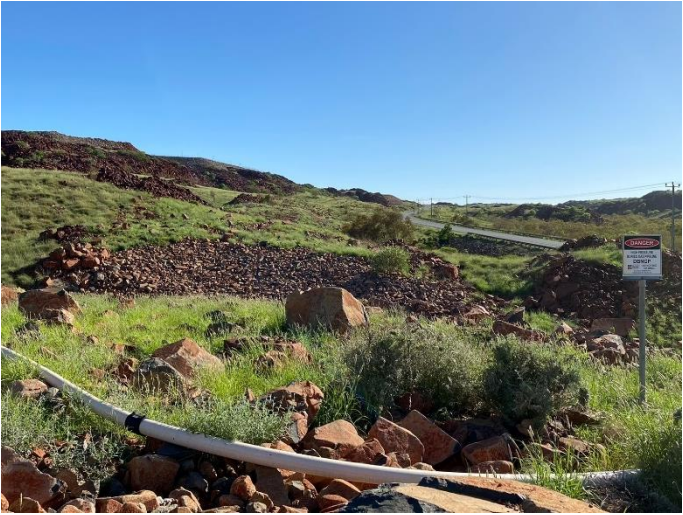
Site Identifier	Direction facing	Easting	Northing	Photo – 2023	Photo – 2024
PM-01	North	476097	7720002

A landscape view from a rocky foreground looking north towards a grassy hill under a clear blue sky. A road is visible in the distance.

A similar landscape view from the same rocky foreground, but with a white pipe in the immediate foreground and a warning sign on the right. The hill and road are still visible in the background.
PM-02	South	476702	7720980

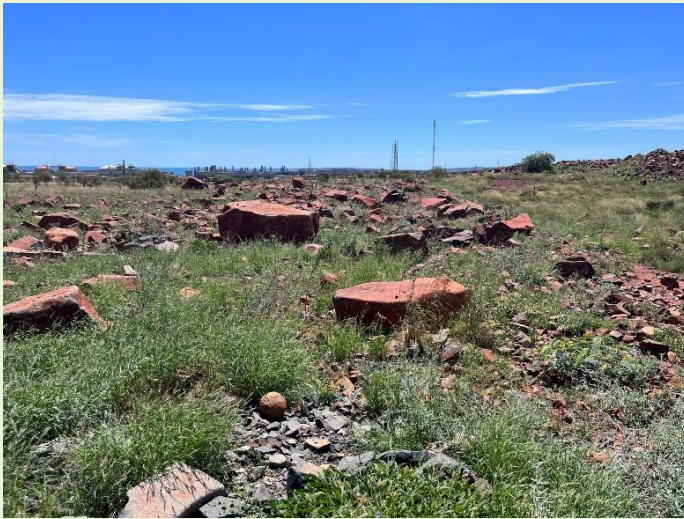
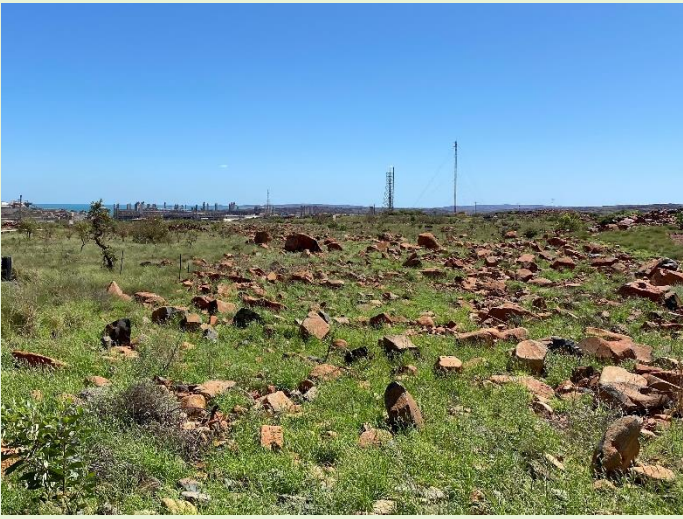
A wide view of a rocky, grassy field looking south. In the far distance, a coastal town and the ocean are visible under a blue sky.

A similar wide view of the same rocky field looking south, showing the coastal town and ocean in the distance.

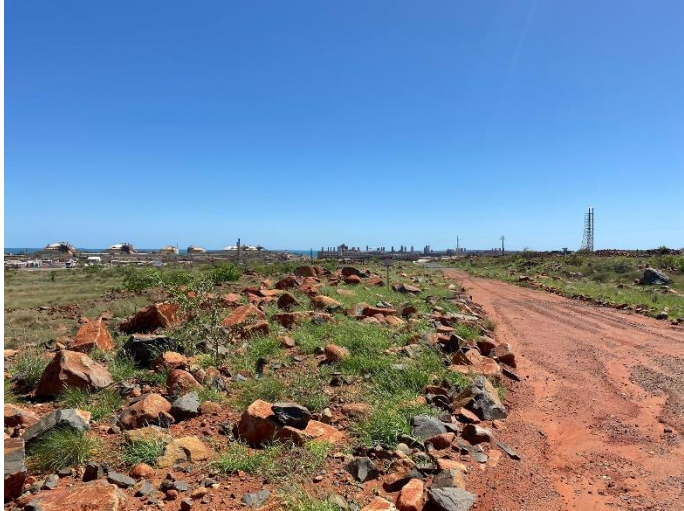
Site Identifier	Direction facing	Easting	Northing	Photo – 2023	Photo – 2024
PM-03	North	476751	7721374	N/A – newly established in 2024

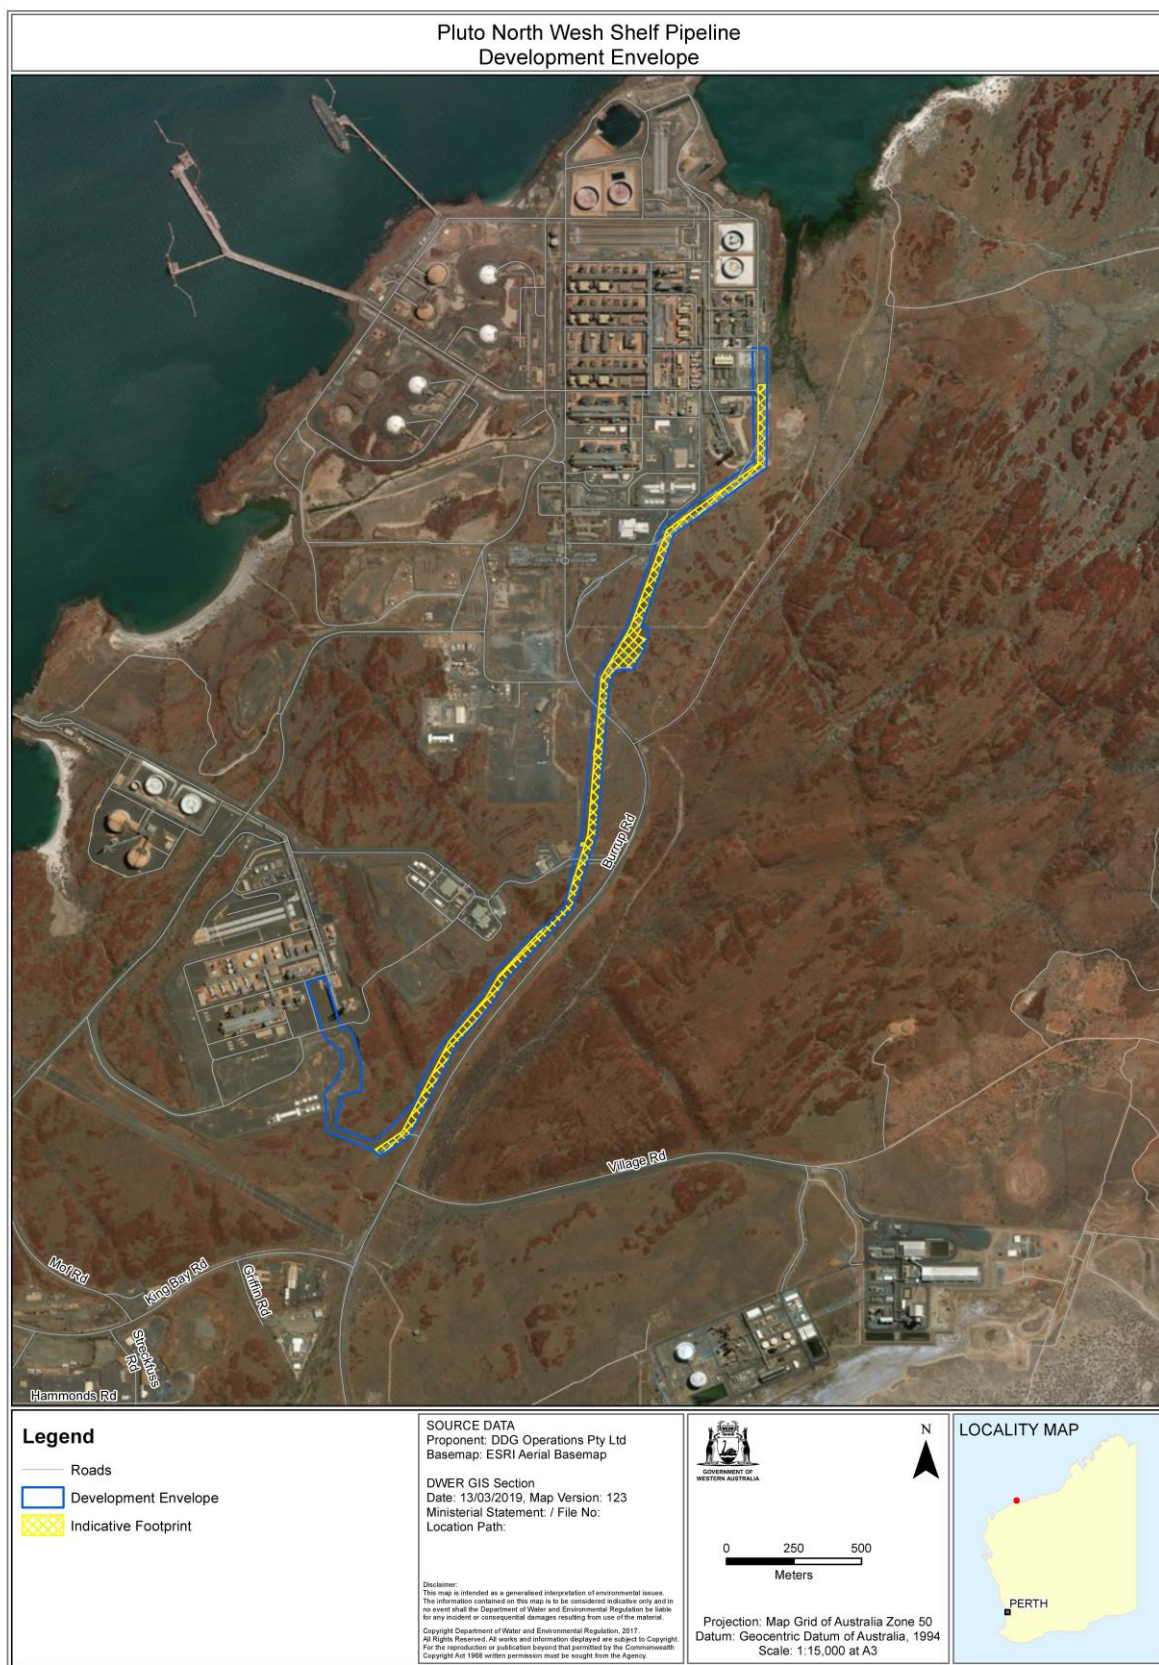
Figure 1: Pluto North West Shelf Interconnector Pipeline development envelope and indicative disturbance footprint

Column 1	Column 2	Column 3
Element	Location	Authorised Extent
Pipeline construction and associated infrastructure	Figure 1	Clearing of no more than 10.69 ha of which 3.26 ha is within the Karratha Gas Plant (KGP) Lease and Buffer Zone Lease and 7.43 ha within Dampier Bunbury Natural Gas Pipeline (DBNGP) Corridor and Dampier facilities area.
