Our Reference: vla071lr270320

27th March 2020

Re: Burrup – Pluto-NWS Interconnector Targeted Flora and Vegetation Survey

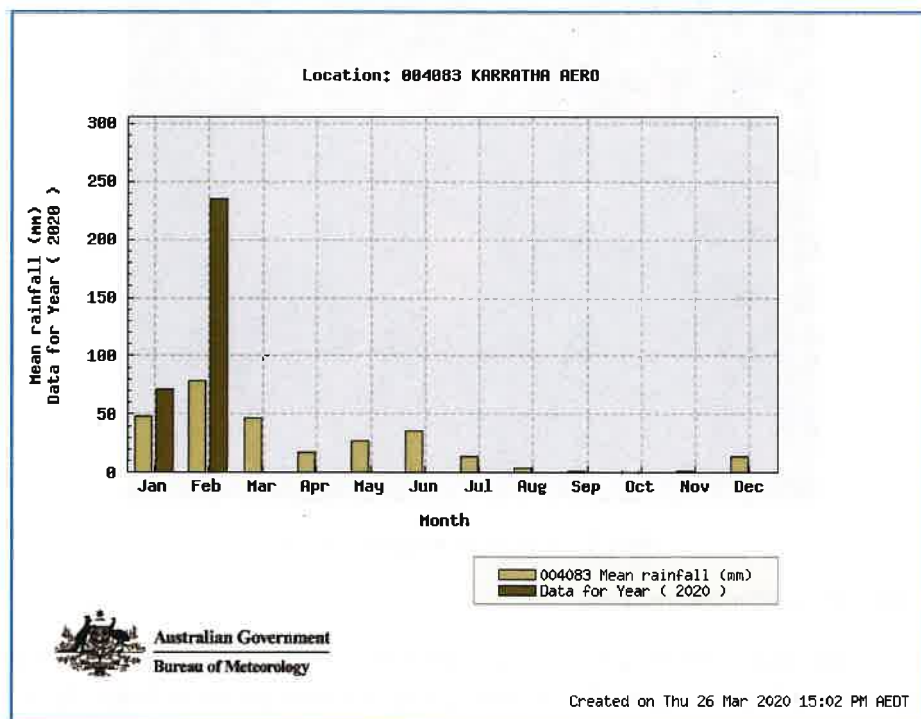
Figure 1: Rainfall received - Karratha Aero 004083 February and March 2020 and Mean Annual Rainfall calculated from 1972 – 2020 (Bureau of Meteorology 2020).

Rainfall data obtained from Karratha Aero 004083 for 2020 indicate adequate rainfall had been received prior to the field survey. The 70.8 mm of rainfall received in January was followed up with 235 mm in February, largely due to the occurrence of Tropical Cyclone Damien. Vegetation was largely recovered from wind damage received from TC Damien.

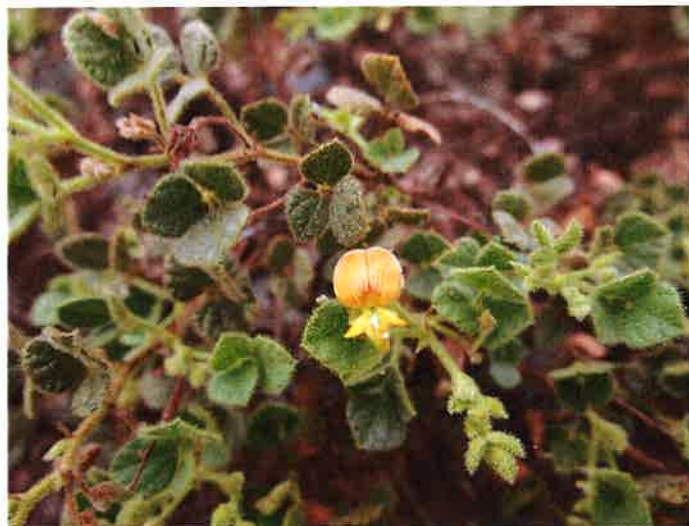
Plate 1: *Rhynchosia bungarensis* P4

One occurrence of P4 *Rhynchosia bungarensis* was found in association of the rockpile at GPS location 0476803E 7721862N. It was approximately 5 m from the estimated 1 m width to be cleared. This vinelike species is common and widespread on the Burrup Peninsula and has been recorded at other location in the Pilbara. Its close relative, *Rhynchosia minima* was also recorded at several locations in the survey area – it is not a Priority Species.

The one Priority 4 (*Rhynchosia bungalowensis*) found was outside the envisaged 1 m clearing envelope. The plant is widespread and relatively commonly occurring on the Burrup Peninsula in association with rockpiles and drainage gullies. The removal of this one plant, if it was necessary would not impact the population at all.

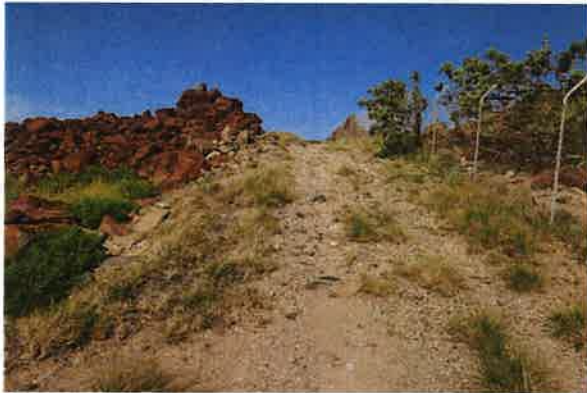
Plate 2: Track 1 through rockpiles – vegetation surveyed was surveyed for 15 m on the northern side and along the fenceline on the southern side.

Track one is a narrow track built up with imported stony soils and is fenced on the western southern side. It passes through vegetation of *Triodia epactia* hummock grassland with scattered shrubs of *Dichrostachys spicata* and *Grevillea pyramidalis* and there are small rockpiles with *Brachychiton acuminatus* and *Terminalia circumalata*. The vegetation condition along the edges of the track based on Trudgen 1988 (Attachment 1) is Very Good.

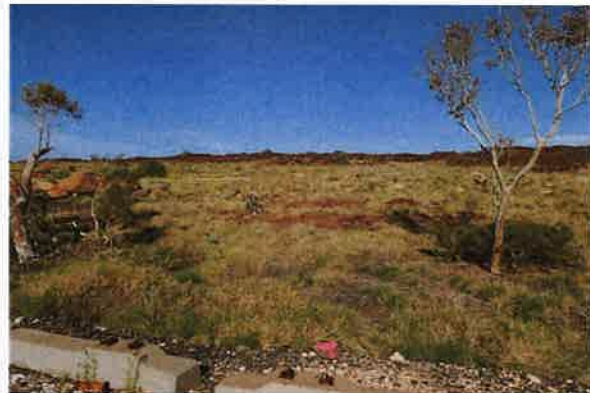
Plate 3: Flagged rock at western end of Track 2 through *Eucalyptus victrix* trees in drainage line.

Vegetation along this very short section of alignment is uncleared but some disturbance has occurred in the area generally in the past. On the eastern end, the alignment runs through *Triodia epactia* hummock grassland with scattered shrubs and at its western extent it runs through a drainage line with scattered *Eucalyptus victrix*, *Terminalia circumalata* low trees over *Triodia angusta* hummock grassland. The vegetation condition of Track 2 based on Trudgen is Very Good.

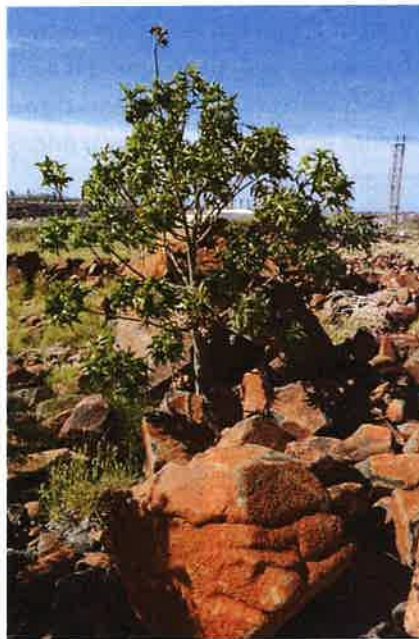
Plate 4: Small northern kurrajong

No Burrup Rockpile PECs were found. Individual trees do occur on the rockpiles which the track intersects but these individual species do not constitute a Burrup Rockpile PEC. The trees included one large and one relatively young northern kurrajong (*Brachychiton acuminatus*) and if the latter was to be removed, it would be possible to extract it and replant it in landscaping either in the KGP garden or as a donation to the City.
