Tanami Gas Pipeline Annual Rehabilitation Monitoring Report 2023

Australian Gas Infrastructure Group

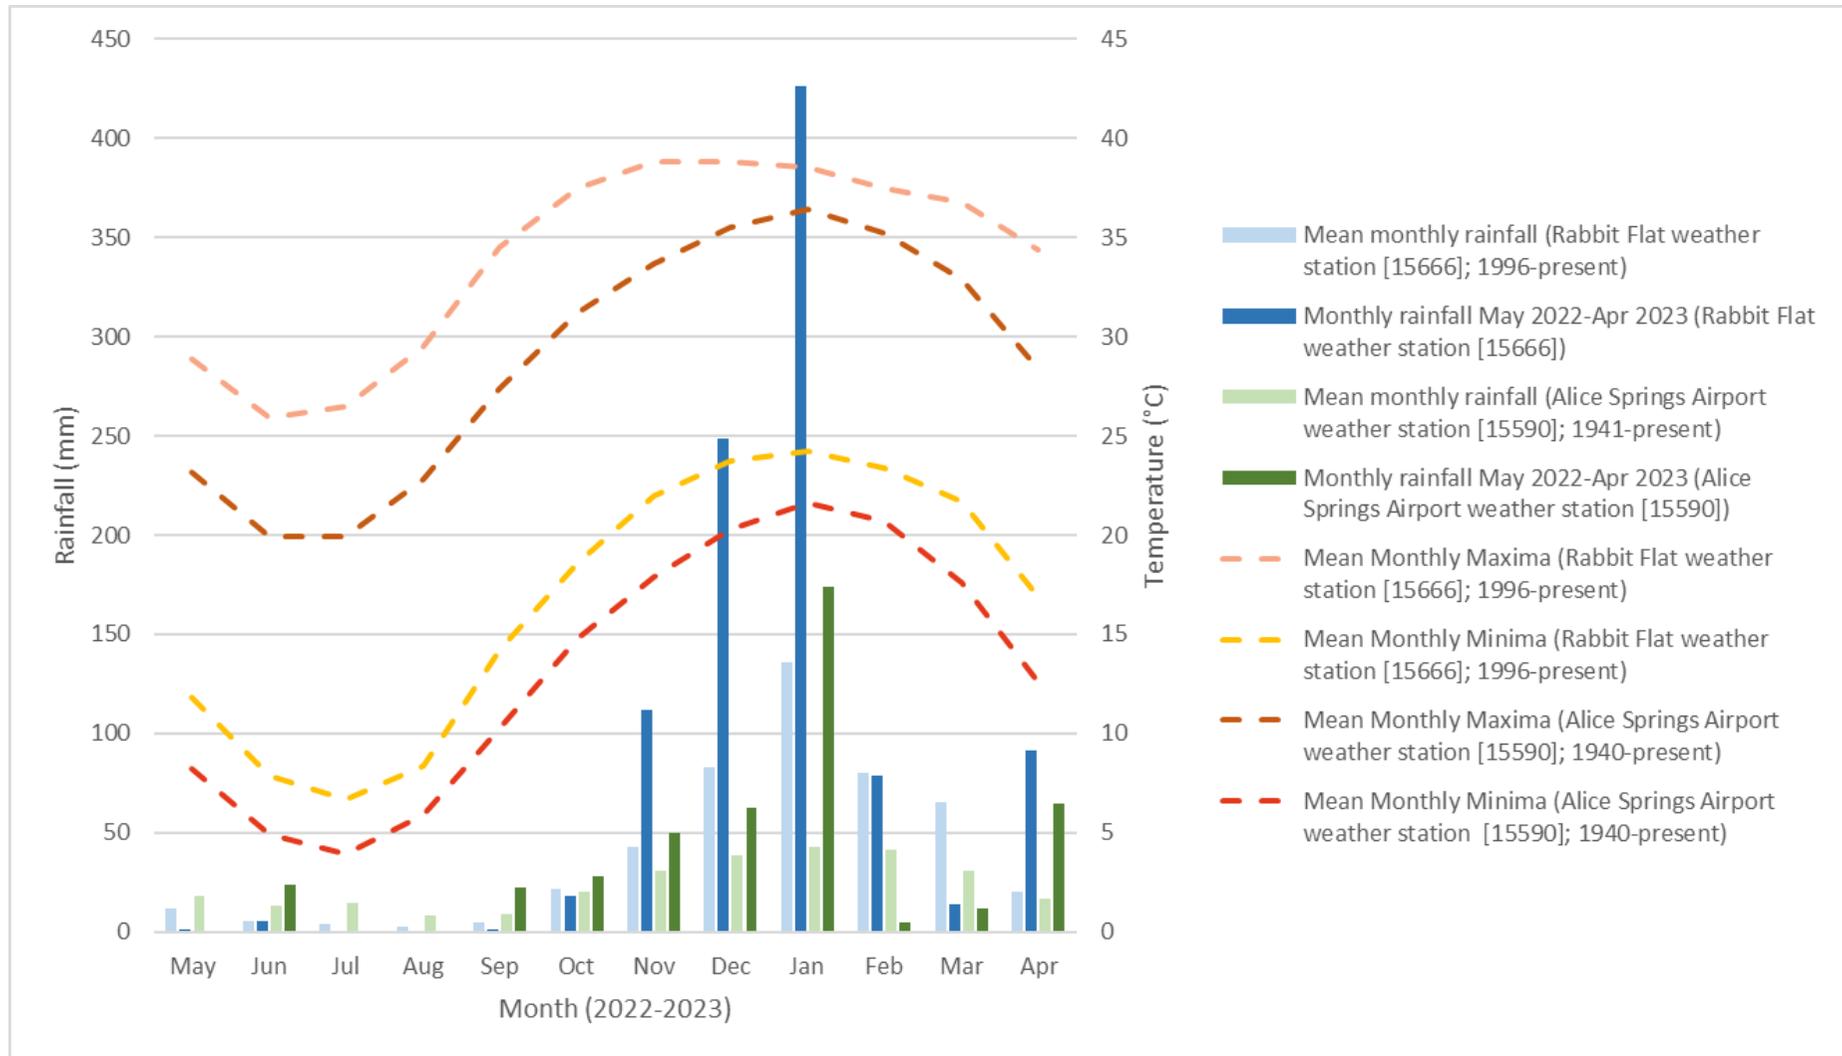
Figure 2-1: Rainfall and temperature data recorded from the Rabbit Flat (15666) and Alice Springs Airport (15590) weather stations 12 months prior to the field survey compared to the long-term average (BoM 2023)

Mean maximum temperatures in the region ranged from 25.9°C in June to 38.8°C in November and December in the north (Rabbit Flat) and 19.9°C in June and July to 36.4°C in January in the south (Alice Springs Airport). Mean minimum temperatures in the region range from 6.7°C in July to 24.2°C in January in the north (Rabbit Flat) and 3.9°C in July to 21.6°C in January in the south (Alice Springs Airport).

Rainfall and temperature data are presented in **Figure 2-1** below.

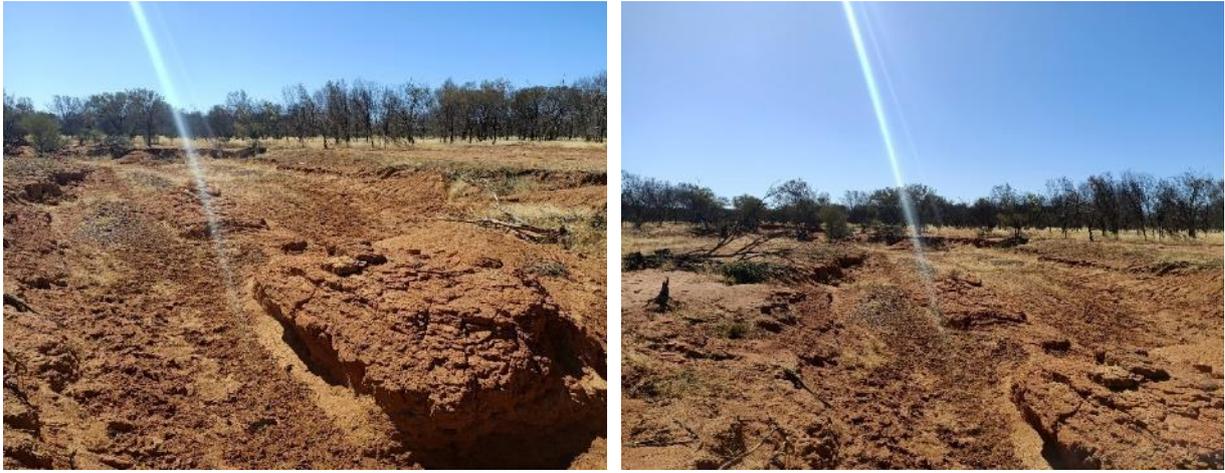
Plate 1: Erosion recorded at site 6 – rehabilitation quadrat

Significant erosion was observed in 2022 and again in 2023 within site 6 rehabilitation quadrat (**Plate 1; ELA 2022**). Heavy rainfall preceding the 2022 survey, followed by high early season (Dec/Jan) rainfall in 2023 increased waterflow in the minor creekline, resulting in expansion of the channel bed and

Significant erosion was observed in 2022 and again in 2023 within rehabilitation quadrat 6A. Heavy rainfall preceding the 2022 survey, followed by high early season (Dec/Jan) rainfall in 2023 increased waterflow in the minor creekline, resulting in expansion of the channel bed and undercutting of the creek bank. Minor sheet and pedestal erosion were observed within rehabilitation quadrat 10A in 2022 and again in 2023. Early intervention is recommended to stabilise and recontour the landform in both areas.

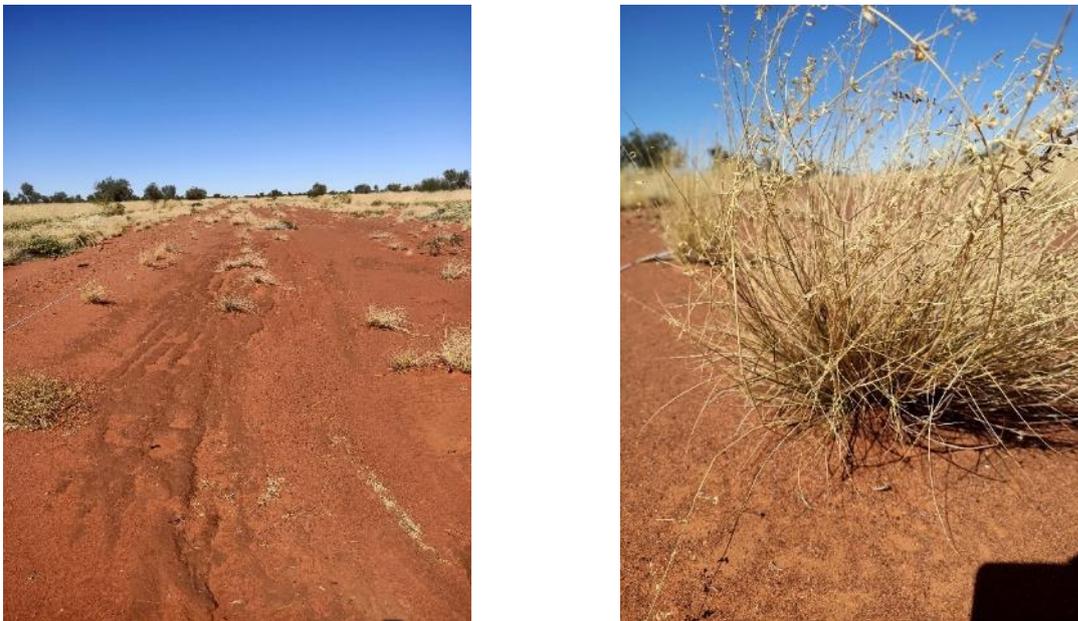
Plate 2: Erosion recorded at site 10 – rehabilitation quadrat

undercutting of the creek bank; Some sheet and pedestal erosion were observed within site 10 rehabilitation quadrat in 2022 and again in 2023 (**Plate 2**; ELA 2022).

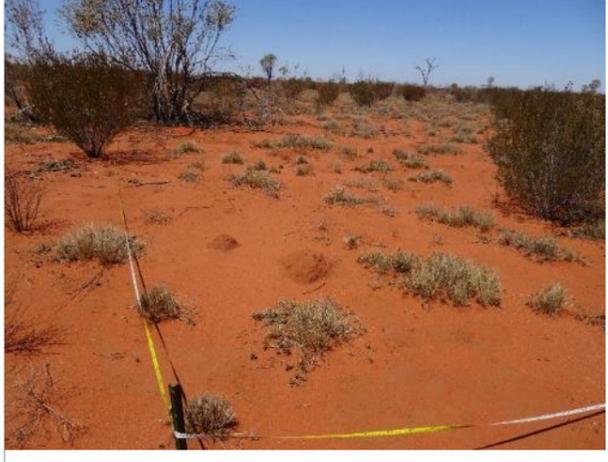
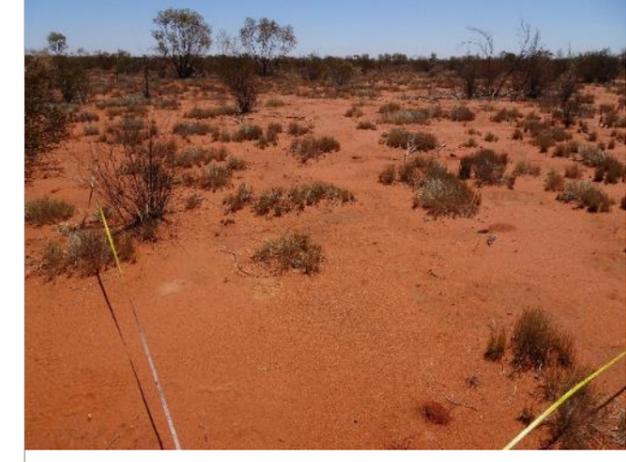
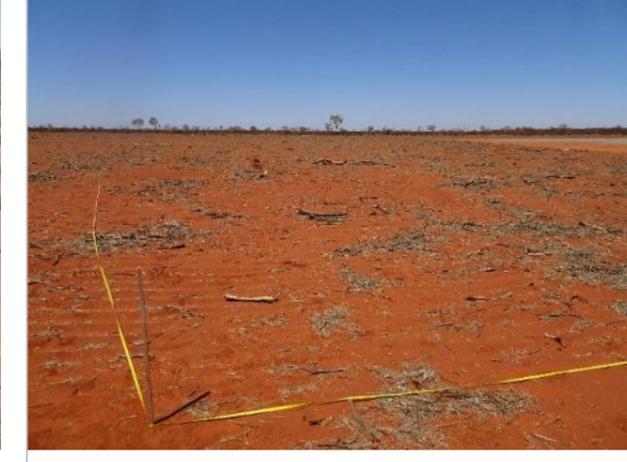
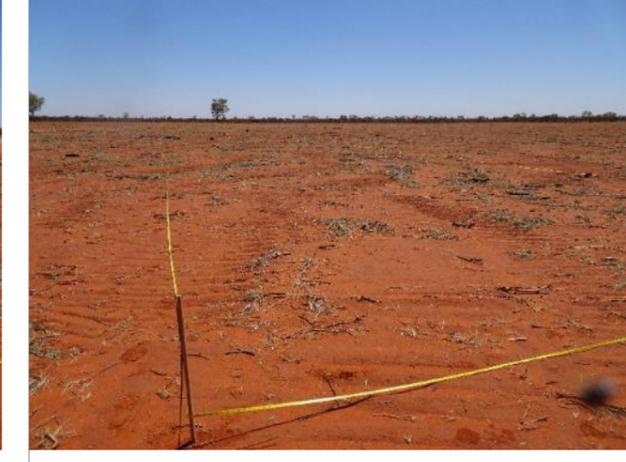
Monitoring site 16

Control – photo from the northwest	Control – photo from the southeast	Rehabilitation – photo from the northwest	Rehabilitation – photo from the southeast
2021

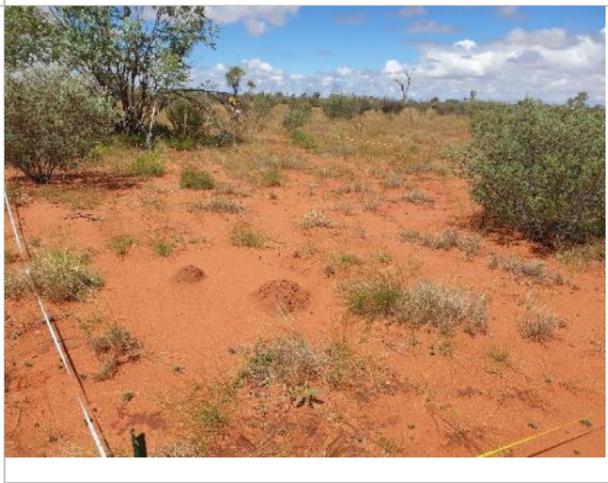
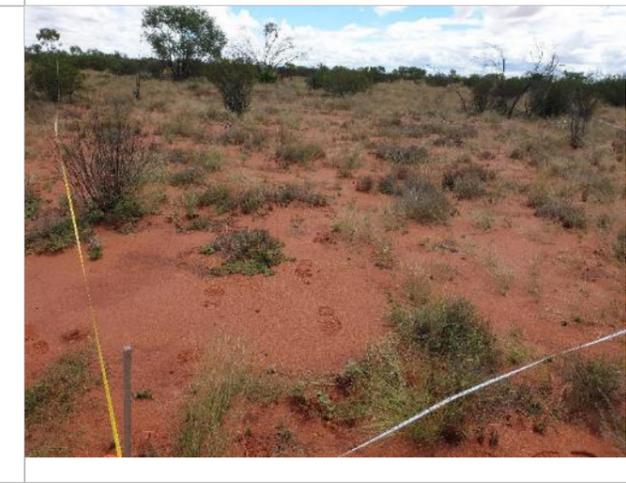
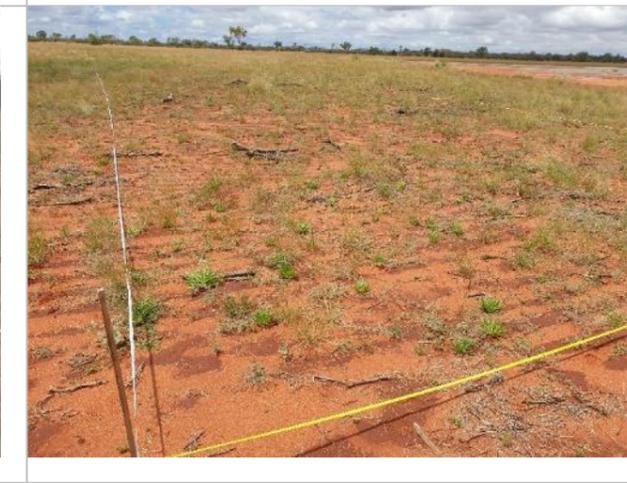
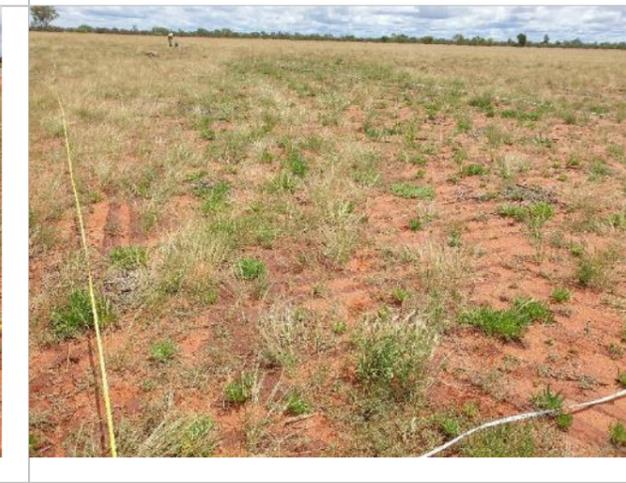
Control – photo from the northwest	Control – photo from the southeast	Rehabilitation – photo from the northwest	Rehabilitation – photo from the southeast

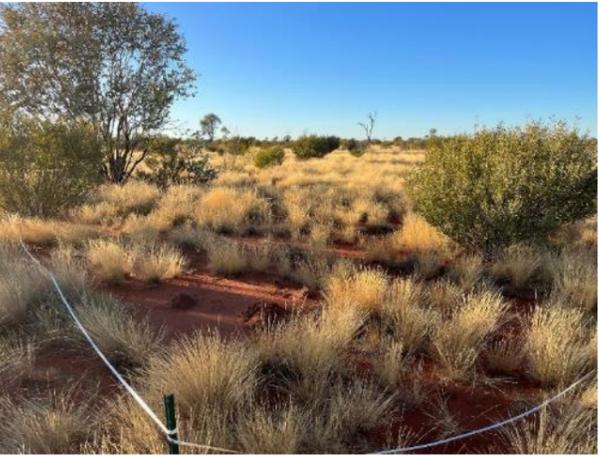
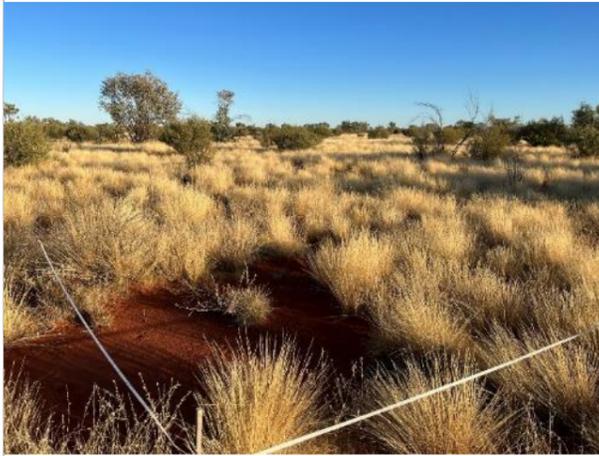
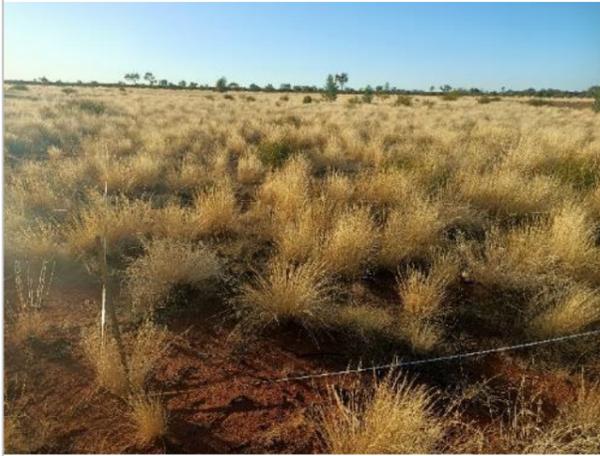
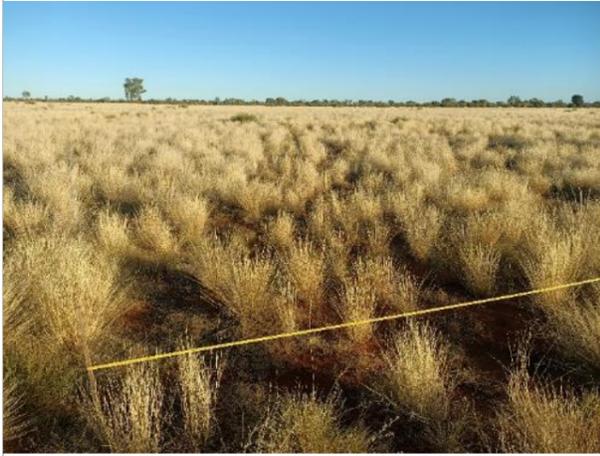
Control – photo from the northwest	Control – photo from the southeast	Rehabilitation – photo from the northwest	Rehabilitation – photo from the southeast
2023

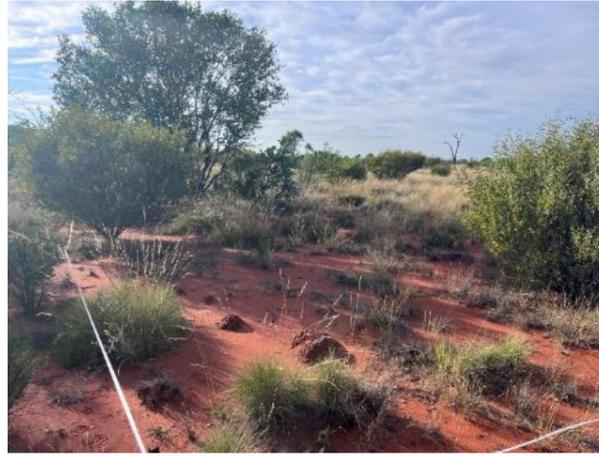
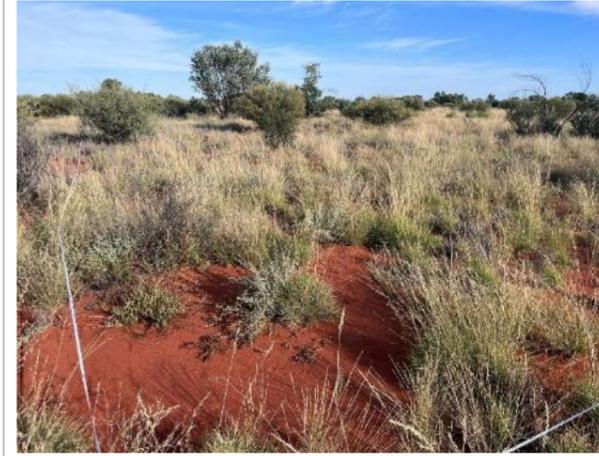
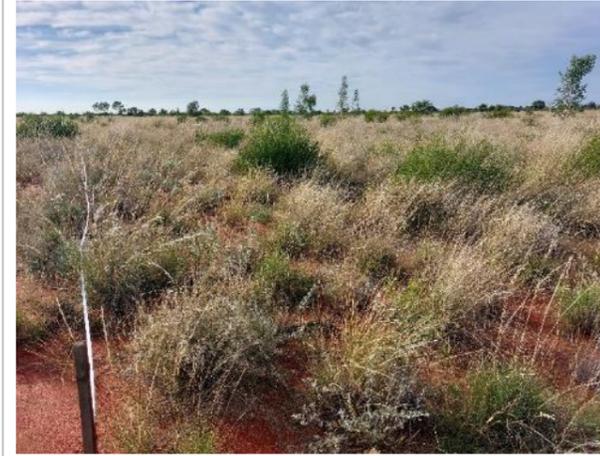
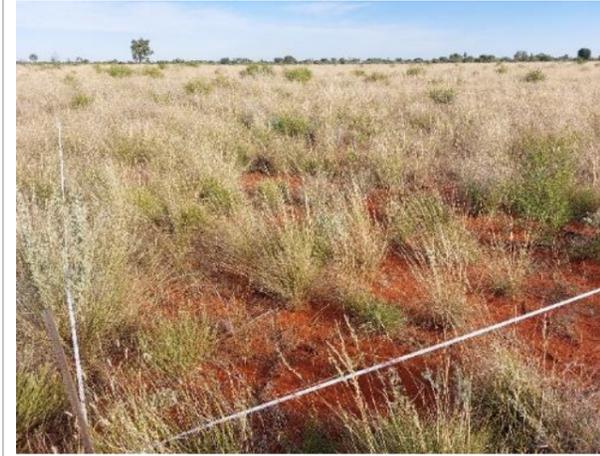
Control – photo from the northwest	Control – photo from the southeast	Rehabilitation – photo from the northwest	Rehabilitation – photo from the southeast

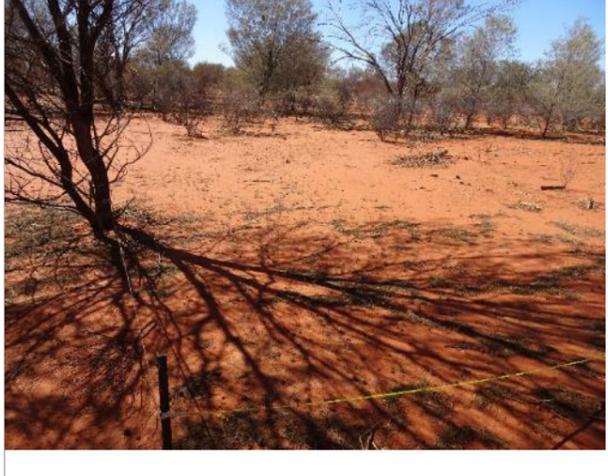
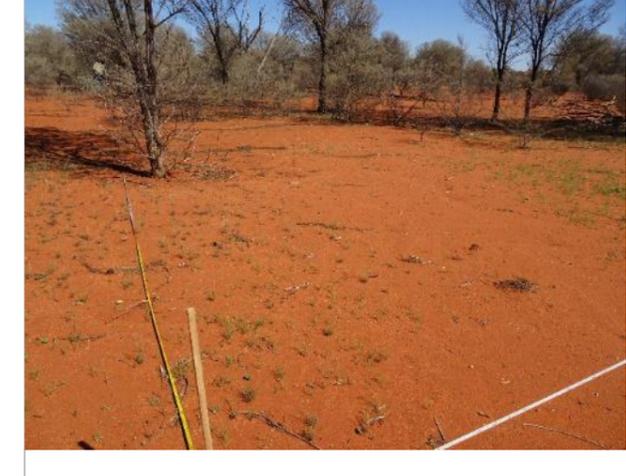
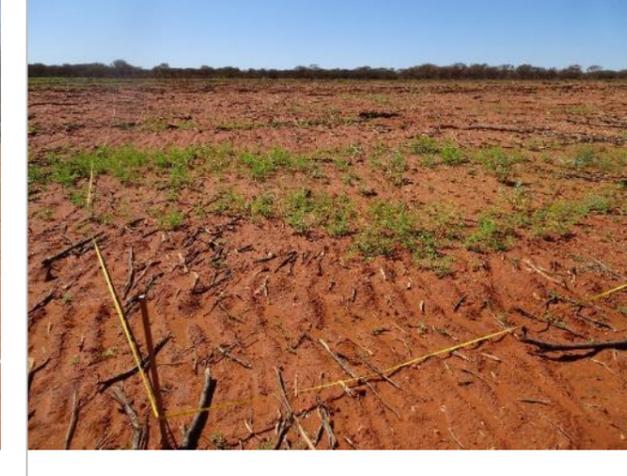
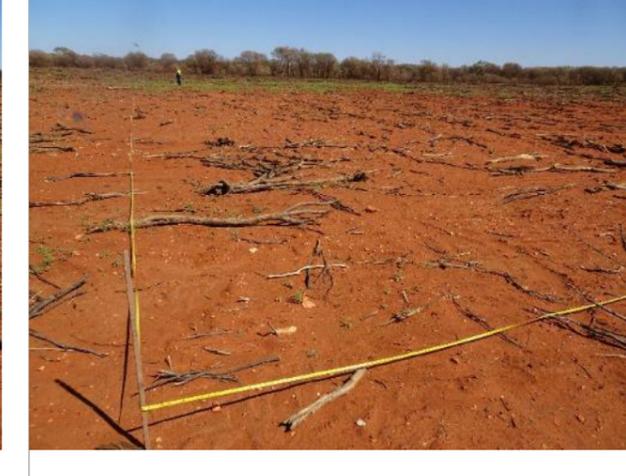
Monitoring site 17

Control – photo from the northwest	Control – photo from the southeast	Rehabilitation – photo from the northwest	Rehabilitation – photo from the southeast
2021

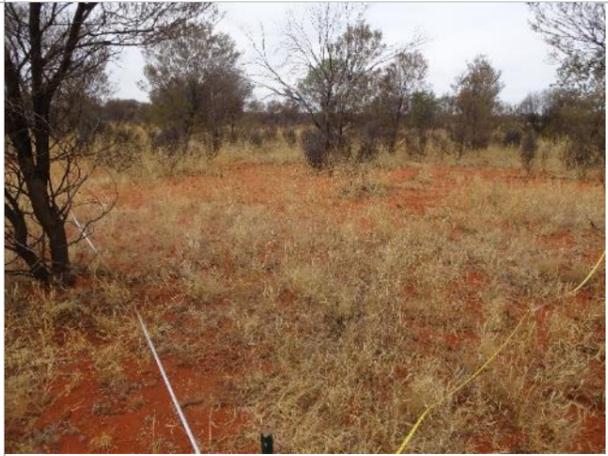
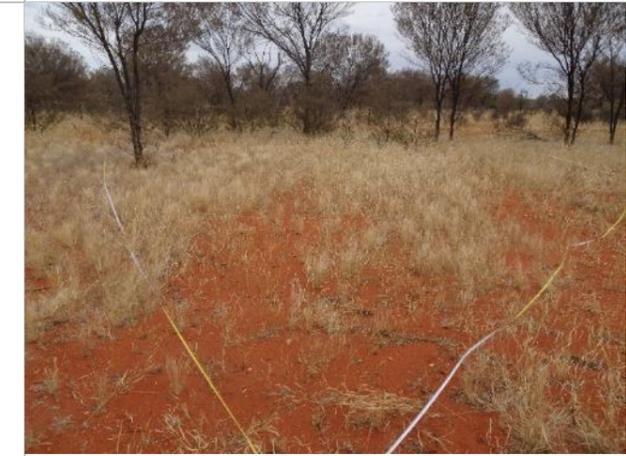
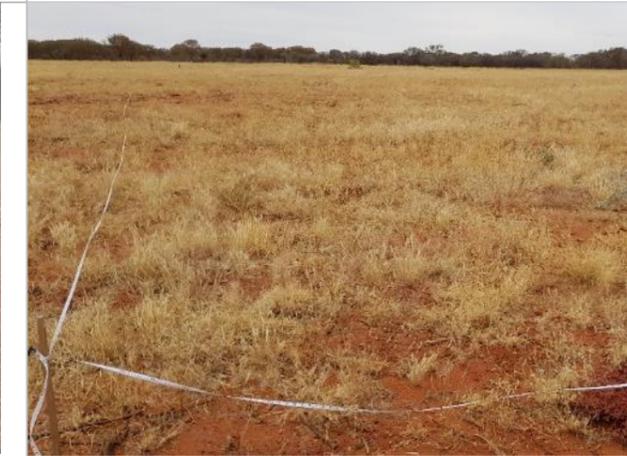
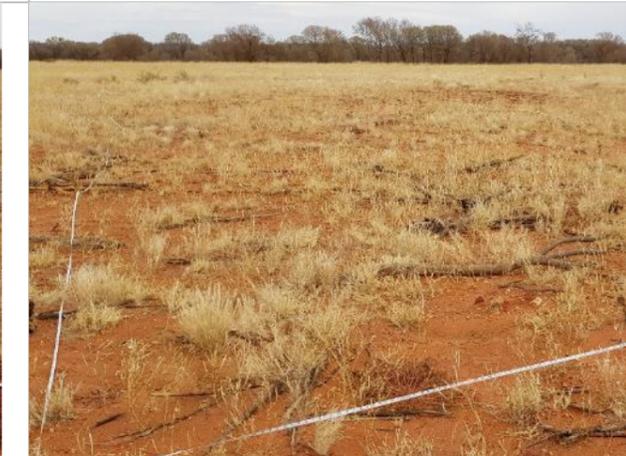
Control – photo from the northwest	Control – photo from the southeast	Rehabilitation – photo from the northwest	Rehabilitation – photo from the southeast

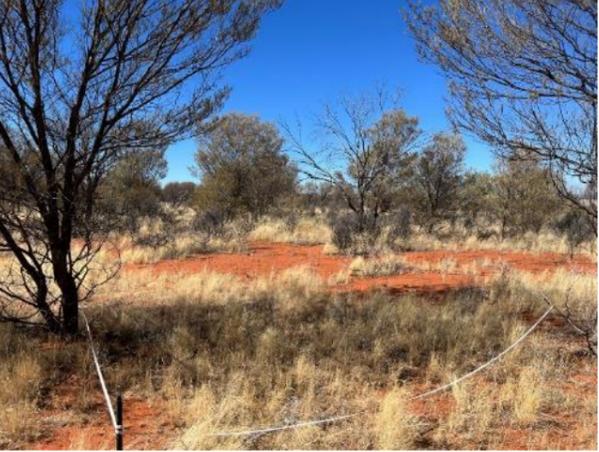
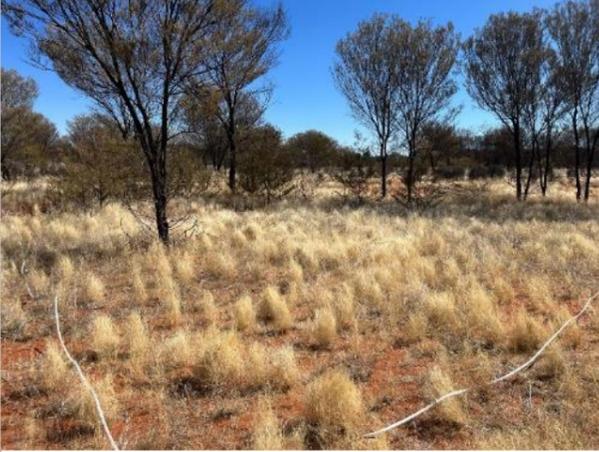
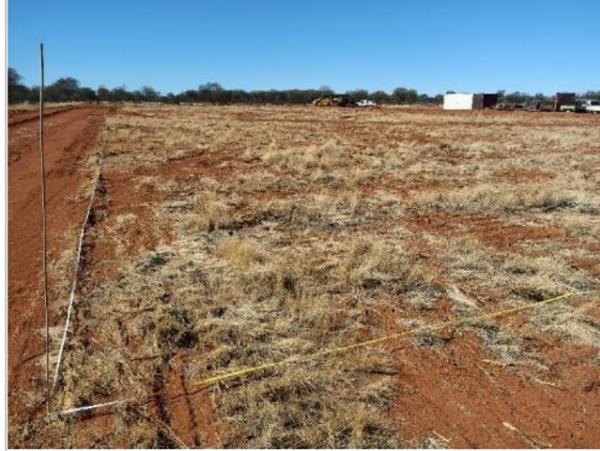
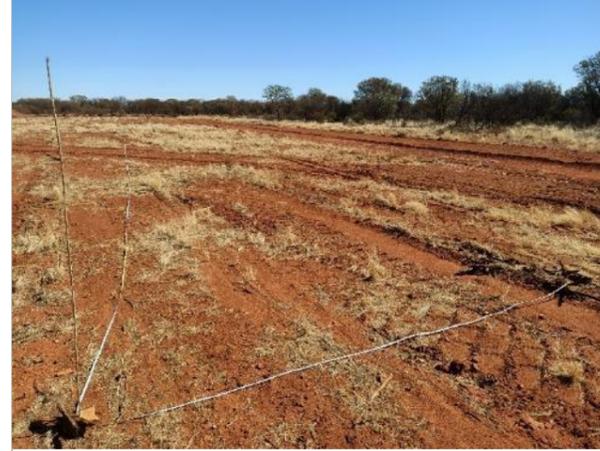
<p>Control – photo from the northwest</p>	<p>Control – photo from the southeast</p>	<p>Rehabilitation* – photo from the northwest</p>	<p>Rehabilitation* – photo from the southeast</p>
<p>2023</p>

* 17 rehabilitation quadrat was moved in 2022 and 2023 as the 2020/2021 quadrat had been cleared for a camp for another project.

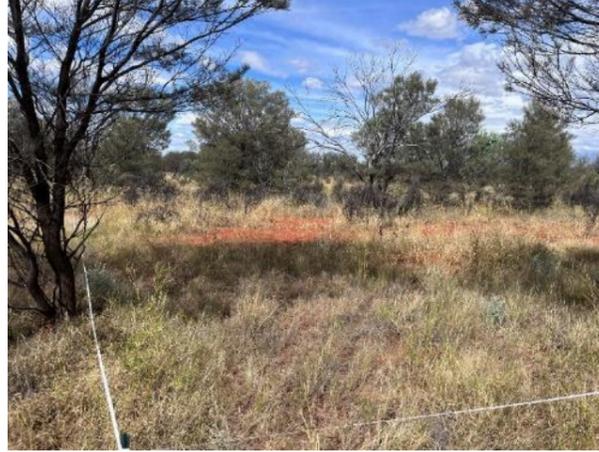
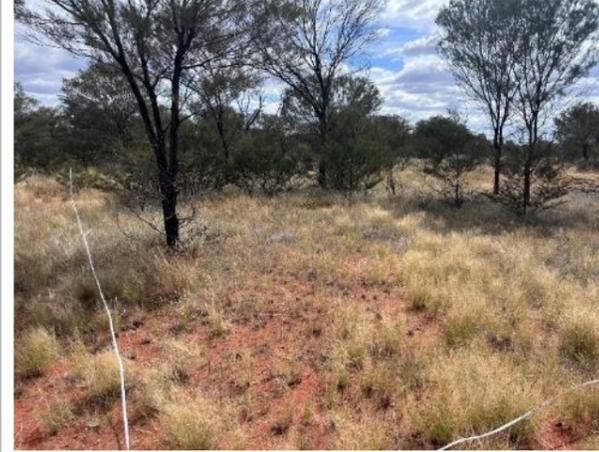
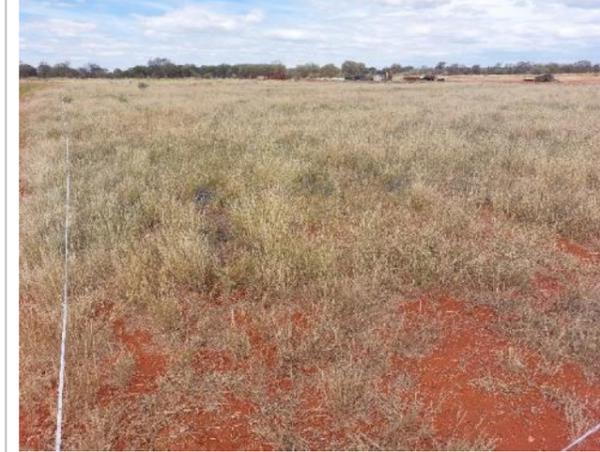
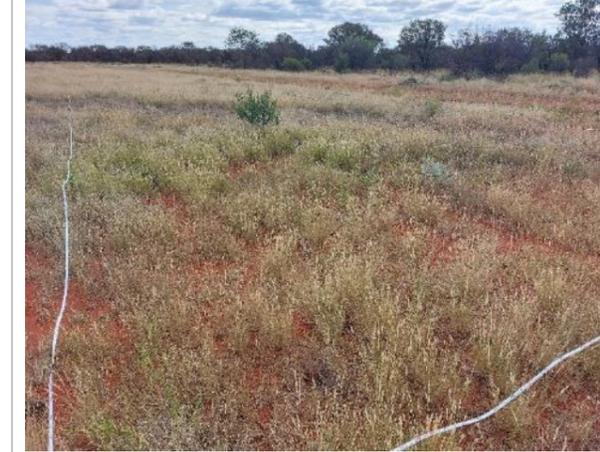
<p>Control – photo from the northwest</p>	<p>Control – photo from the southeast</p>	<p>Rehabilitation – photo from the northwest</p>	<p>Rehabilitation – photo from the southeast</p>
