Tanami Gas Pipeline: Annual Compliance Assessment Report EBPC

E-REP-069

Date: 7 August 2023

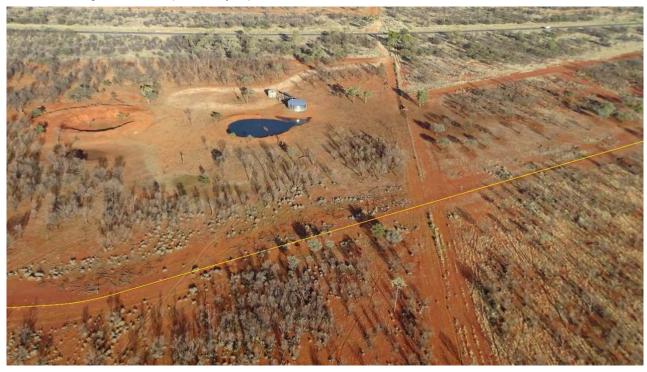
KP 8.250

• Below image shows the previously reported water tank built on the Western side of the corridor.

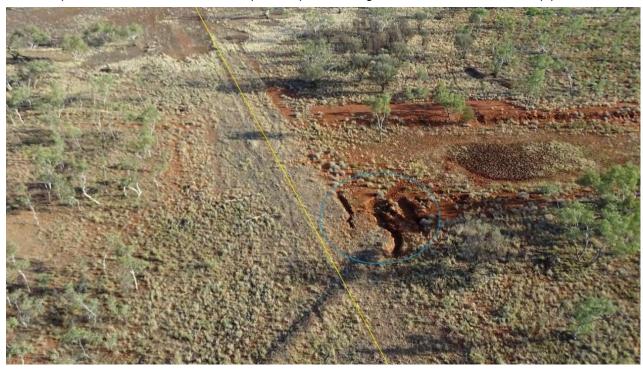
KP11.63

• A deep, narrow erosion channel has opened up on the edge of the corridor clear of the pipe centreline.

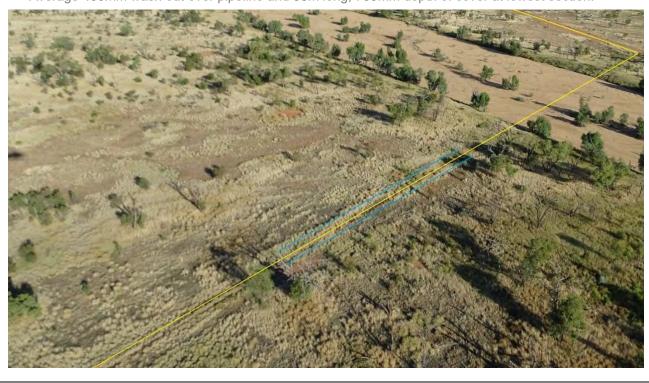
KP 34.620

- Buffel grass has covered the erosion and banks of Napperby Creek; unable to see if it has changed in depth due to vegetation cover.
- Average 400mm wash out over pipeline and 35m long; 700mm depth of cover at lowest section.

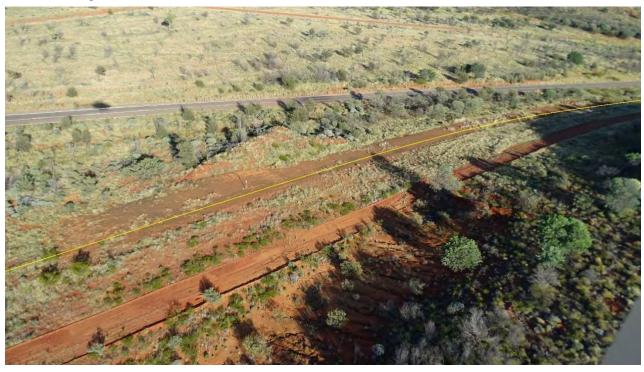
KP 48.05

• Below image shows the condition of the easement at KP 48.000

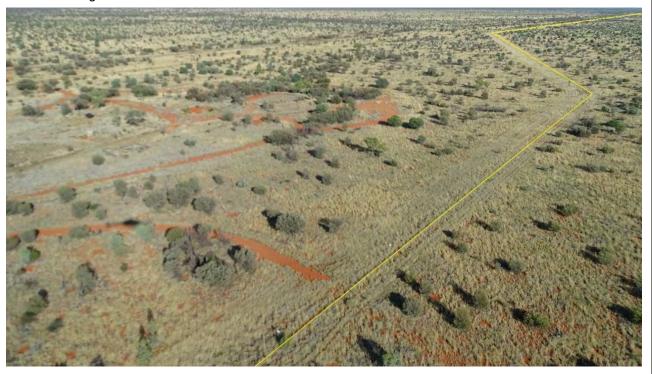
KP 62.81

Below image shows the condition of the easement at KP

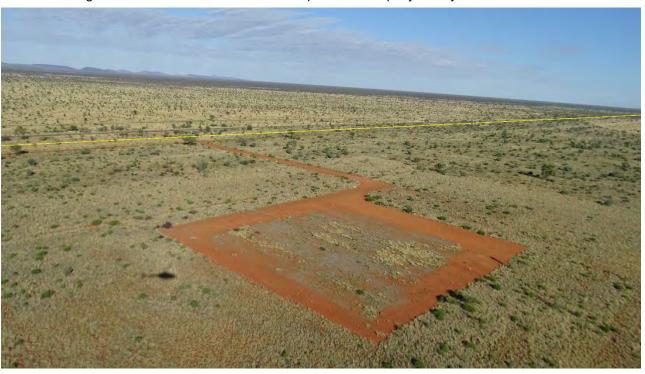
Camp 1 / Laydown KP 65.50 • Below image shows the current condition of the previous camp/laydown yard.

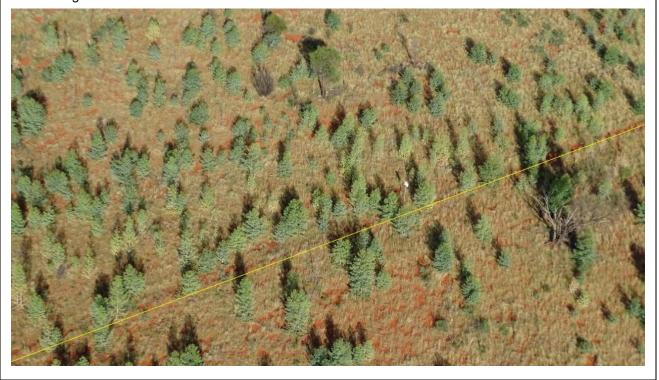
KP 65.00 – KP 72.00 Below image shows an area example of significant vegetation growth obstructing line of sight within this KP range.

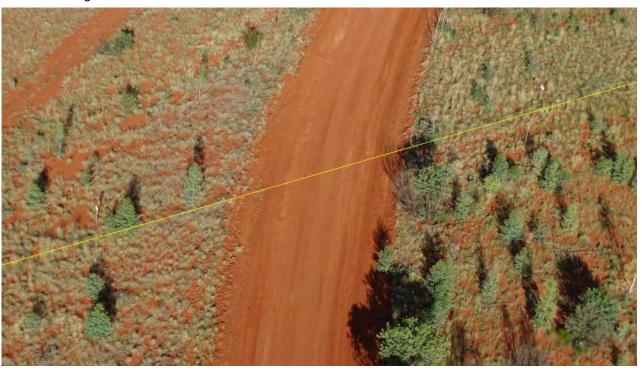
Gravel Track to Pulardi KP 72.90 Below image shows the current condition of the track to Pulardi.

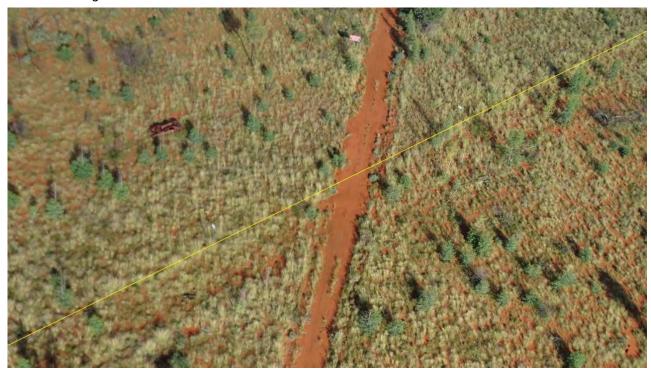
Pulardi Rd Gravel to Laramba KP 78.51 Below image shows the current condition of the track.

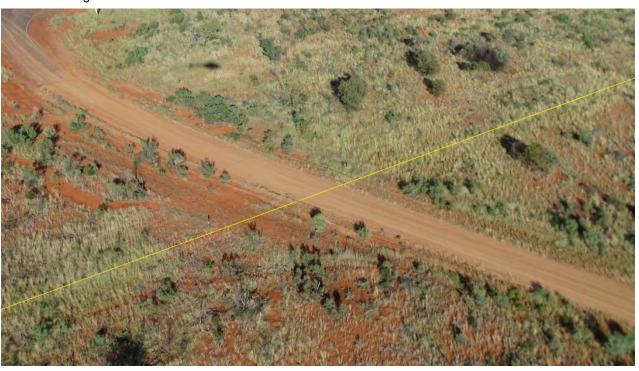
Yeulamu Rd Gravel KP 100.15 • Below image shows the current condition of the track.

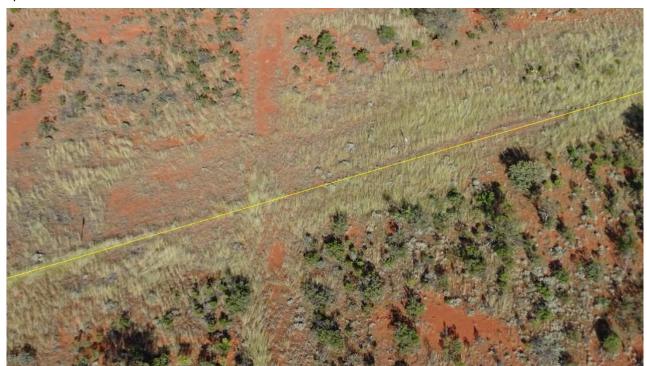
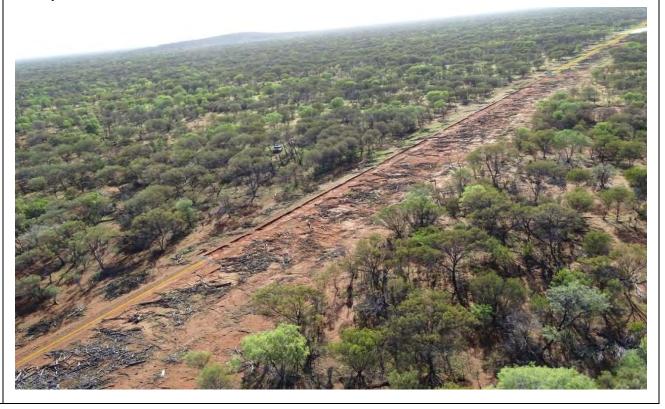
• Previously reported significant erosion along the pipeline trench in this location is covered by Buffel grass and no longer visible.

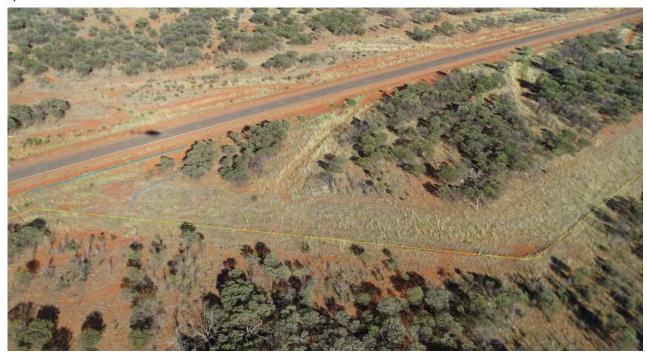
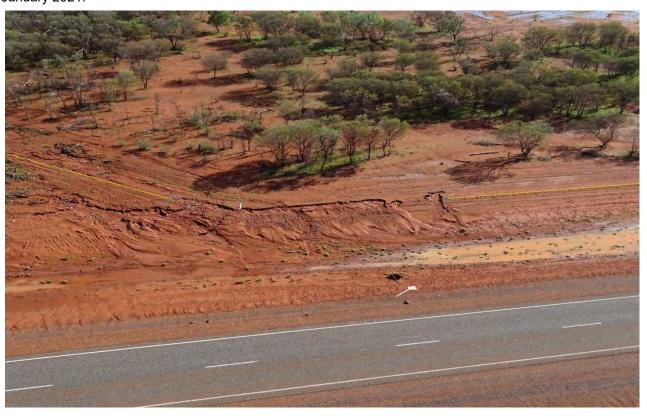
- Below image shows a previous area of moderate water erosion at a bend in the pipeline.
- Thick cover of Buffel grass makes the erosion difficult to observe.

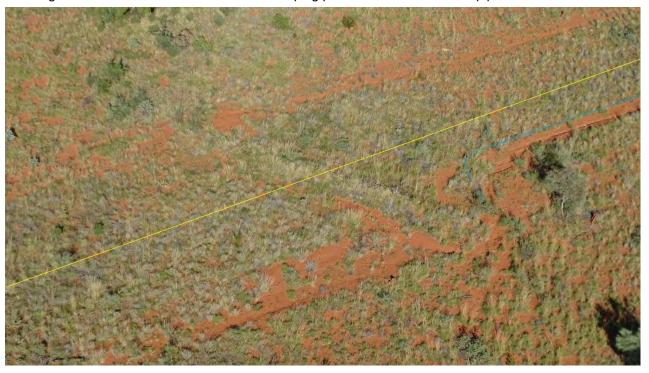
KP 135.20

Image below shows moderate erosion developing parallel to but clear of the pipe centreline.

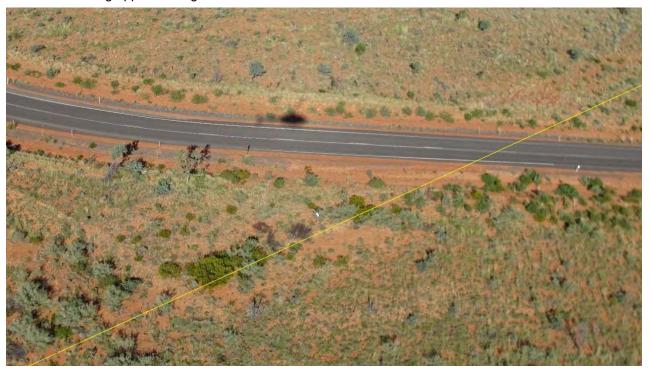
Yuendumu Rd KP 137.92

Road crossing appeared in good condition.

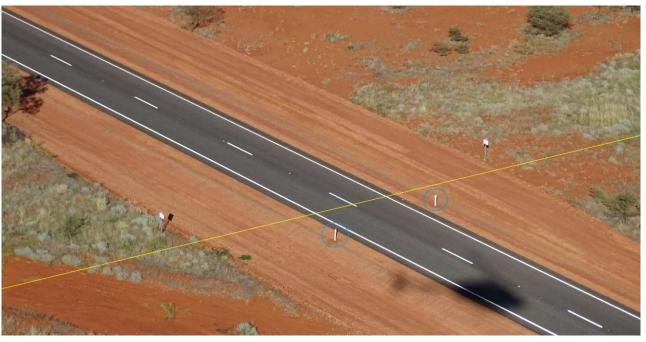
KP 140.04 Road to Yuendumu

- Upgrade of this road crossing appears complete.
- Guide markers have been recently installed by unknown method.
- LM liaison with Exact contracting has been productive and works have been covered under APW application system.
- Liaison post flight will confirm this methodology and future work scope at a number of crossings.

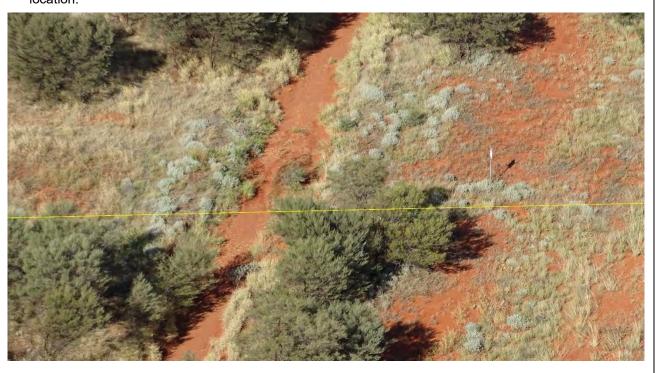
KP140.22

• Image below shows no significant changes to the natural water course forming across the pipeline at this location.

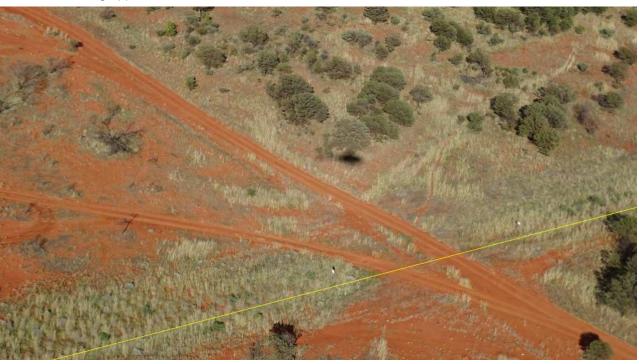
Track to Yuendumu Airport Gravel KP 140.88 Road crossing appeared in reasonable condition.

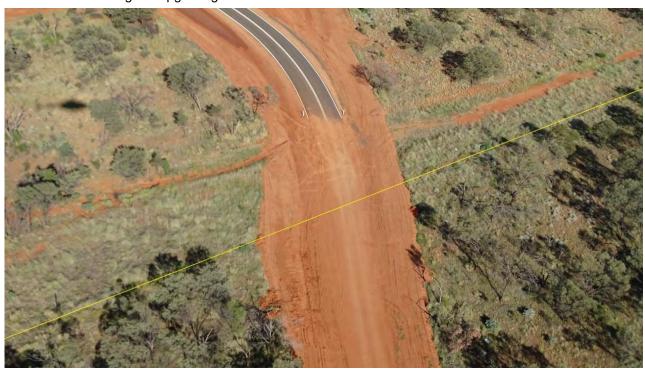
Rd to Yuendumu Airport Intersection KP 143.85

- Image below shows works to the existing track as part of the Tanami Road upgrade project continue.
- Exact Contracting are upgrading this section of the road.

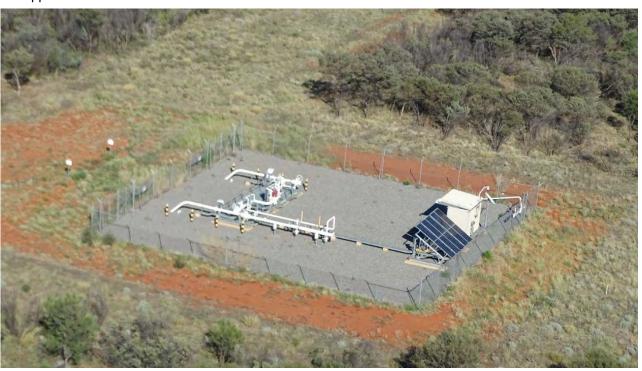
SS1 Yuendumu KP 144.91 • Appeared correct and secure.

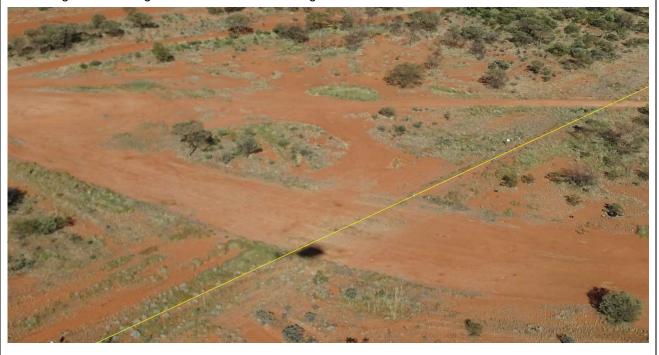
Truck Turning & Parking Bay KP 147.39

No significant changes observed to this crossing.

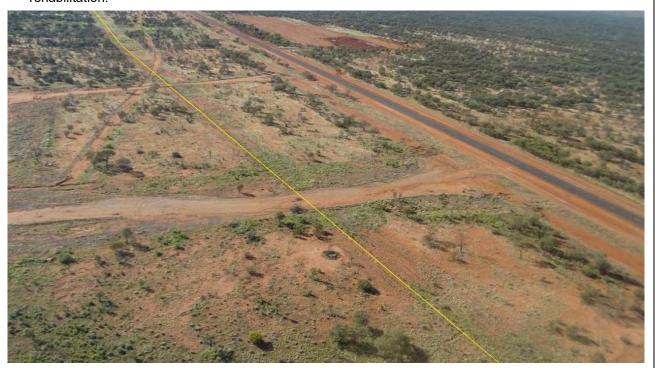
KP148.48

- Image below shows the current condition 3 x approved H.V crossing points that are part of the Tanami Road upgrade project being completed by Exact Contracting.
- H.V crossings were inspected on the ground in Dec 2022 and met the required specs for height / width.
- Activity at the neighbouring laydown / camp area appears complete and the site is undergoing rehabilitation.

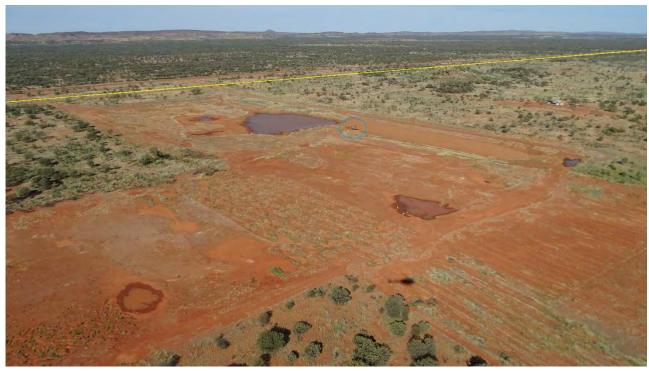
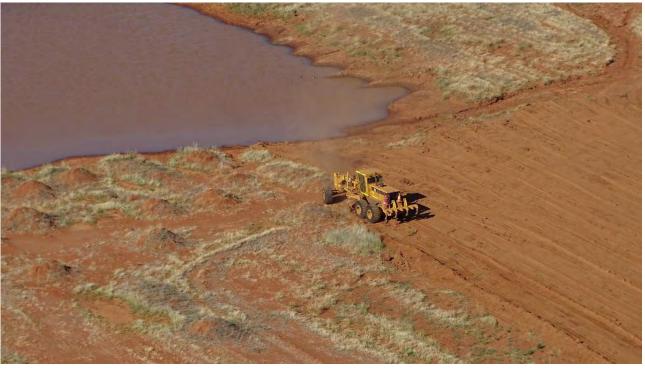
Camp Laydown KP148.48

- Below image shows the current condition of the previous camp/laydown yard.
- Activity at the laydown / camp area appears complete and the site is undergoing rehabilitation.

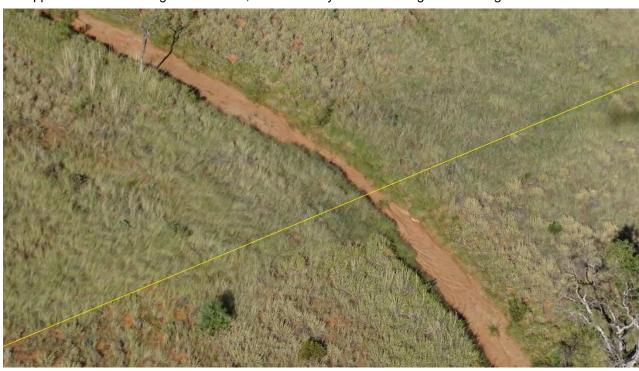
Mission Creek T2 KP KP 153.04 • Appeared to remain in good condition; banks heavily covered in vegetation overgrowth.

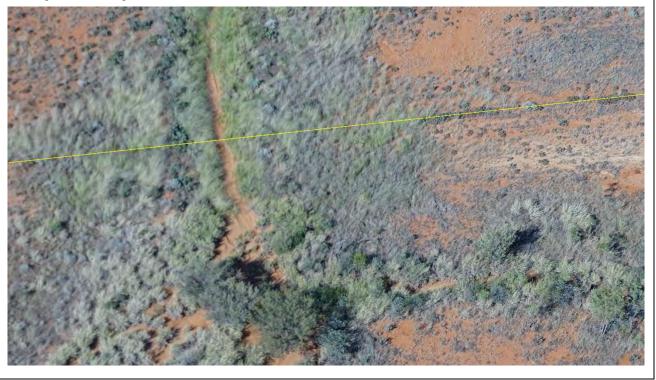
KP 153.57

Previously reported significant erosion developing along the trench line in this location is covered by vegetation overgrowth.

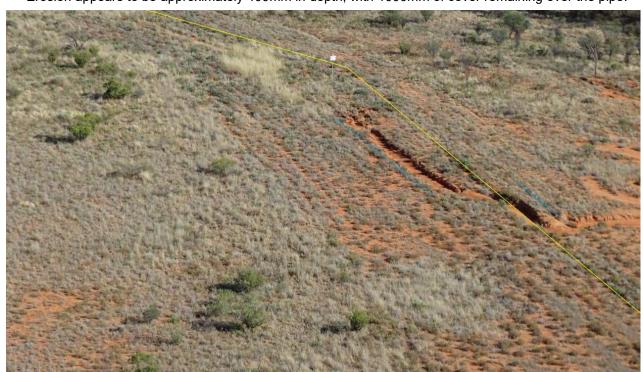
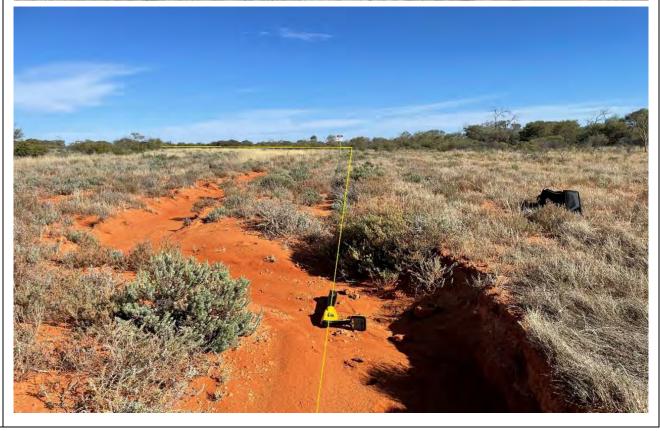
ROW KP 155.67

- A natural water course forming across the pipeline in this location; helicopter landed to investigate.
- Erosion appears to be approximately 400mm in depth, with 1000mm of cover remaining over the pipe.

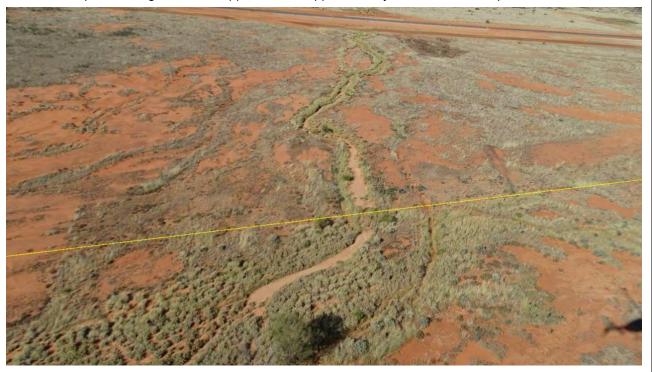
KP 156.29 Keridi Creek T3 Tributary

Below image shows moderate water erosion developing across the pipeline, no noticeable changes since the previous flight; erosion appears to be approximately 300-400mm in depth.

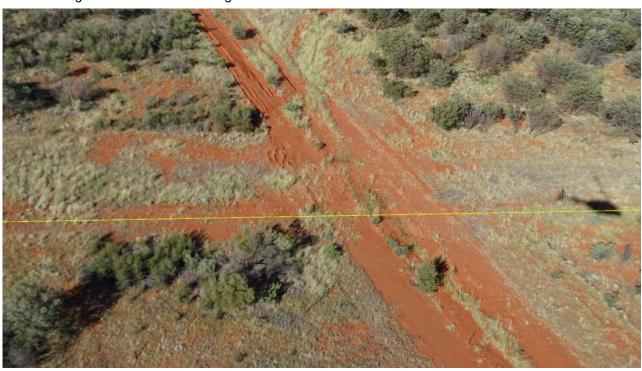
Mount Doreen Station Rd KP 159.93 No change to the old road crossing.

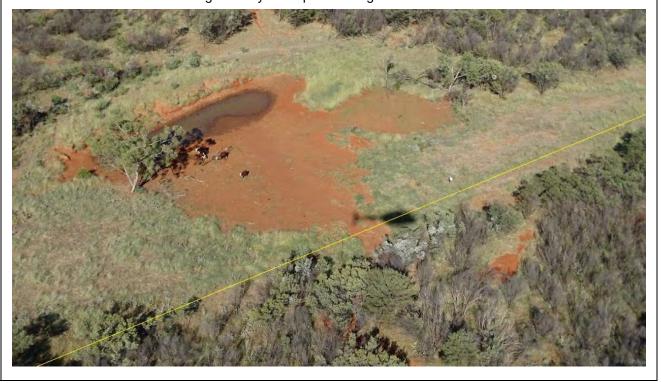
KP 160.89 – KP 161.50

- Below image shows one of a few water catchment areas in the easement within this section.
- Surface water has reduced significantly since previous flight.

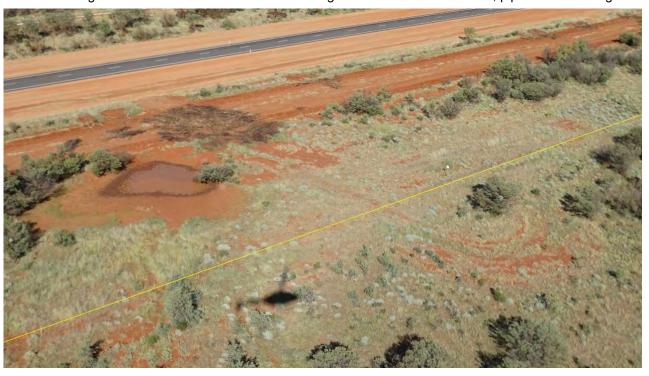
KP 162.61

• Below image shows moderate water erosion leading to a water catchment area; pipe crown eroding.

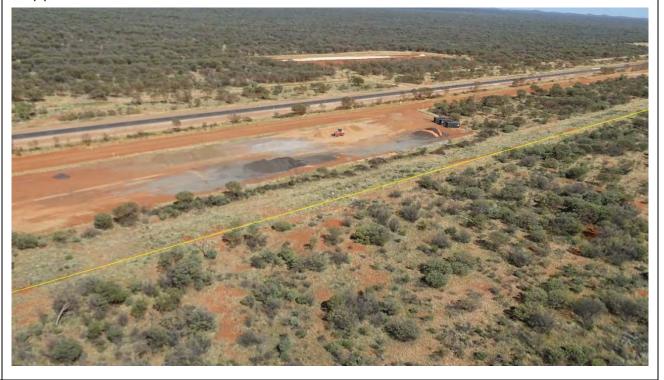
KP 170.01

Below image shows an Exact Contracting laydown yard for the Tanami Rd upgrade in proximity to the pipeline.

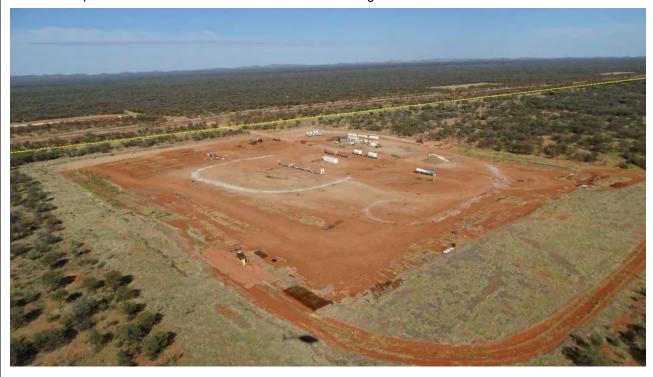
Camp 2 / Laydown KP 170.62

- Below image shows the camp site recently utilised by Exact Contracting for the Tanami Road upgrade.
- The camp has now been demobilised and the site is being rehabilitated.

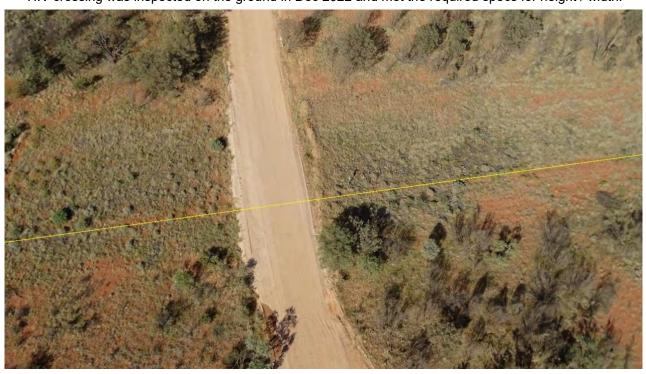
Camp 2 / Laydown KP 170.62 Access Track

- Below image shows the approved H.V crossing leading into the Exact Contracting camp site.
- H.V crossing was inspected on the ground in Dec 2022 and met the required specs for height / width.

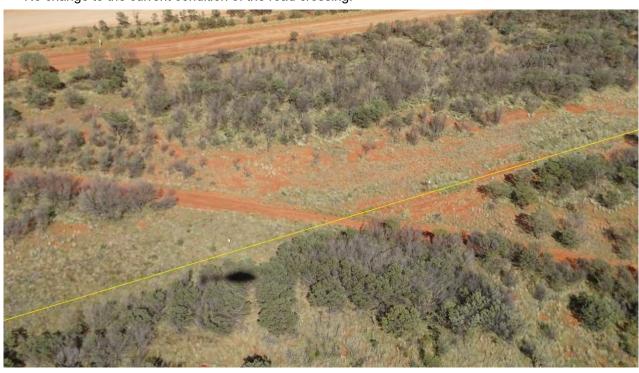
Gintys Bore Access Road KP 173.10 No change to the current condition of the road crossing.

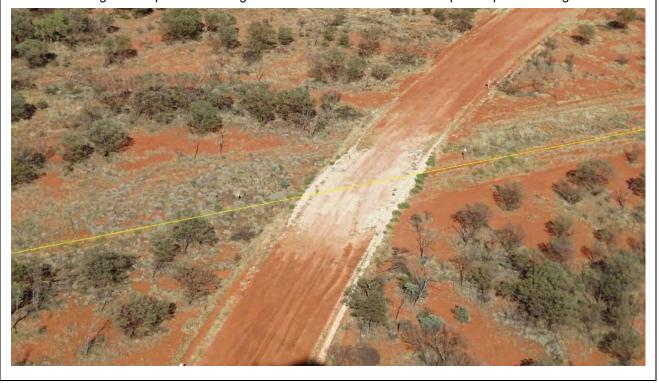
KP 177.31

- Below image shows an approved H.V crossing constructed by Exact Contracting at this location.
- H.V crossing was inspected on the ground in Dec 2022 and met the required specs for height / width.

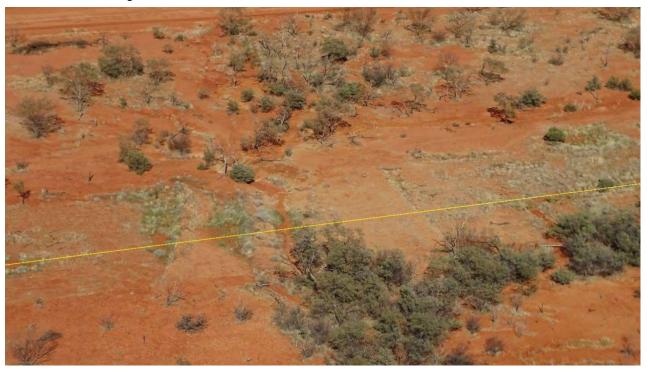
KP177.70

• Minor creek appears to be in reasonable condition and no significant change to erosion observed since the time of last flight.

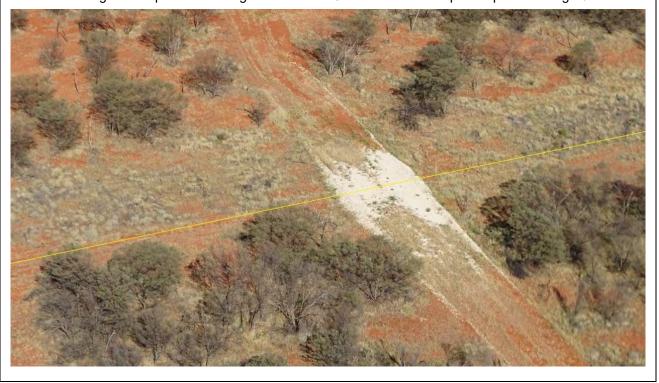
KP 177.94

- Below image shows an approved H.V crossing constructed by Exact Contracting at this location.
- H.V crossing was inspected on the ground in Dec 2022 and met the required specs for height / width.

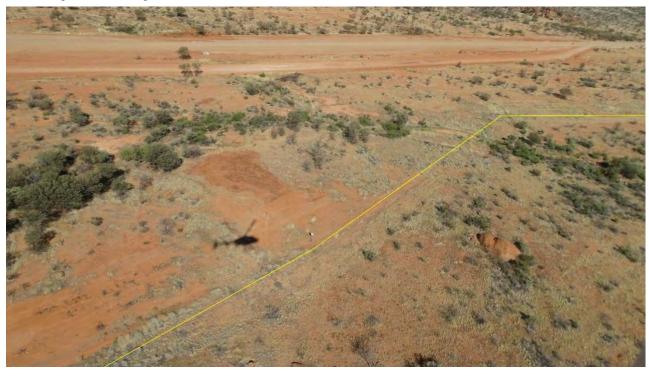
Yaloogarrie Creek T1 & Tributaries KP 179.96 – KP 181.36 No significant changes observed to the creek and its tributaries.

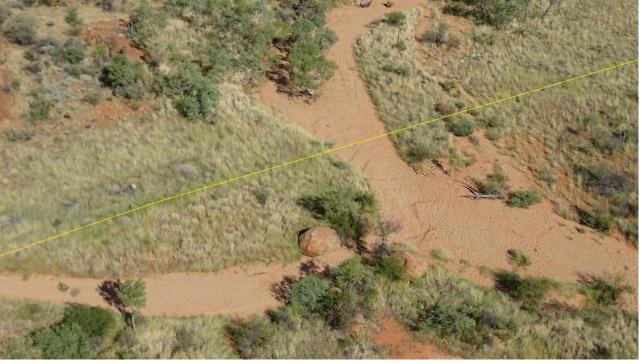
Yaloogarrie Creek T1 & Tributaries KP 179.96 – KP 181.36 No significant changes observed to the creek and its tributaries.

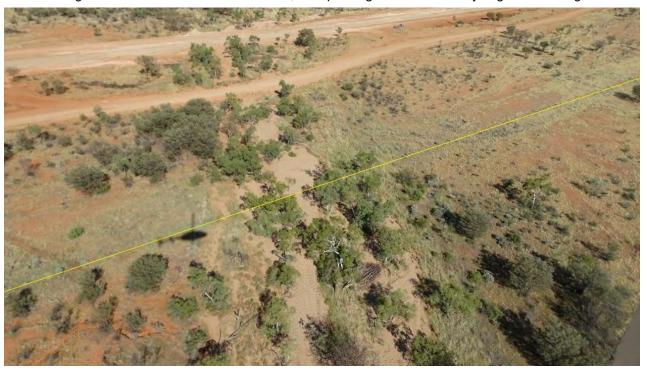
Yaloogarrie Creek Tributaries KP 184.20 KP 185.00 • No change observed to the creeks tributaries, rock pitching areas covered by vegetation overgrowth.

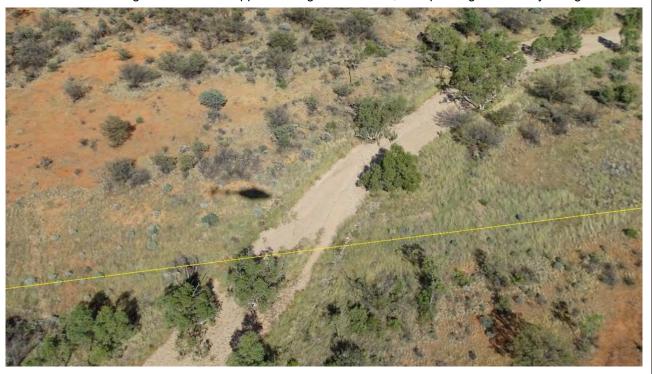
Yaloogarrie Creek Tributaries KP 188.90 – 189.24 • The water crossing at this location appeared in good condition; rock pitching covered by overgrowth.

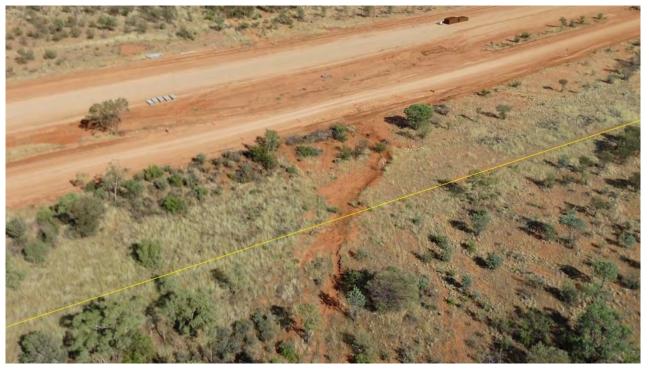
KP 191.83

• Below image shows some moderate erosion developing close to a known T3 water crossing.

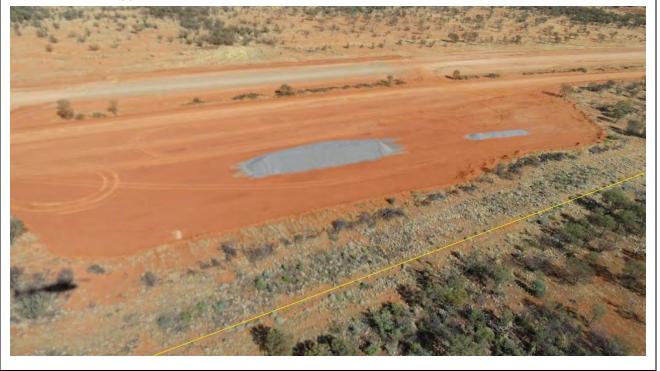
KP 192.66

Below image shows an Exact Contracting laydown yard cleared in very close proximity to the pipeline easement; all appears correct.

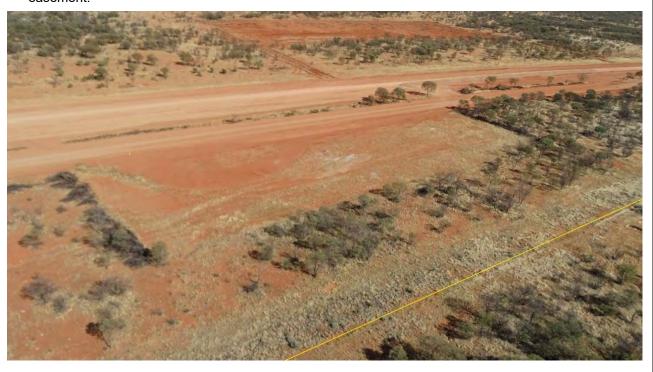
KP 193.09

• Below image shows an Exact Contracting laydown yard cleared in close proximity to the pipeline easement.

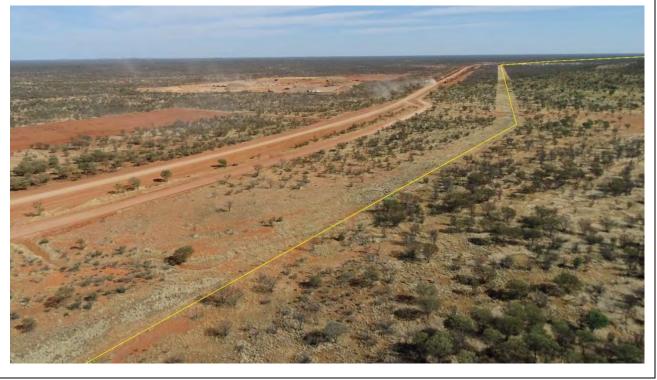
KP 196.40

Below image shows a section of the Tanami Road upgrade in proximity to the pipeline, approaching the new Exact Contracting camp and stockpile area.

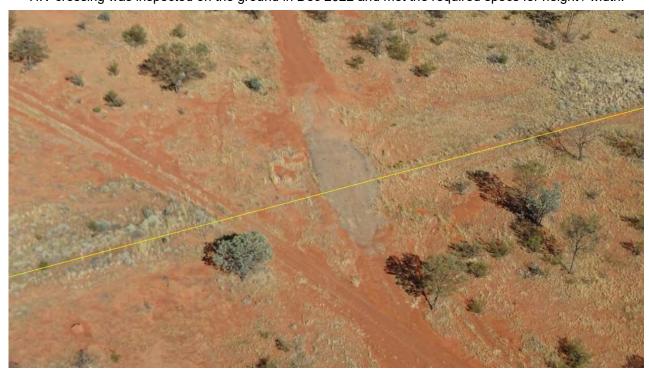
KP 196.74

- Below image shows an approved H.V crossing constructed by Exact Contracting at this location.
- H.V crossing was inspected on the ground in Dec 2022 and met the required specs for height / width.

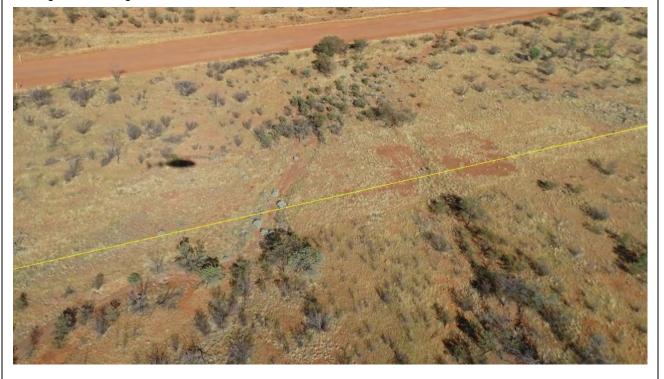
Watercourse T3 KP 198.07 • The water crossing at this location appeared in reasonable condition; rock pitching not visible due to vegetation overgrowth.

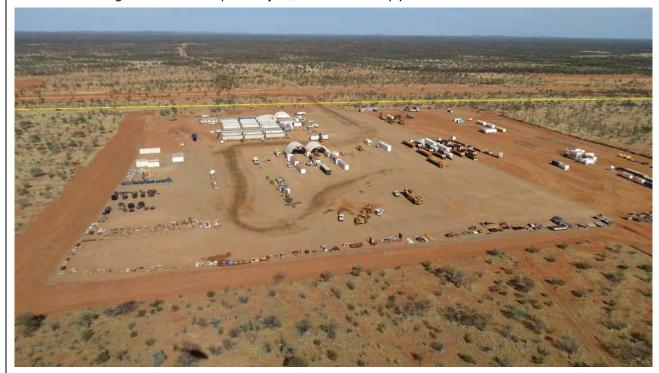
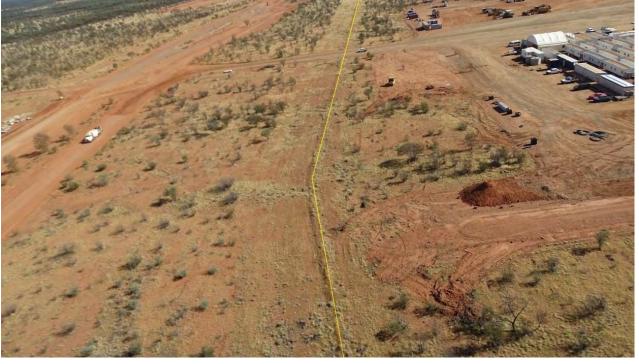
KP 199.07 New Camp Exact Contracting

- Below image shows the newly set up camp, utilised by Exact Contracting for the next stage of the Tanami Road upgrade.
- Some clearing has occurred in proximity to, but clear of the pipe centreline.

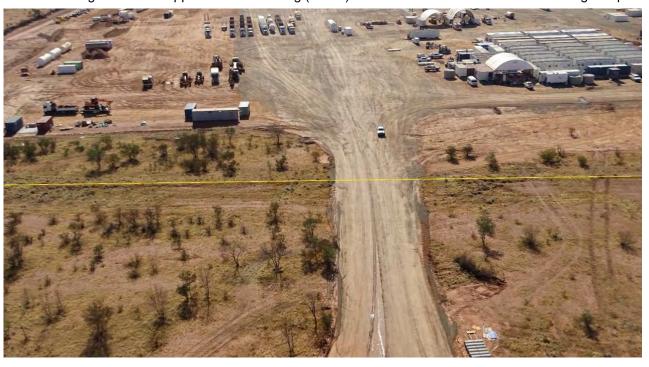
KP 199.07

• Below image shows an approved H.V crossing (No.11) for access to the new Exact Contracting camp.

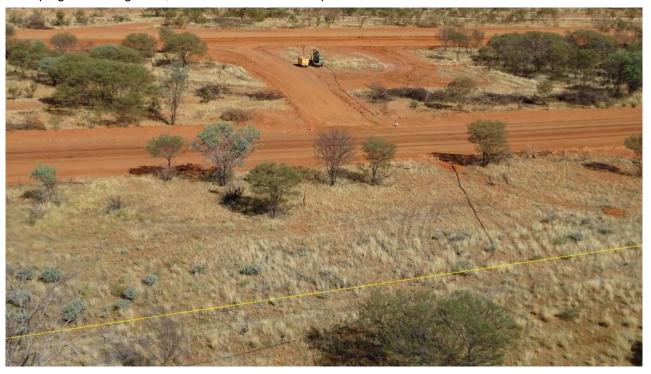
KP 200.22

- A poly water line has been placed within the corridor, but no excavations observed.
- Pipe goes underground, outside of the corridor to pass under the Tanami Road.

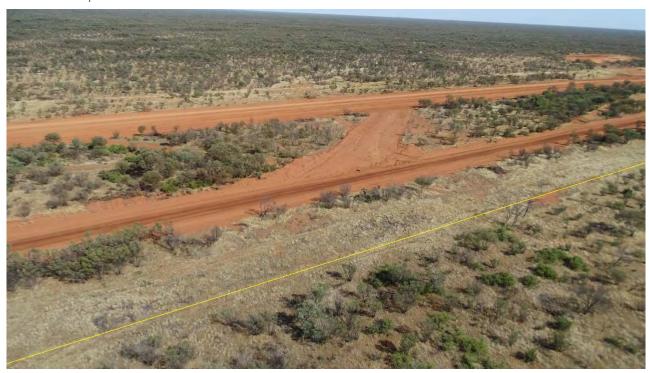
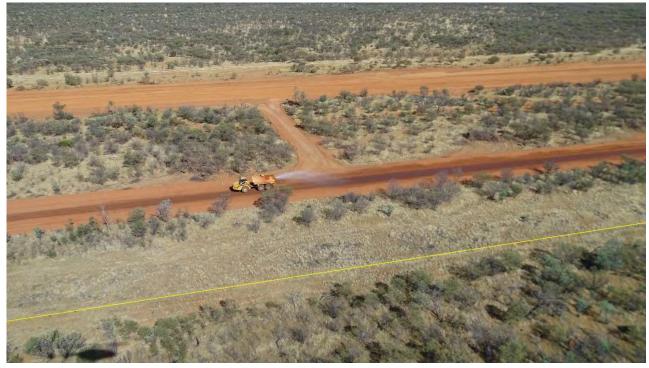
KP 203.00 - 206.00

Below image shows Exact Contracting are clearing a new slip road in very close proximity to the easement; no encroachments were observed.

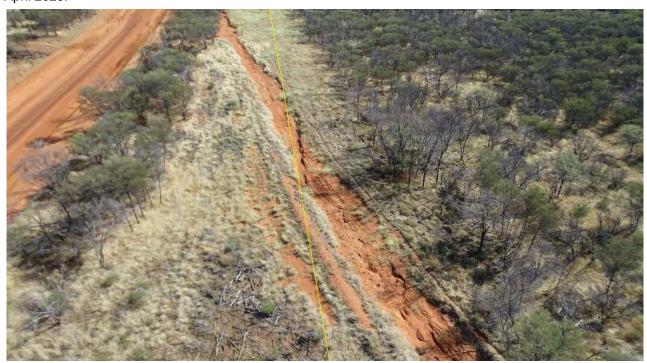
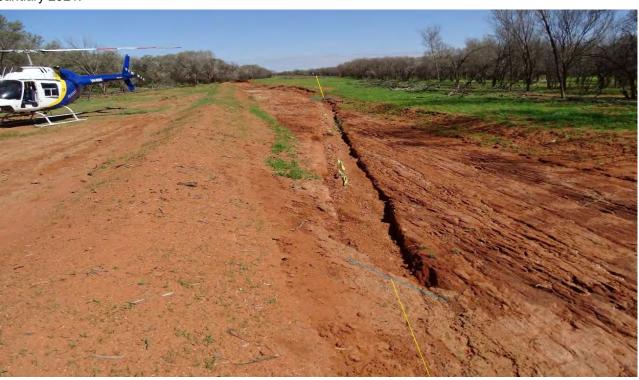
- Below image shows previously reported major erosion and washout over the easement.
- Marker tape is exposed but actual loss of cover over the pipeline is approximately 200 300mm.

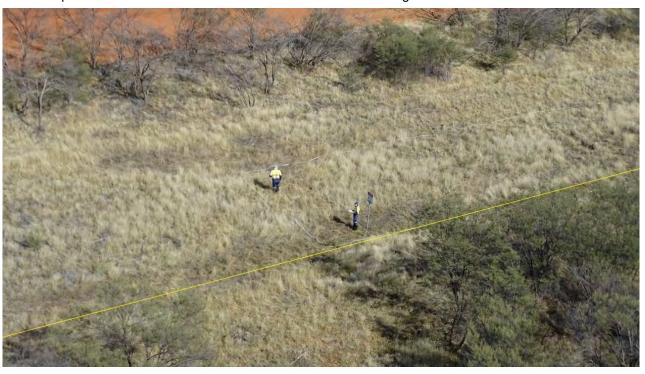
KP 207.00

- Environmental crew observed working in the corridor for AGIG.
- Helicopter landed to check all was correct and all work is above ground with no excavations etc.

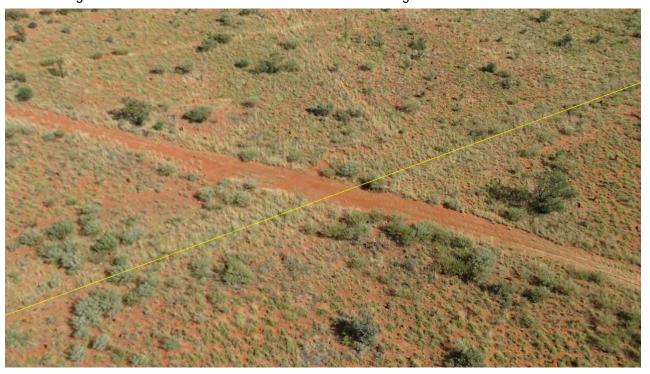
Gravel Road KP 218.100

No change observed to the current condition of the road crossing.

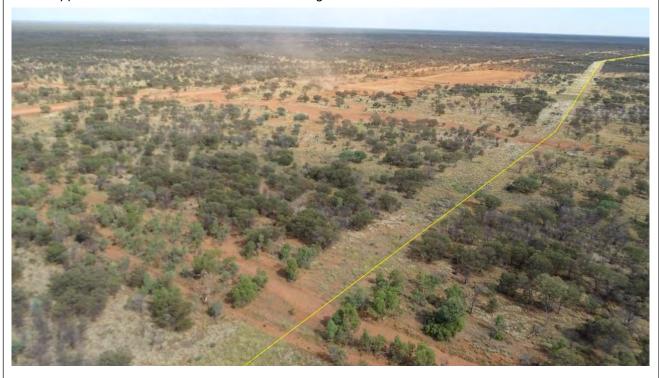
Flood Out Creek T2 KP 228.16 • All appeared correct at Flood Out Creek crossing.

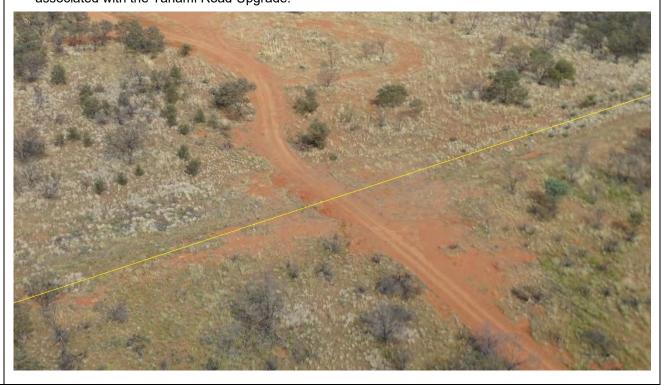
KP228.39

Below image shows an approved H.V crossing (No.12) built up by Exact Contracting for works associated with the Tanami Road Upgrade.

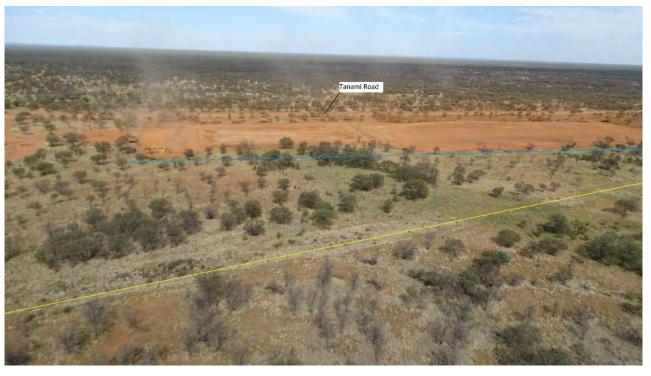
KP 228.90

• Below image shows clearing and civil works underway in proximity to the pipe corridor, in preparation for a future camp or laydown yard to service the Tanami Road Upgrade.

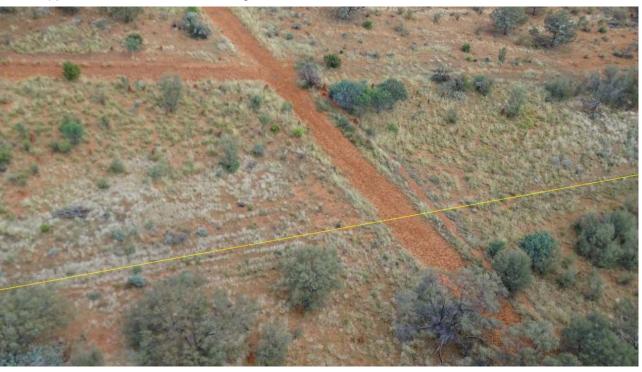
KP 235.57

All appear correct at the track crossing.

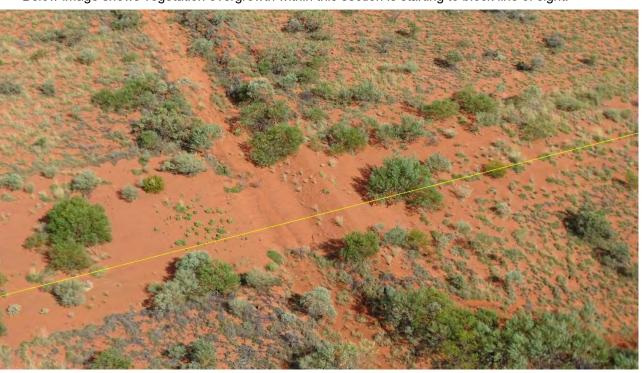
KP 252.00 -KP 264.00

• Below image shows vegetation overgrowth within this section is starting to block line of sight.

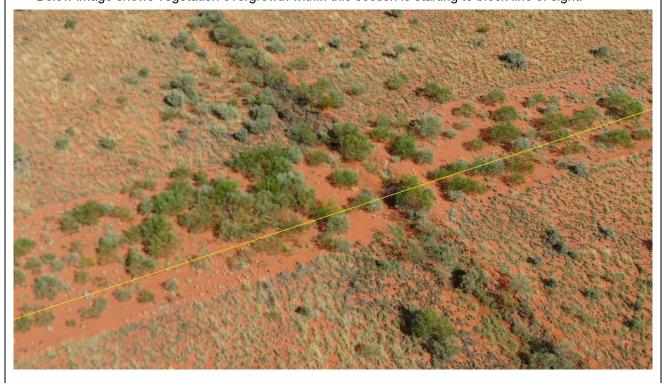
KP 252.00 -KP 264.00 Below image shows vegetation overgrowth within this section is starting to block line of sight.

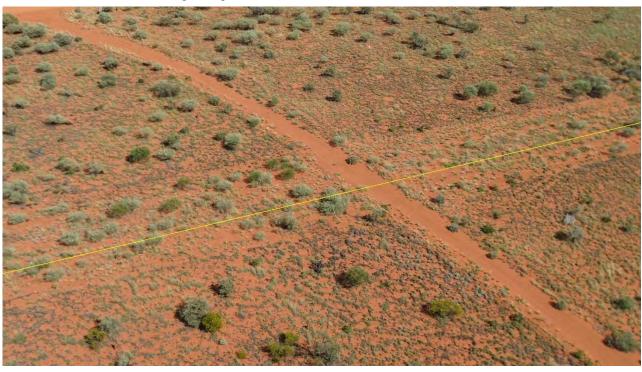
Mount Theo Road KP 263.24 Mount Theo Road Crossing is in good condition.

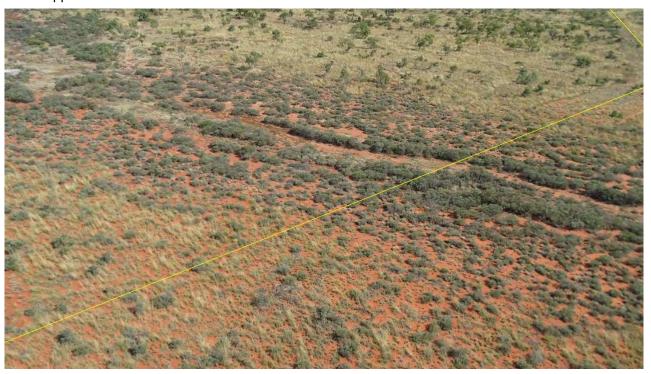
Watercourse T2 Chilla Well KP 266.64

All appeared correct at the watercourse at KP 266.640.

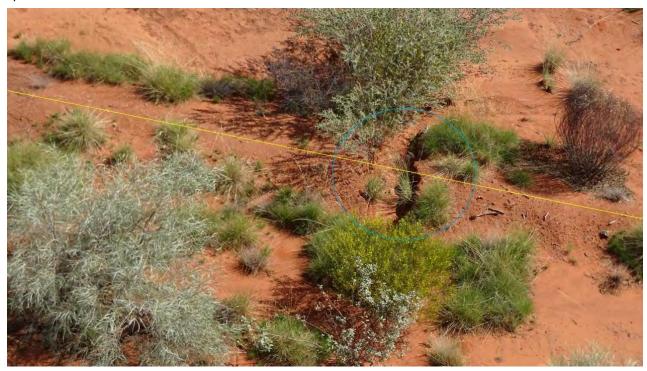
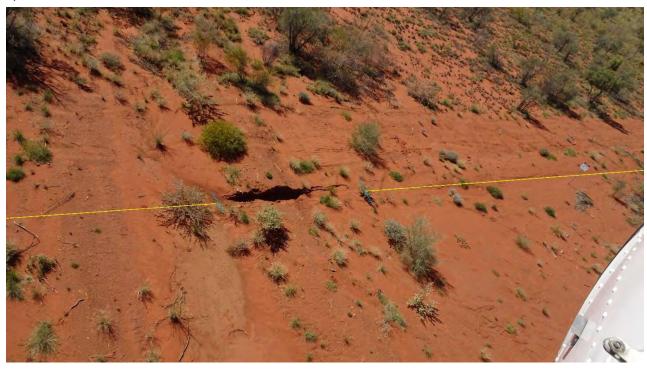
• Significant erosion at the bank of a known swale drain crossing point, has been covered by over growth and appears to have partially filled in naturally during water flows.

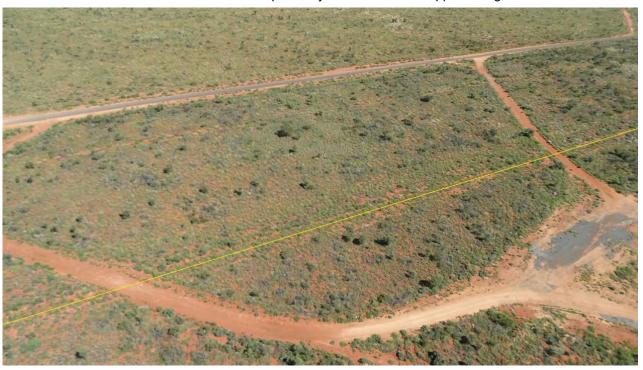
KP 323.83

• Access track and truck turn around site in proximity to the easement appears in good condition.

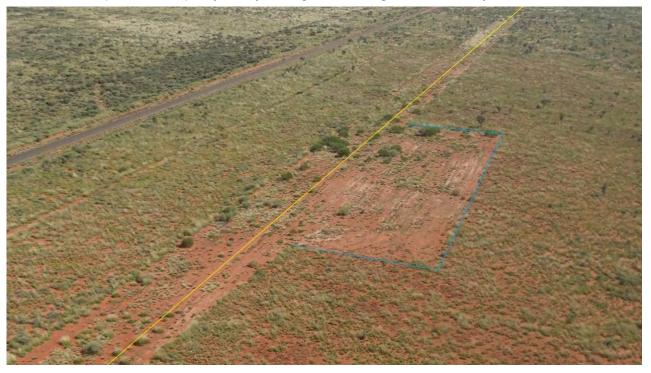
Camp 3 / Laydown KP 332.00 All correct at previous camp / laydown yard; regrowth making it hard to identify now.

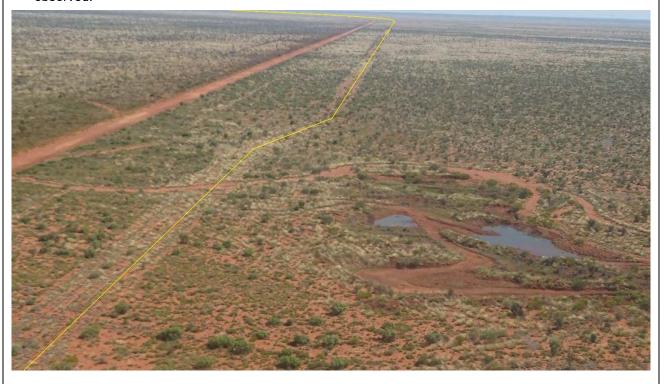
KP 335.16

• Gravel extraction site in proximity to the easement is slightly flooded and no new activity has been observed.

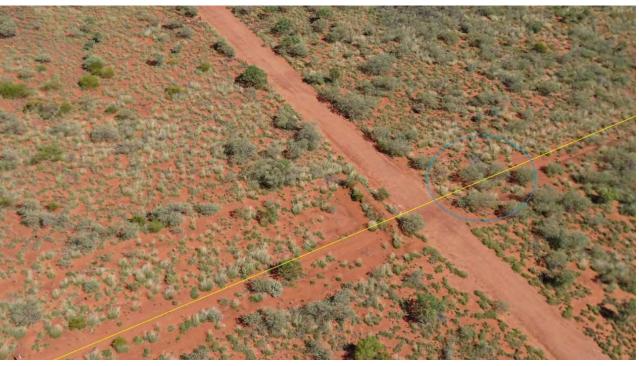
KP 385.45

• All correct at the road crossing; vegetation on the downstream side is now impacting line of sight.

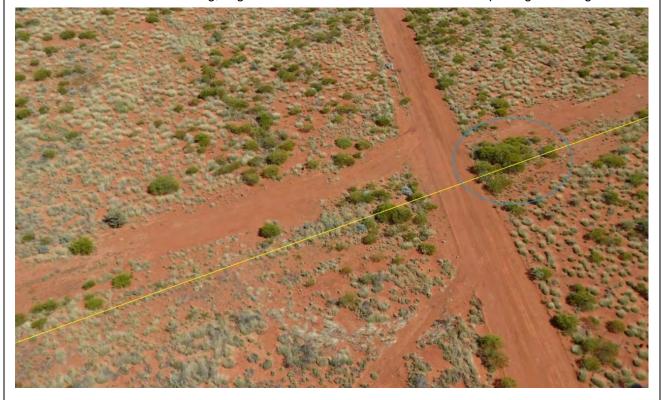
Mount Davidson / Billabong Borefield Rd KP 390.58 All correct at the road crossing; vegetation on the downstream side is now impacting line of sight.

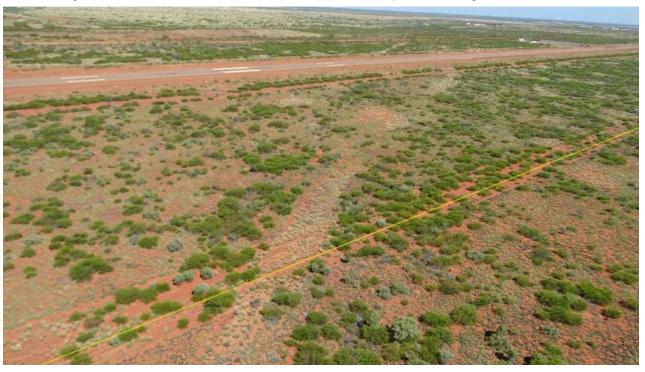
KP 395.10 Granites Airstrip

• Thick regrowth has occurred on the corridor and will start to impact line of sight in the near future.

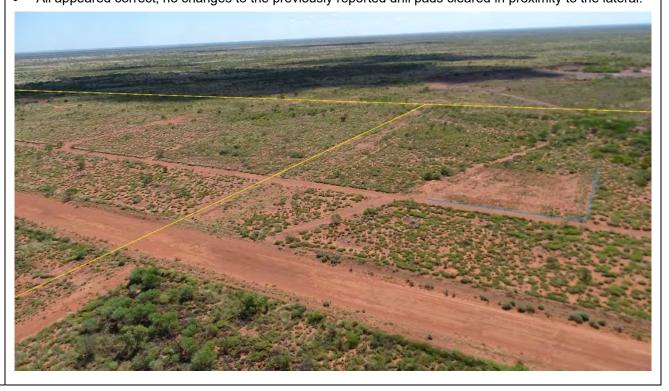
Off take / Valve for Granites Lateral KP 397.84 • All appeared correct; no changes to the previously reported drill pads cleared in proximity to the lateral.

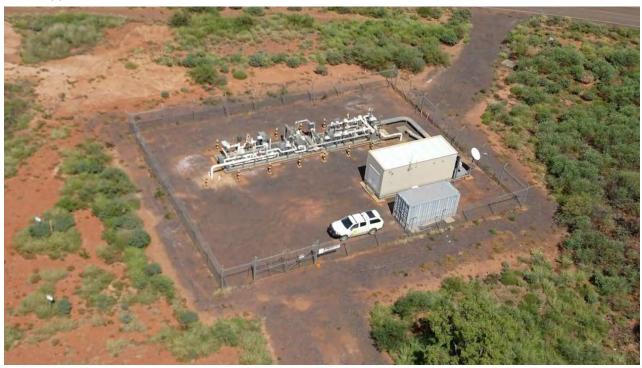
Granites Meter Station KP 0.69 • All appeared correct and secure.

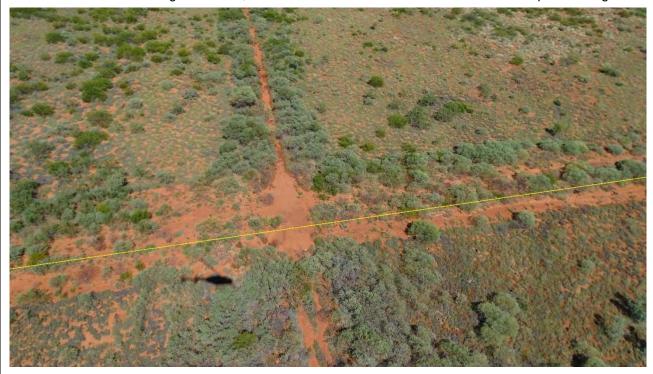
Swale Drain KP 403.98 No water erosion damage observed, but some evidence of water flow observed since previous flight.

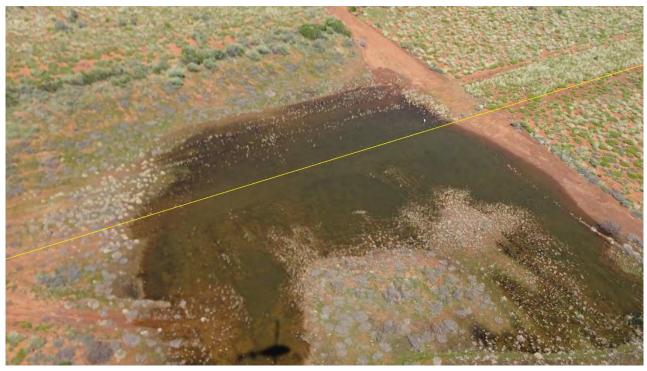
KP 418.47

• Image below shows the only location of any significant standing surface water observed along the line during this flight.

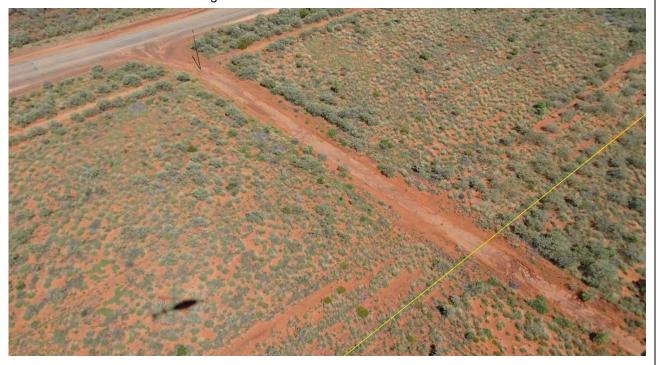
KP 436.07

No further water erosion damage to the Swale Drain outside the corridor at KP 436.070

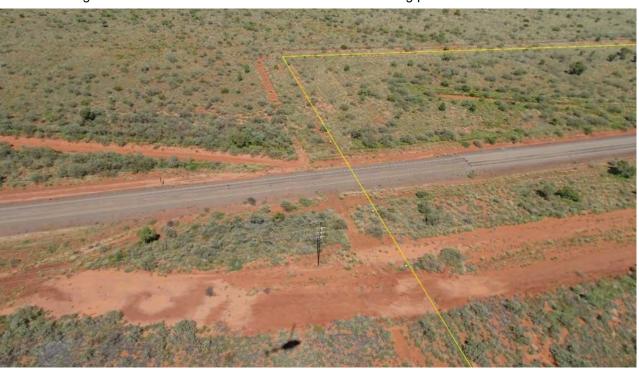
DBS Haul Road KP 436.99 • Below image shows the current condition of the haul road crossing point.
