Tanami Gas Pipeline: Annual Compliance Assessment Report EBPC

E-REP-069

Date: 7 August 2023

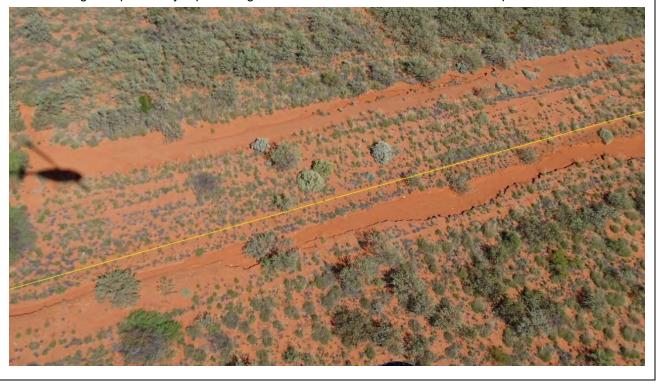
KP 439.47

No changes to previously reported significant erosion confirmed at 670mm in depth.

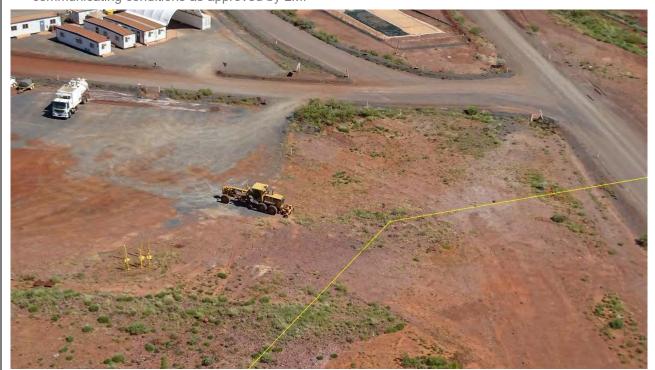
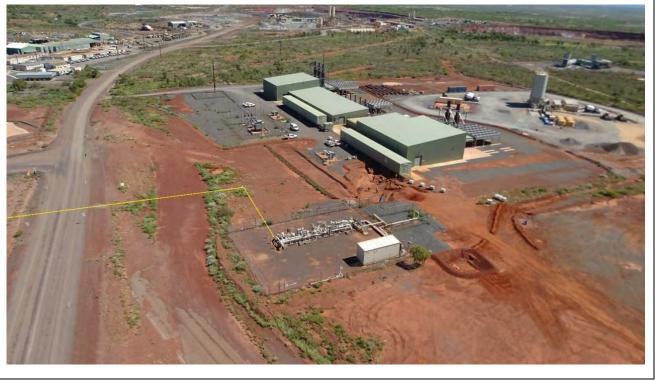
DBS Meter Station & Haul Road KP 440.00

- Below images show the current condition of the haul road and lay down areas leading up to the DBS Meter Station.
- Zenith Power Station upgrade construction continues.
- Facilities management inspected site 15th 18th August 2022; providing exclusion zones and communicating conditions as approved by LM.

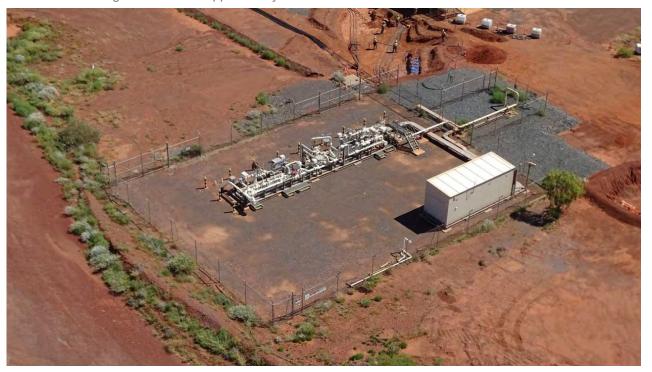
DBS Meter Station & Haul Road KP 440.00

- Below images show the current condition of the DBS Meter Station.
- Zenith Power Station upgrade construction continues.
- Facilities management inspected site 15th 18th August 2022; providing exclusion zones and communicating conditions as approved by LM.
