**KEMERTON LATERAL PIPELINE**

**Rehabilitation Plan**

**September 2005**

**WOODMAN ENVIRONMENTAL CONSULTING PTY LTD**

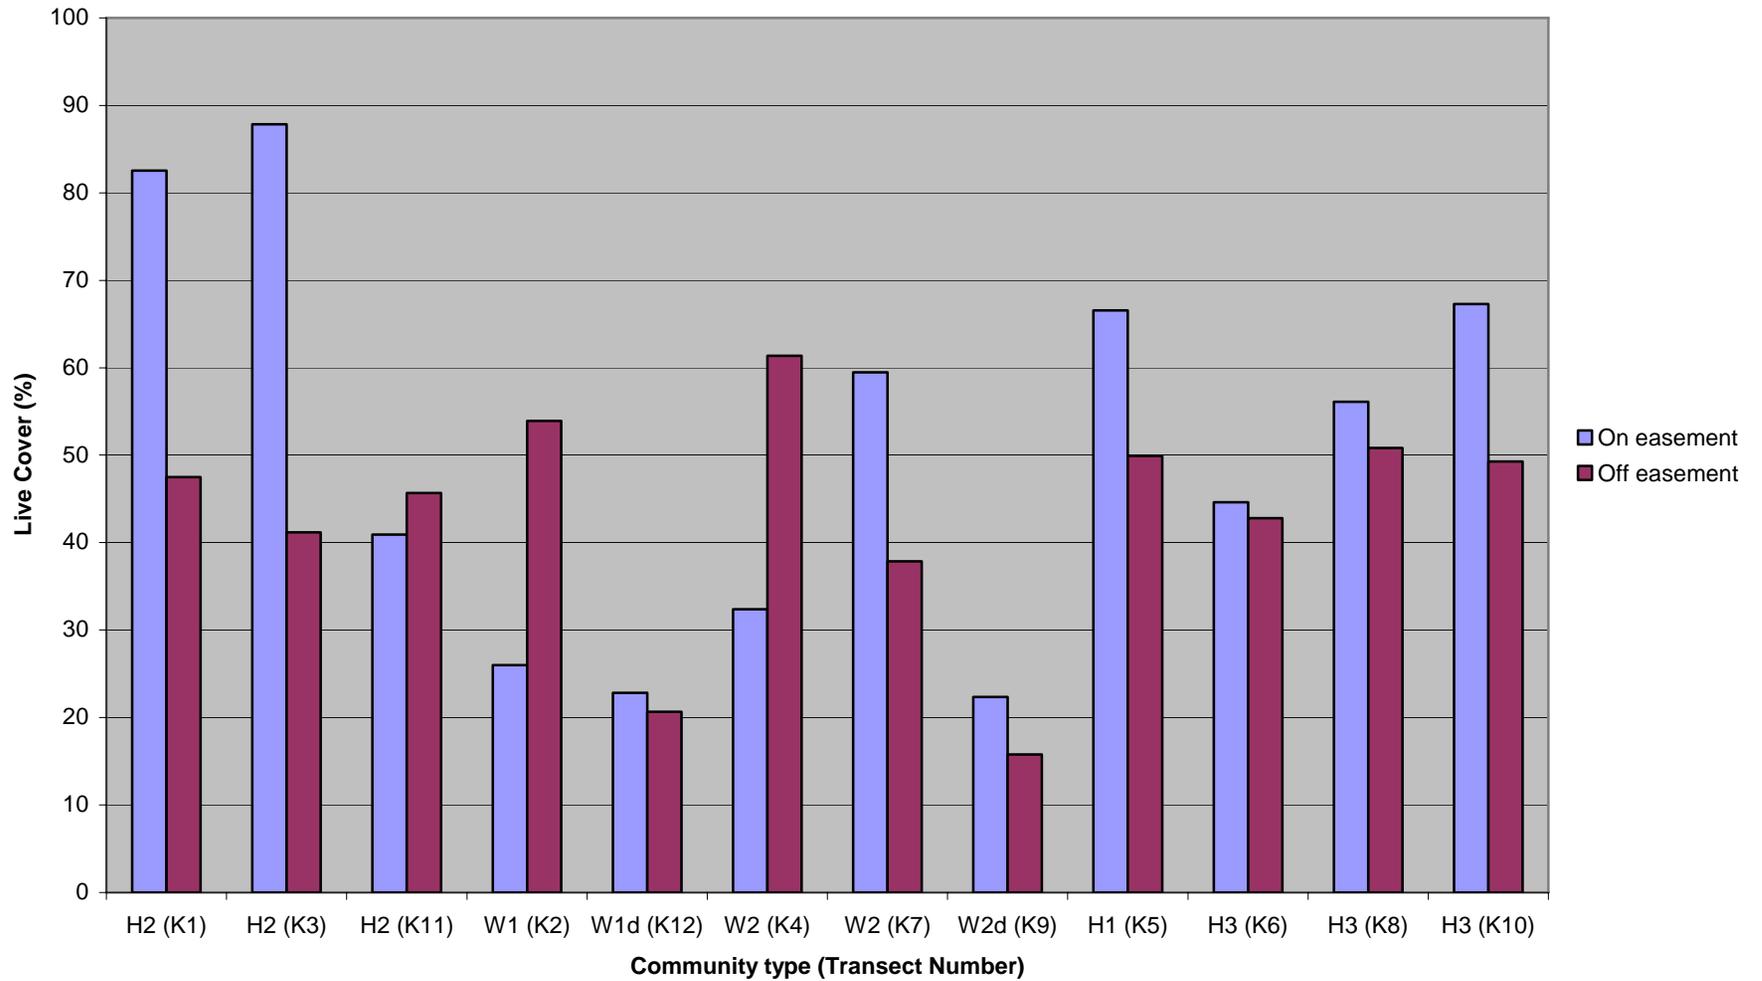
**Figure 3: Foliage Cover Measured On and Off the Pipeline Easement**

The high foliage cover recorded in transect K7 on the easement may be attributed to extensive cover of *Adenanthos meisneri* and moderate cover of *Kunzea glabrescens* within quadrats on the easement. Within quadrats off the easement few species had high covers.

The results generally indicate that the woodland plant communities had higher cover of plants off the easement compared to on the easement, however Figure 3 illustrates contrasting results for cover of plants in community W2.

In contrast to the woodland communities, the wetland heath communities have developed similar or greater foliage covers on the easement compared to the adjacent undisturbed vegetation. Figure 3 illustrates a significantly higher cover of plants in two transects in community H2 on easement compared to off the easement. This may be attributed to very high covers of *Hypocalymma angustifolium* and *Melaleuca preissiana* in transect K1. Also, the species composition on the easement appears to be slightly different with several key species having developed significantly higher covers on the easement. In particular, very high covers of *Astartea affinis* were recorded on the easement in contrast to much reduced covers of this species off the easement for transect K3.

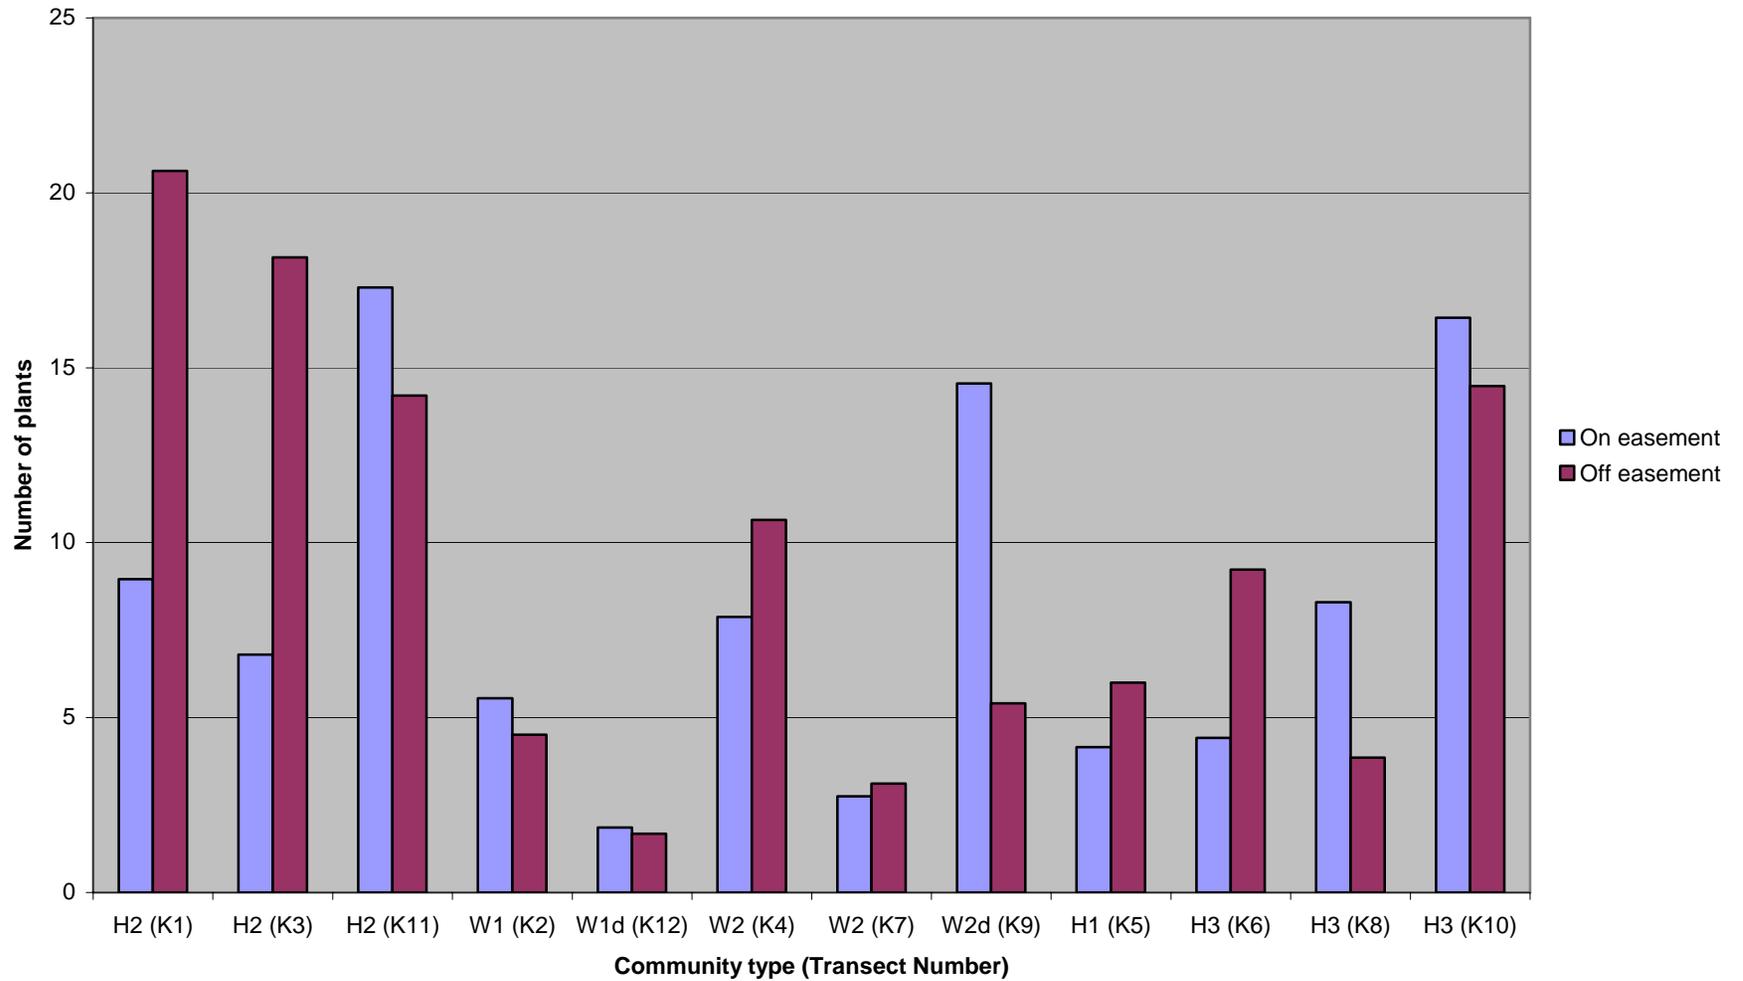
**Figure 4: Plant Density Measured On and Off the Pipeline Easement**

Plant densities were generally higher in quadrats located off the easement, however several quadrats located in a disturbed woodland had higher densities recorded on the easement. Figure 4 illustrates significantly higher density of plants in two transects in wetland heath communities H2 and H3 off the easement.

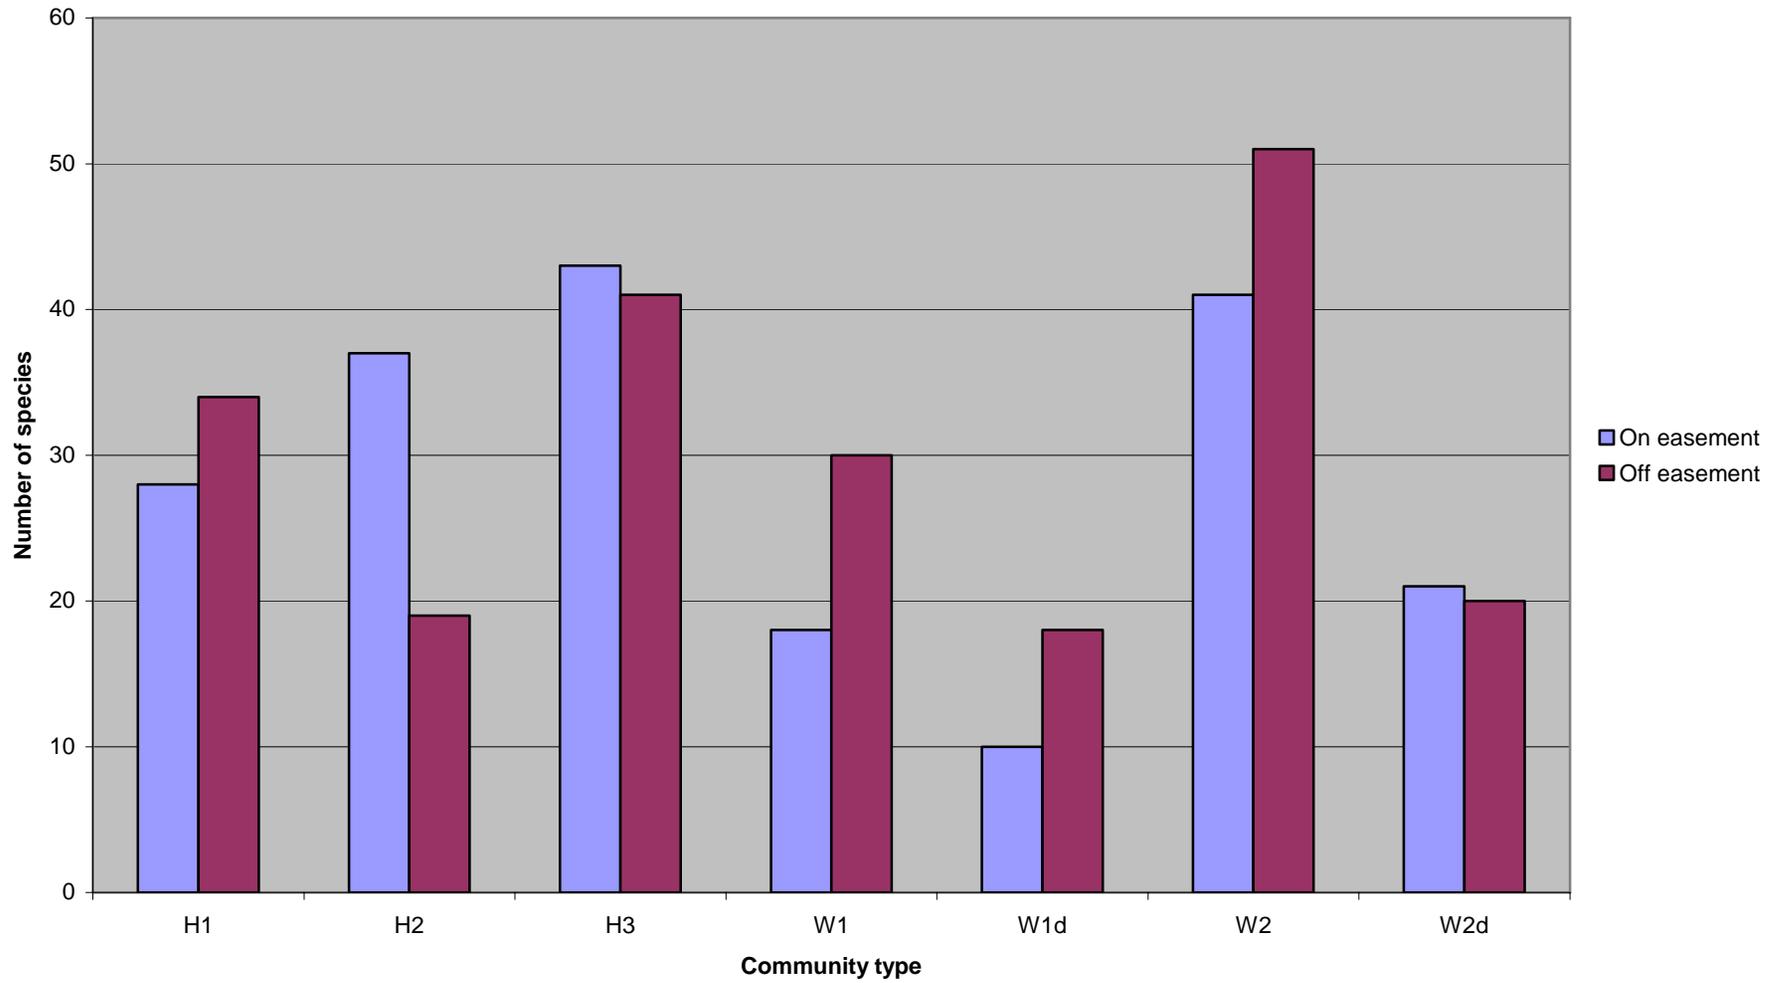
**Figure 5: Species Richness Measured On and Off the Pipeline Easement**

Figure 5 illustrates that in general more species were recorded off the easement than on it, though the wetland heath communities had similar numbers of species recorded both on and off the easement. However, significantly more species were recorded on the easement in comparison to off the easement in community type H2. This may be attributed to the presence of a different community type on the easement that is much more diverse than the *Pericalymma ellipticum* swamp that occurs off the easement in K1. This community type may have developed as a result of the easement disturbance, however it is also possible that the easement coincides with a natural boundary between two plant communities.
